HYUNDAI Technical Service Bulletin	GROUP CAMPAIGN	NUMBER 22-01-064H
	DATE JULY, 2022	MODEL(S) SANTA FE (TMa)
SUBJECT: INSTRUMENT CLUSTER SOFTWARE UPDATE (SERVICE CAMPAIGN T8Q)

This bulletin provides the service procedure to update the instrument cluster software to resolve the condition stated above.

Applicable Vehicle: Certain 2021MY Santa Fe (TMa) equipped with all digital instrument cluster (Supervision) display.

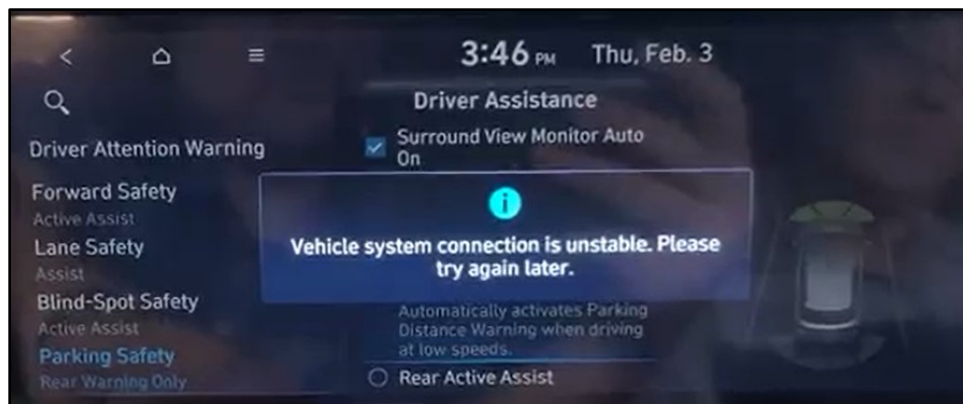
Description: Some 2021 Santa Fe (TMa) vehicles may display an error message in the instrument cluster when making a selection in the Driver Assistance Menu. Possible messages are:

- "Vehicle controller error, settings cannot be applied for RCTA alert active assist, please try again later."
- "Vehicle controller error, settings cannot be applied, please try again later."
- "Vehicle system connection is unstable. Please try again later."
