GLOBAL SAFETY FIELD INVESTIGATIONS
DCS6224
URGENT - DISTRIBUTE IMMEDIATELY

Subject: N212354525 - Customer Satisfaction Program
Heated Vented Seats Retrofit Due to Chip Shortage
Rear Seat Heater Module, Switches and Programming

Models: 2022 Buick Enclave
2022 Chevrolet Traverse

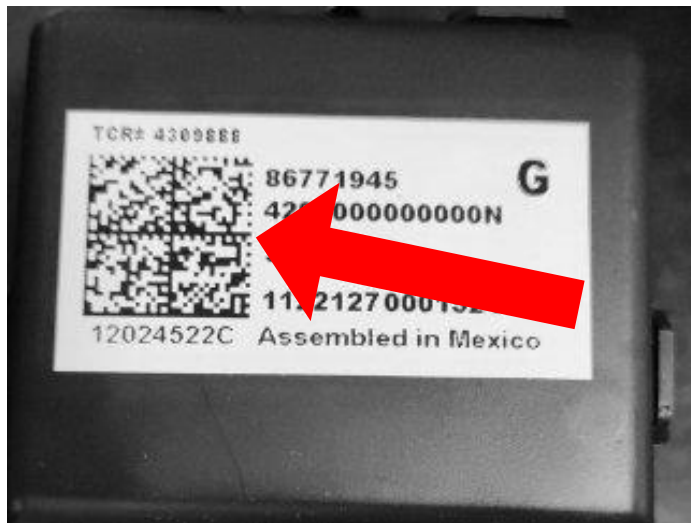
If the App is already loaded to your phone, simply:

1. Scan the VIN (door pillar QR code or windshield VIN barcode) and
2. Scan the new part (QR code) and
3. Check the information and if correct then, Submit.
