ECU Flash Reprogramming With Security Signature

Service Category Engine/Hybrid System

Section Engine Control

Introduction

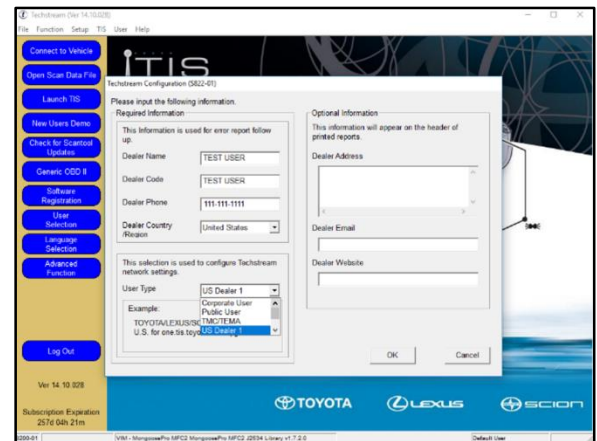
Figure 1.

1. Select Setup from the Techstream main menu screen.
2. Select Techstream Configuration from the Setup dropdown menu.
3. Select the area and language.
4. Input information and select US Dealer 1 from the dropdown menu.

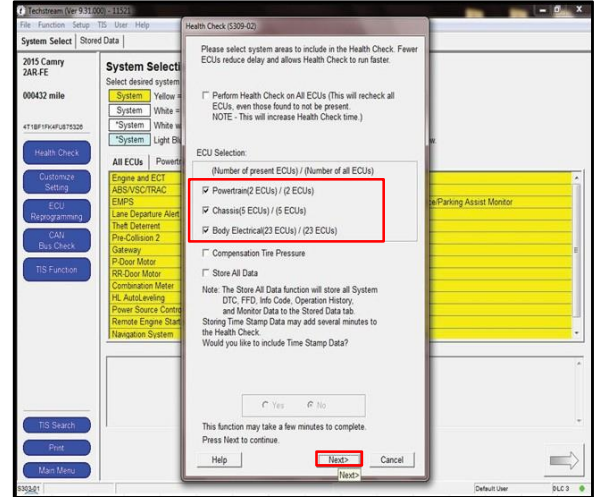
Figure 6.

- C. Choose the desired ECU group(s) in the Health Check dialog box, then click Next.

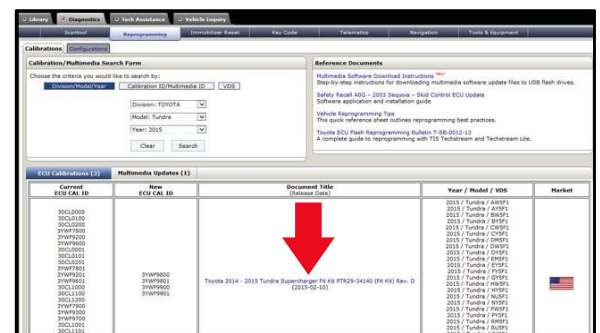
Figure 9.

- G. To review the Service Bulletin and access the calibration file, click the Service Bulletin link in the Document Title column of the Calibration Search Result portlet.

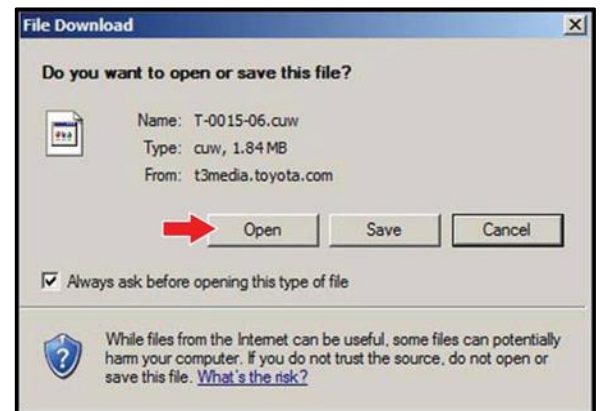
Figure 11.

- B. Click Open to load the calibration file information.

Techstream downloads calibration files as needed to ensure the latest calibration file is used. Do NOT save calibrations locally on the hard drive or other media.

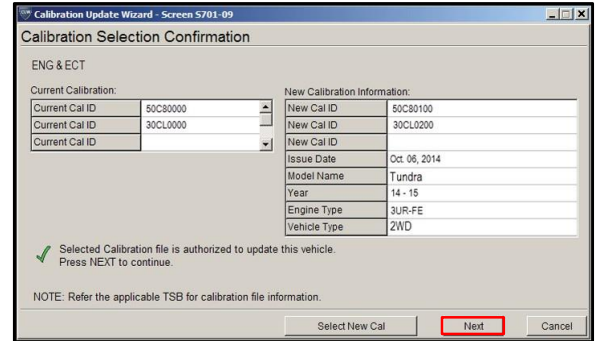
Figure 14.

- E. Verify correct current and NEW calibration information, then click Next.

- The total number of calibration IDs in the calibration file corresponds to the number of reprogrammable processors in the ECU.
- Each calibration file may contain up to three separate calibrations.
- Figure 15 shows an example of the update procedure for a two-processor ECU.

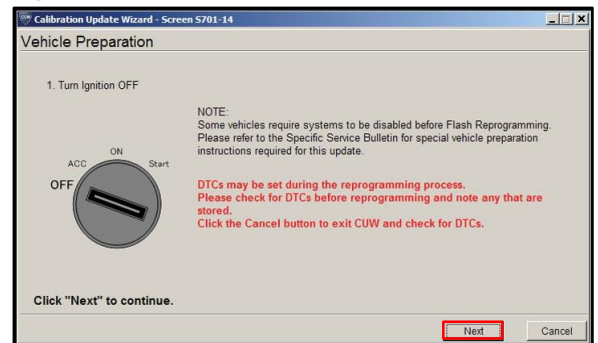
Figure 15.

- F. Turn ignition OFF, then click Next.

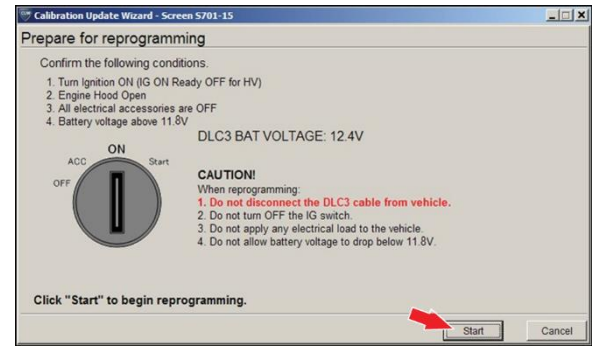
Figure 16.

G. Confirm the following:

- PC is connected to VIM.
- Ignition is ON and engine is OFF or READY OFF (hybrid vehicles).
- Hood is open.
- ALL accessories are OFF.
- Battery voltage is above 11.8V.

Verify the vehicle is connected to a battery charger before continuing. If battery voltage falls below 11.8V, ECU damage may occur.

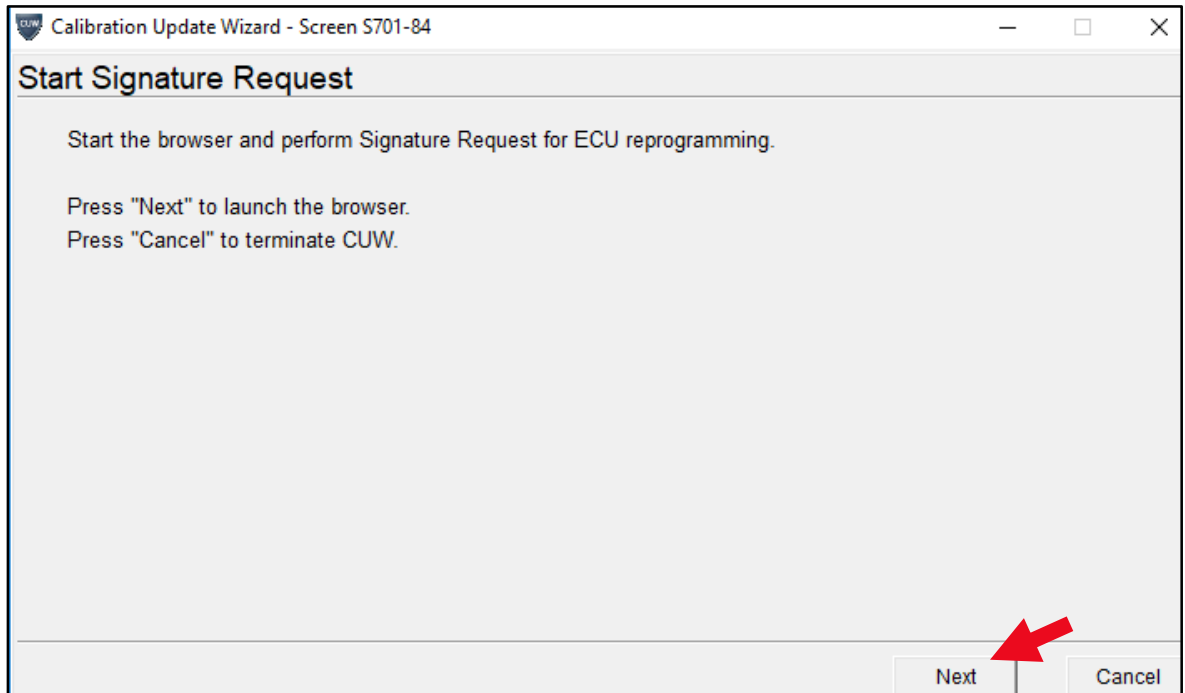
Figure 17.

- H. This vehicle is equipped with additional security measures requiring a Signature from TIS. Select Next to open TIS and retrieve the Signature.

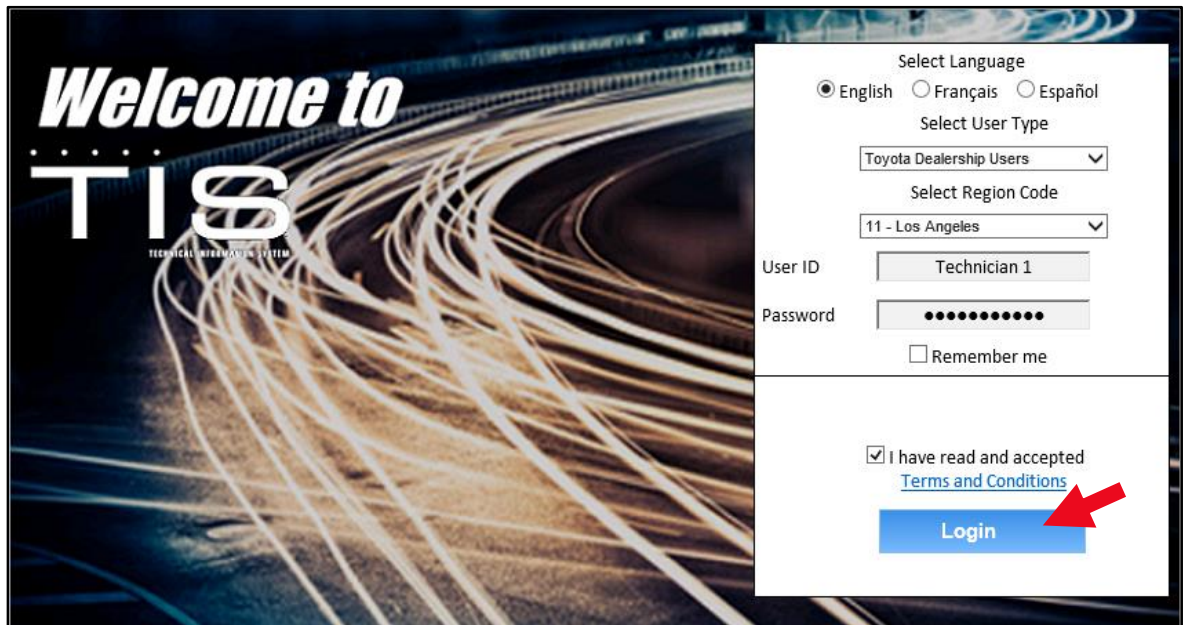
Figure 18.

- I. Input TIS login credentials and select Login.

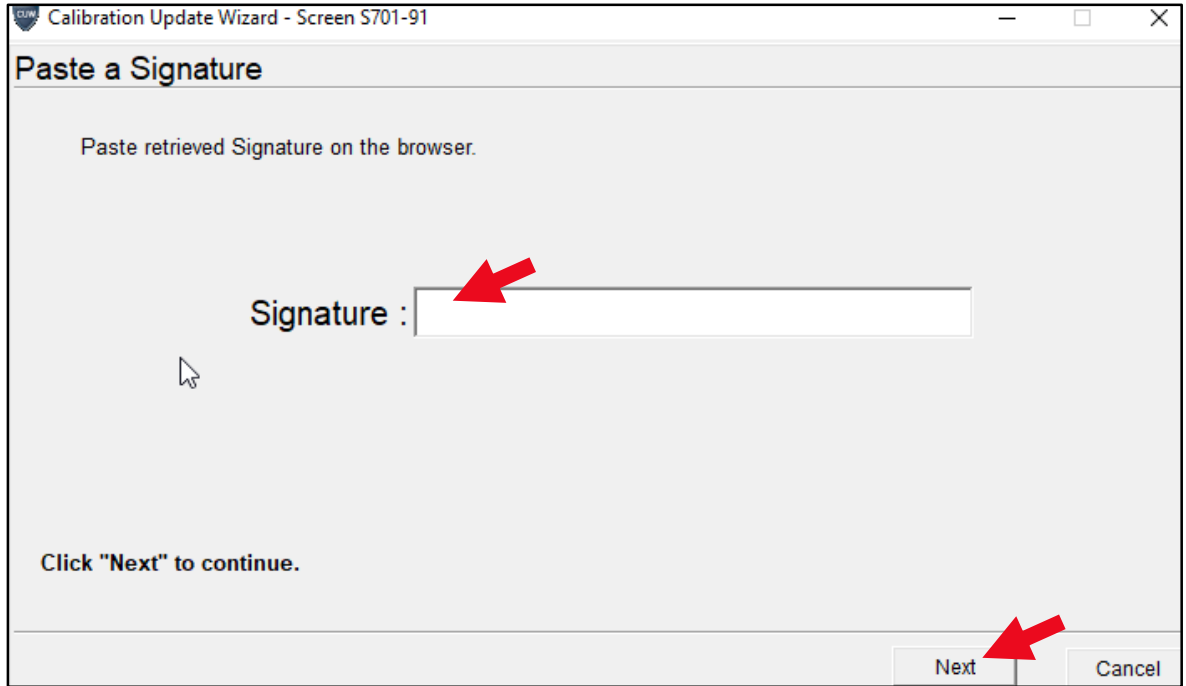
Figure 22.

M. Paste the Signature into Techstream and select Next.

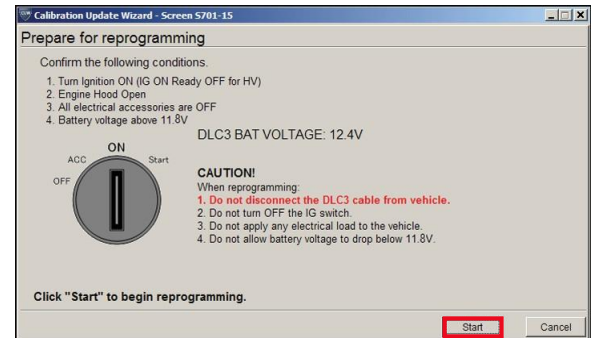
Figure 25.

- O. Turn the ignition to the ON position, then click Start.

If the key cycle is NOT done properly, reprogramming will stop at 10% and Cal 2 will fail to load.

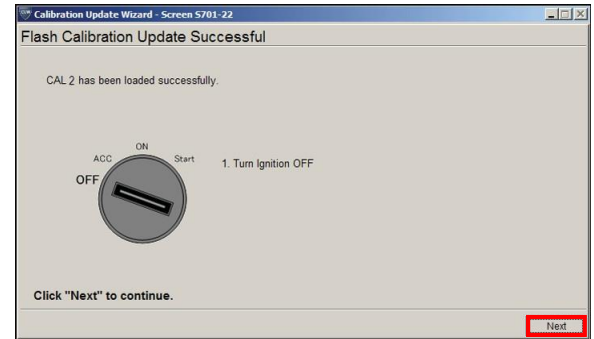
Figure 27.

- Q. Turn the ignition OFF for a minimum of 10 seconds, then click Next.

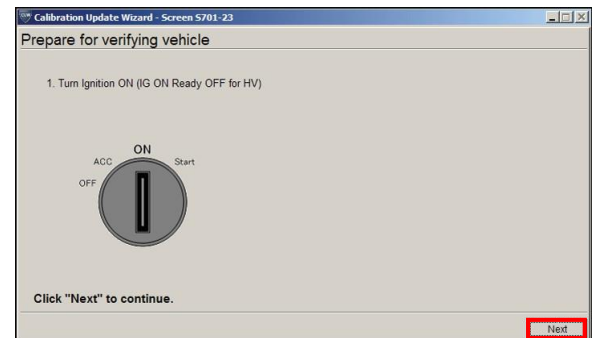
Figure 28.

- R. Turn the ignition to the ON position, then click Next.

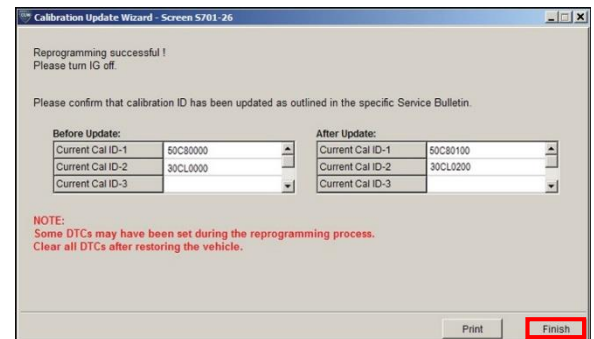
Figure 29.

- S. Confirm ALL calibrations were updated as specified in this Service Bulletin, then click Finish.
