# Service Bulletin

Bulletin No.: 22-NA-033

**Subject: Radio Resets or Reboots and May Display myBrand Splash Animation**

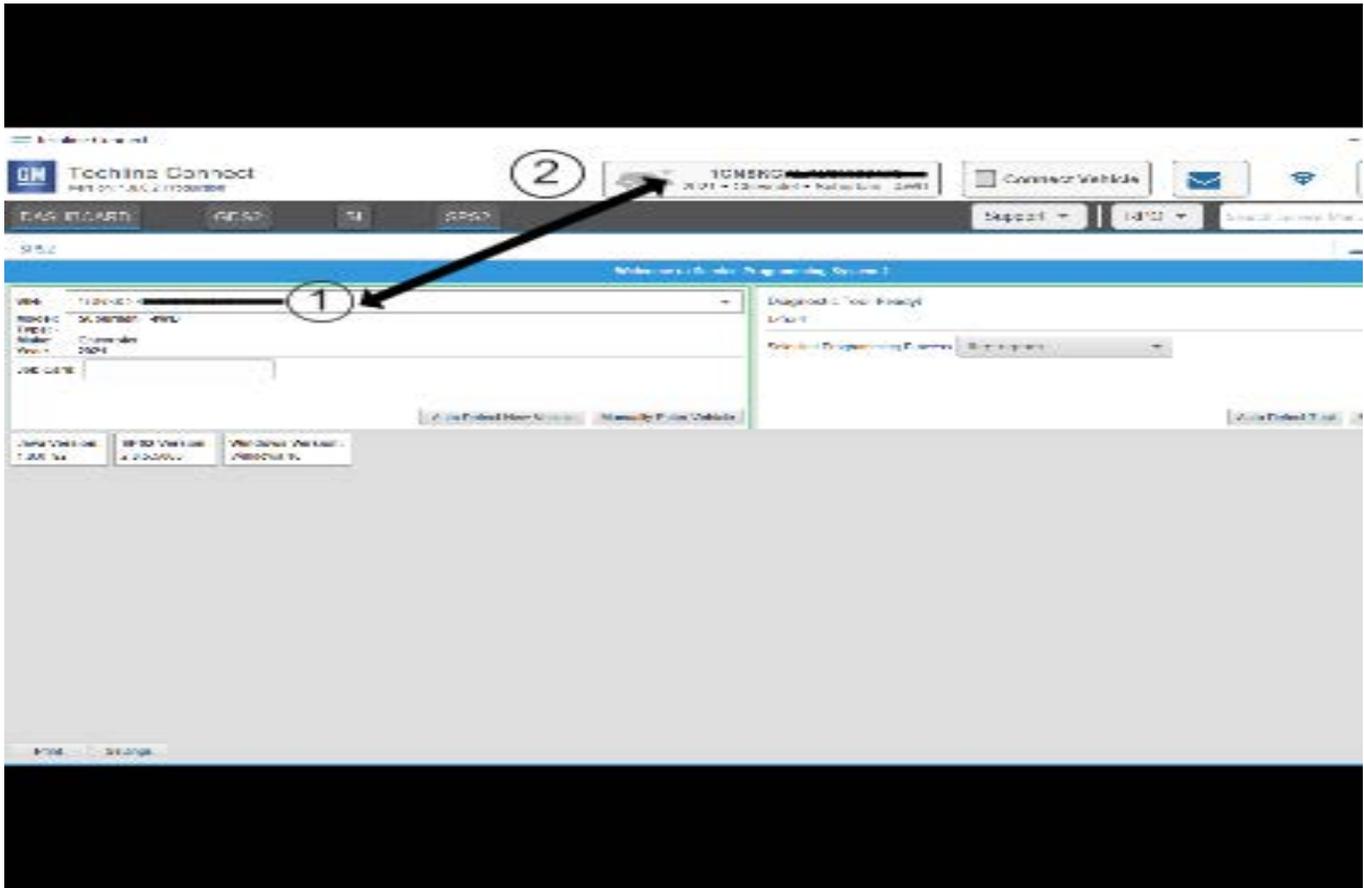
5743643

**Caution:** Be sure the VIN selected in the drop down menu (1) is the same as the vehicle connected (2) before beginning programming.

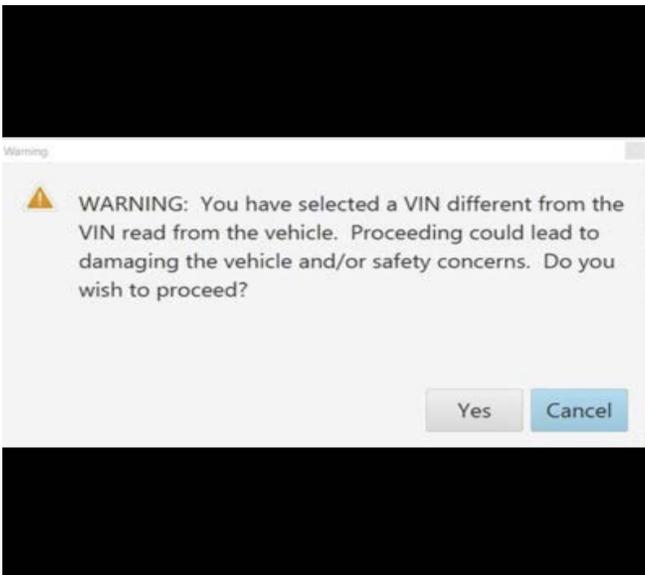
5877000

**Important:** If the vehicle VIN DOES NOT match, the message below will be shown.

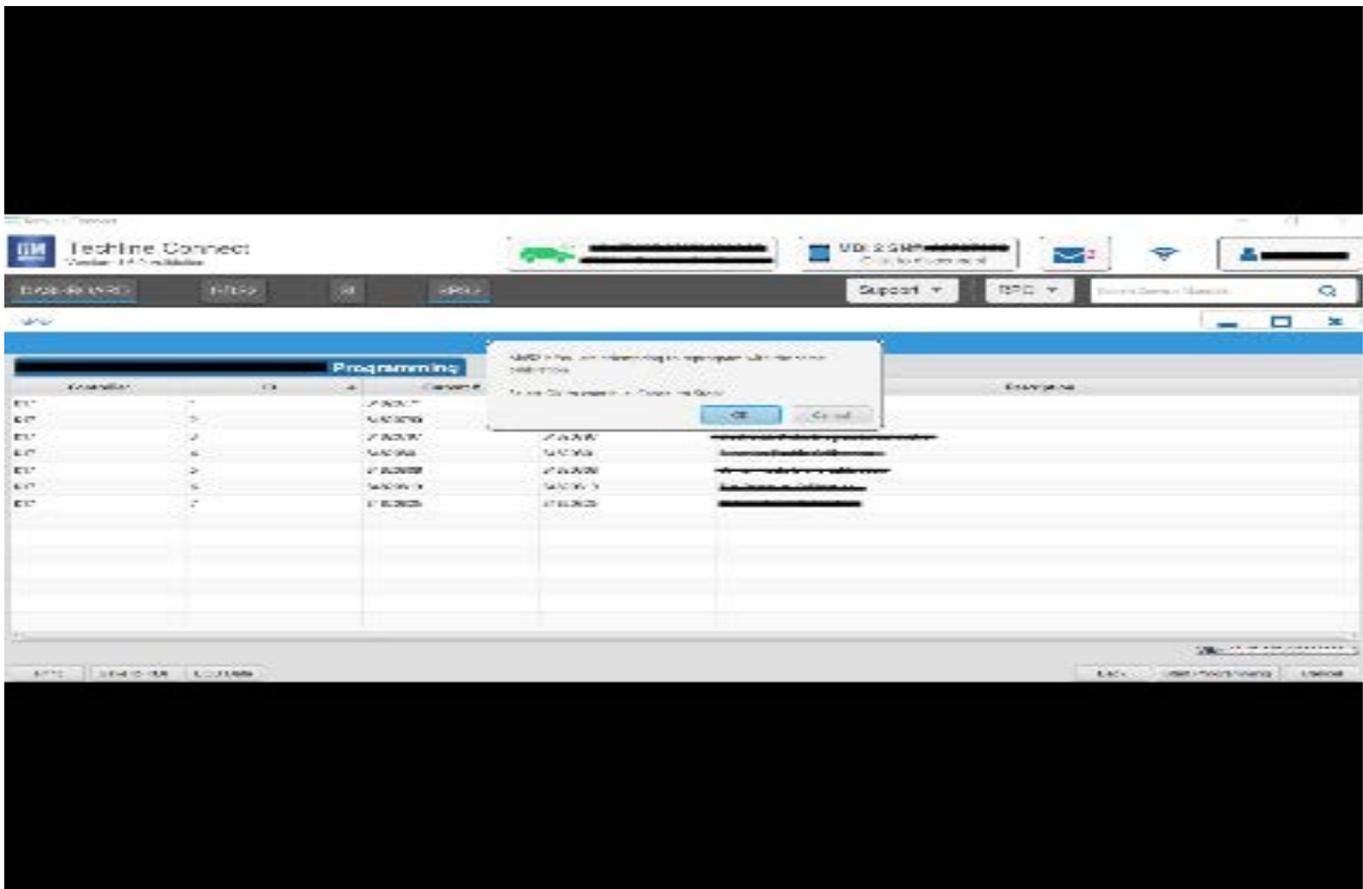
5644477

**Important:** Techline Connect screen shown above.

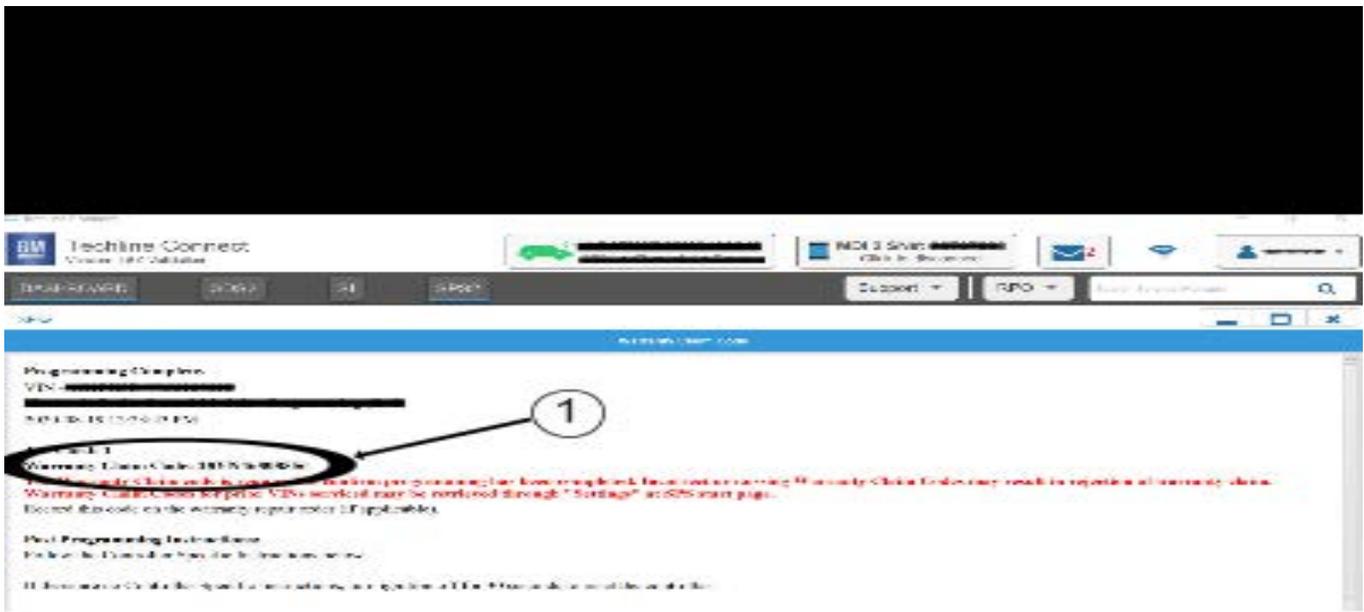
5644478

**Note:** The screenshot above is an example of module programming and may not be indicative of the specific module that is being programmed. Module selection and VIN information have been blacked out.

**Important:** To avoid warranty transaction rejections, you **MUST** record the warranty claim code provided on the Warranty Claim Code (WCC) screen shown above on the job card. Refer to callout 1 above for the location of the WCC on the screen.

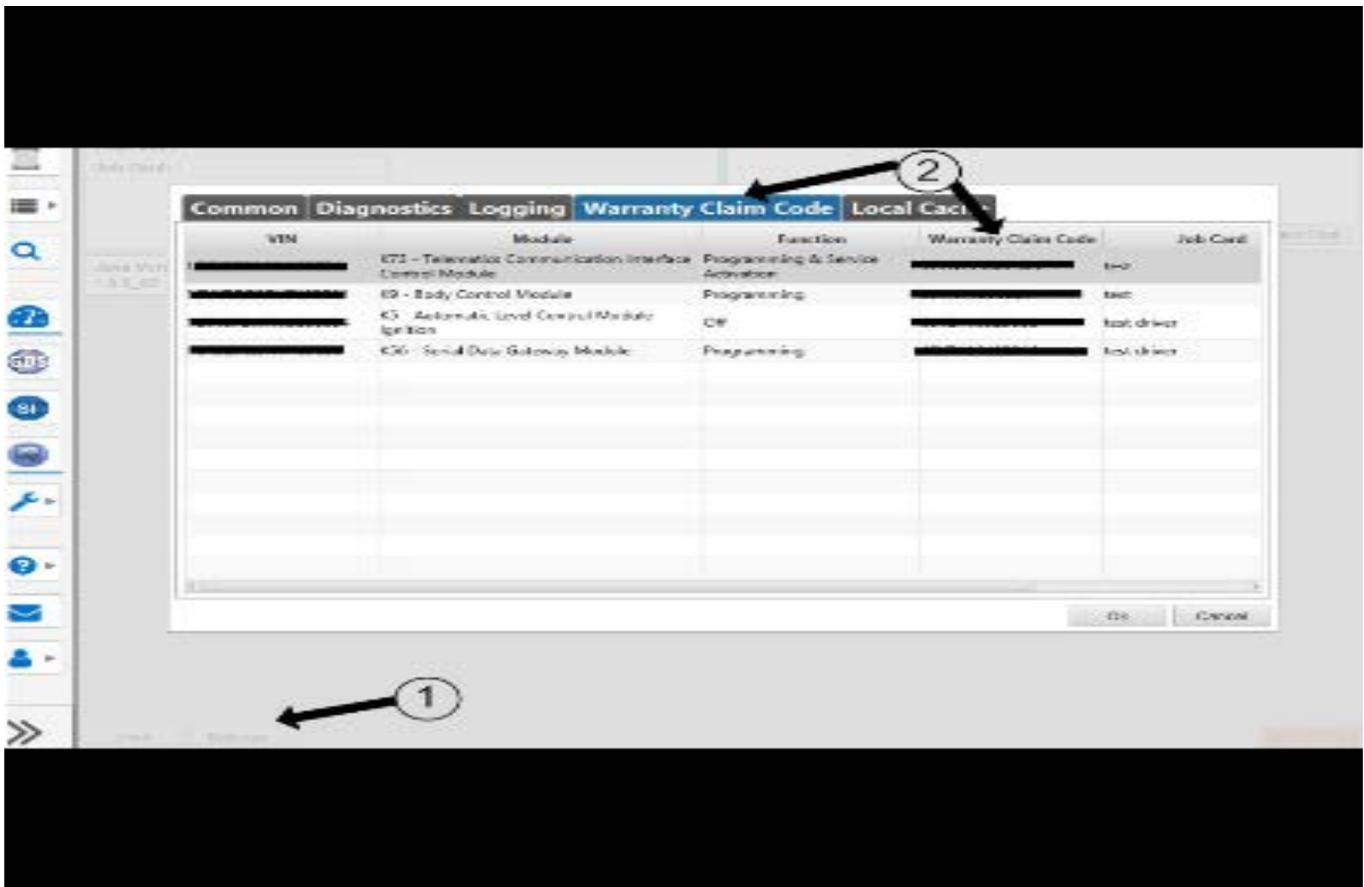
If the Warranty Claim Code was not recorded on the job card, the code can be retrieved in the SPS2 system as follows:

1. Open TLC on the computer used to program the vehicle.
2. Select and start SPS2.
3. Select Settings (1).
4. Select the Warranty Claim Code tab (2).
