Service Bulletin

Bulletin No.: 22-NA-127

Subject: Radio Software Version V160 Update

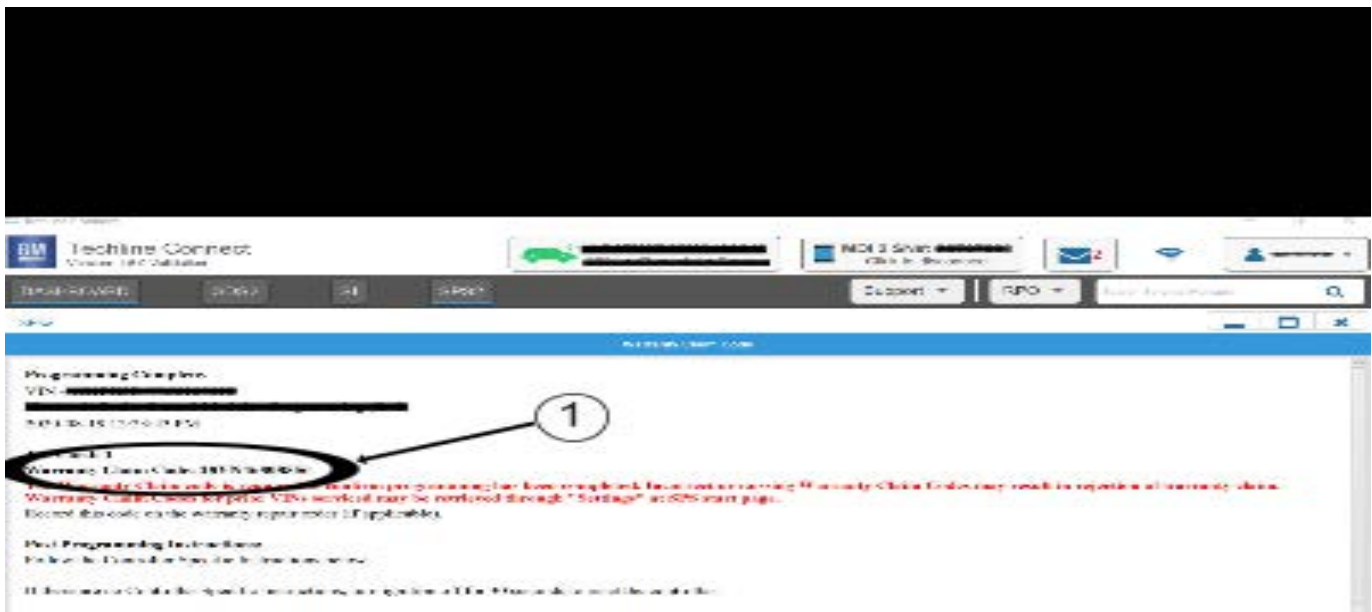
Note: The screenshot above is an example of module programming and may not be indicative of the specific module that is being programmed. Module selection and VIN information have been blacked out.

Important: To avoid warranty transaction rejections, you **MUST** record the warranty claim code provided on the Warranty Claim Code (WCC) screen shown above on the job card. Refer to callout 1 above for the location of the WCC on the screen.

Important: If the same calibration/software warning is noted on the TLC or SPS Summary screen, select OK and follow screen instructions. After a successful programming event, the WCC is located in the Service Programming System dialogue box of the SPS
