# Service Bulletin

Bulletin No.: 22-NA-142

**Subject:** Radio Software Version W164 – Multiple Updates

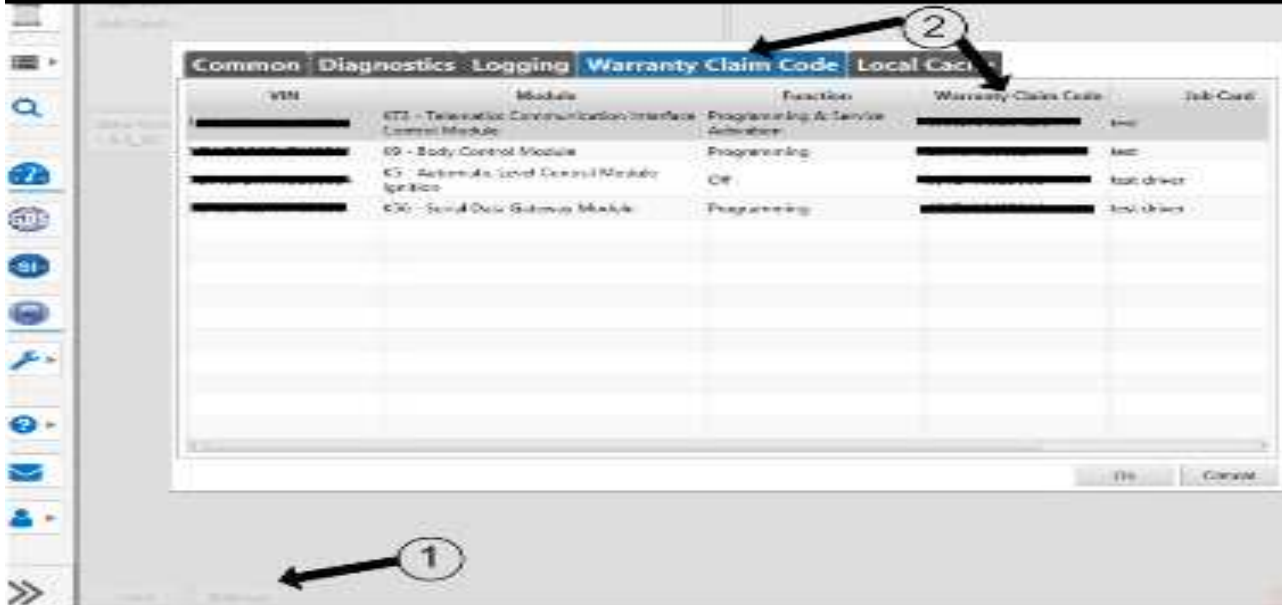
6125774

If the Warranty Claim Code was not recorded on the Job Card, the code can be retrieved in the SPS2 system as follows:

The VIN, Warranty Claim Code and Date/Time will be listed on a roster of recent programming events. If the code is retrievable, dealers should resubmit the transaction making sure to include the code in the SPS Warranty Claim Code field.
