# Service Update

## N222369401 Advanced Diagnostic Software (ADS) Improvements

Release Date: August 2022

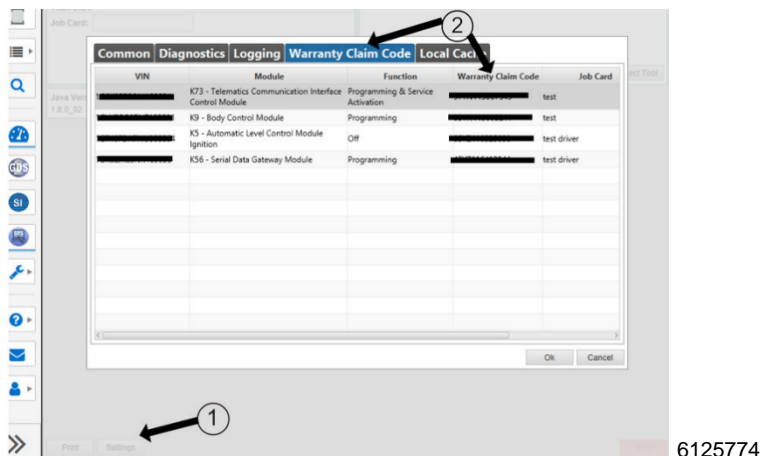
### Warranty Claim Code Information Retrieval

If the Warranty Claim Code was not recorded on the Job Card, the code can be retrieved in the SPS2 system as follows:

1. Open TLC on the computer used to program the vehicle.
2. Select and start SPS2.
3. Select Settings.
4. Select the Warranty Claim Code tab.

The VIN, Warranty Claim Code and Date/Time will be listed on a roster of recent programming events. If the code is retrievable, dealers should resubmit the transaction making sure to include the code in the SPS Warranty Claim Code field.

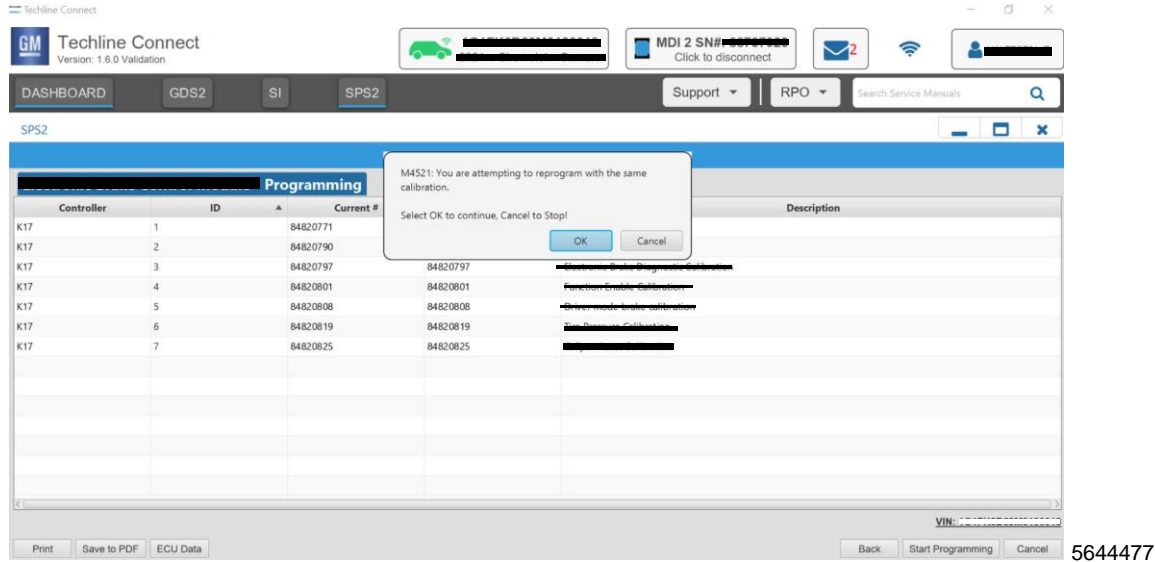
**Important:** Techline Connect screens shown above.

**Important:** If the same calibration/software warning is noted on the TLC Summary screen, select OK and follow screen instructions. After a successful programming event, the WCC is located in the Service Programming System dialogue box of the SPS Summary screen. No further action is required. Refer to the Warranty section of the bulletin.

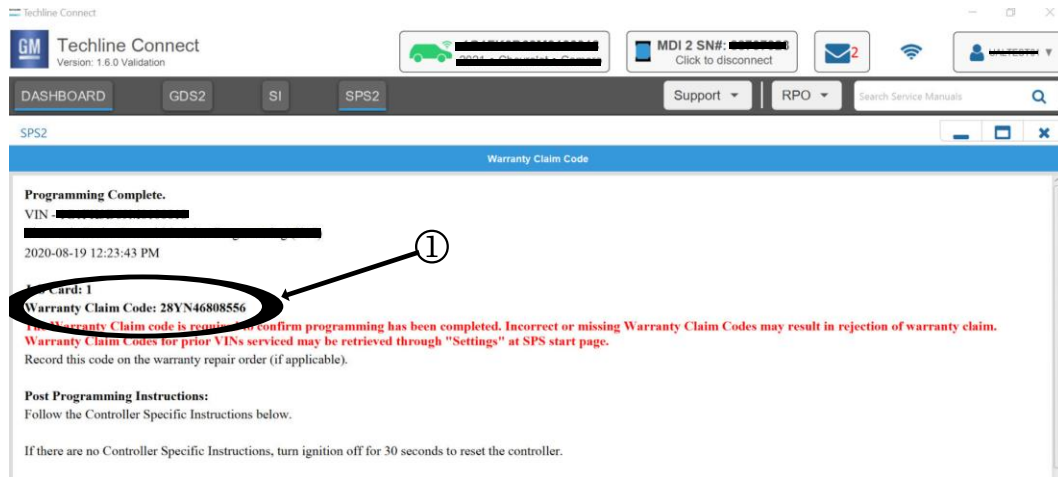
5644478

**Note:** The screenshot above are an example of module programming and may not be indicative of the specific module that is being programmed. Module selection and VIN information have been blacked out.
