GLOBAL SAFETY FIELD INVESTIGATIONS
DCS6252
URGENT - DISTRIBUTE IMMEDIATELY

Subject: REVISION: N212351870-01 – Service Update Bulletin
State of Charge Estimation of 12 Volt Battery
Revised warranty information and updated population

Models: 2022 Chevrolet Corvette

N212351870 State of Charge Estimation of 12 Volt Battery

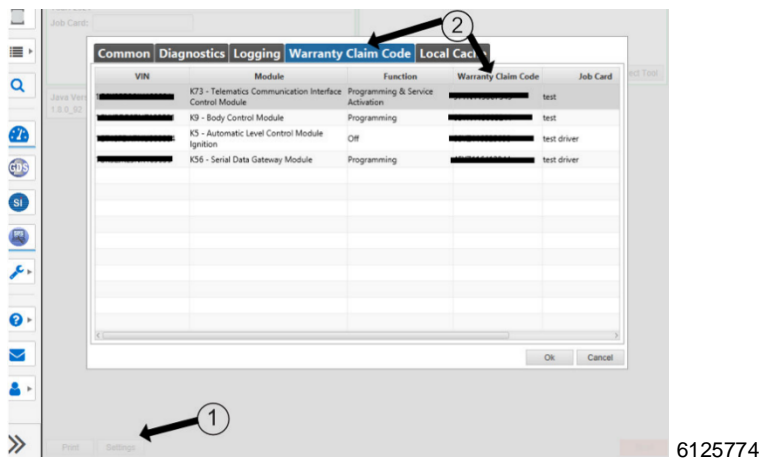
Warranty Claim Code Information Retrieval

If the Warranty Claim Code was not recorded on the Job Card, the code can be retrieved in the SPS2 system as follows:

1. Open TLC on the computer used to program the vehicle.
2. Select and start SPS2.
3. Select Settings.
4. Select the Warranty Claim Code tab.

The VIN, Warranty Claim Code and Date/Time will be listed on a roster of recent programming events. If the code is retrievable, dealers should resubmit the transaction making sure to include the code in the SPS Warranty Claim Code field.

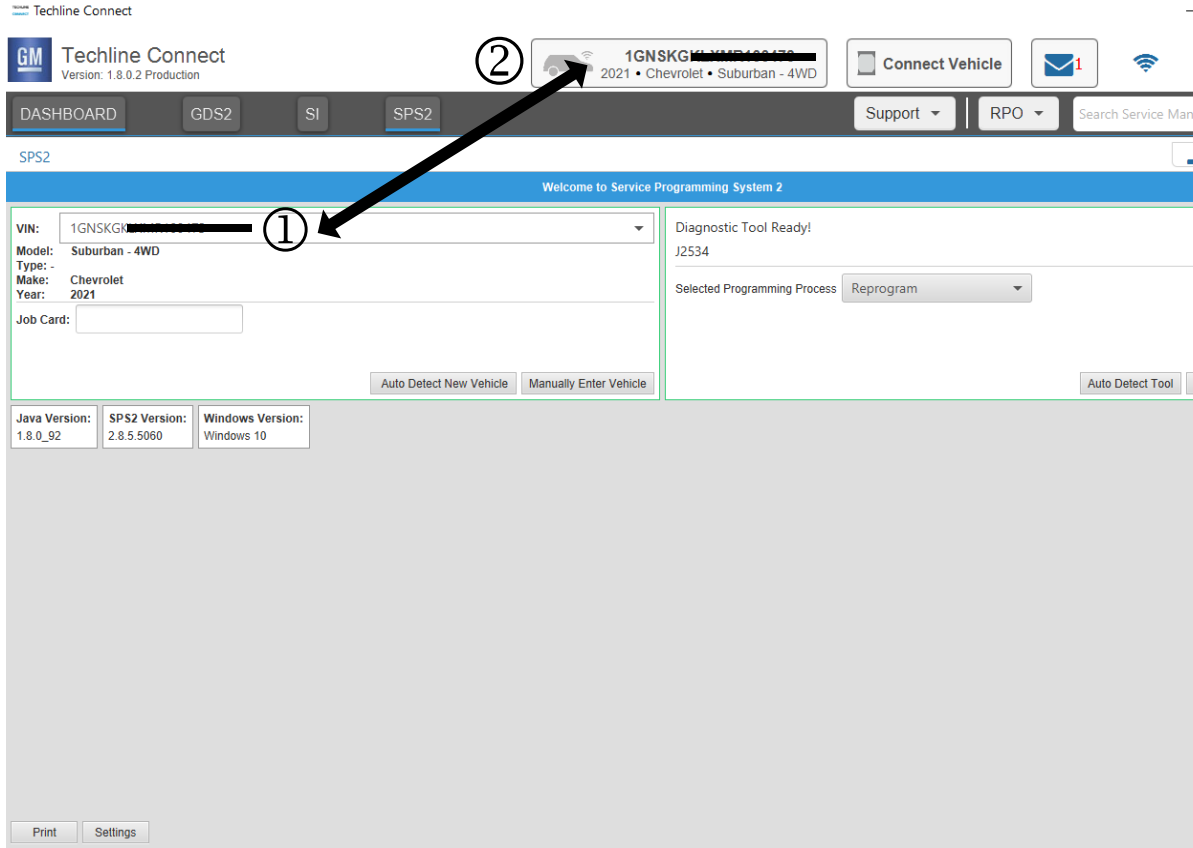
5743643

Caution: Be sure the VIN selected in the drop-down menu (1) is the same as the vehicle connected (2) before beginning programming.

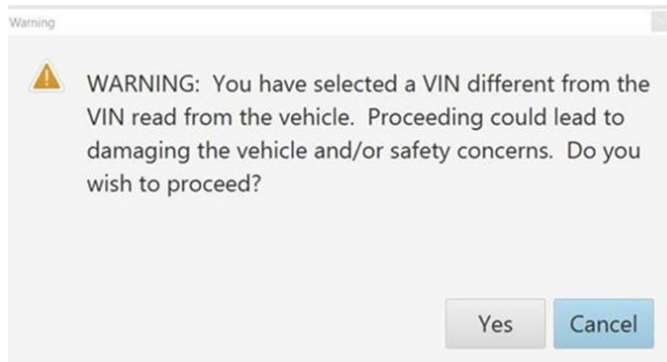
5877000

Important: If the vehicle VIN DOES NOT match, the message below will be shown.

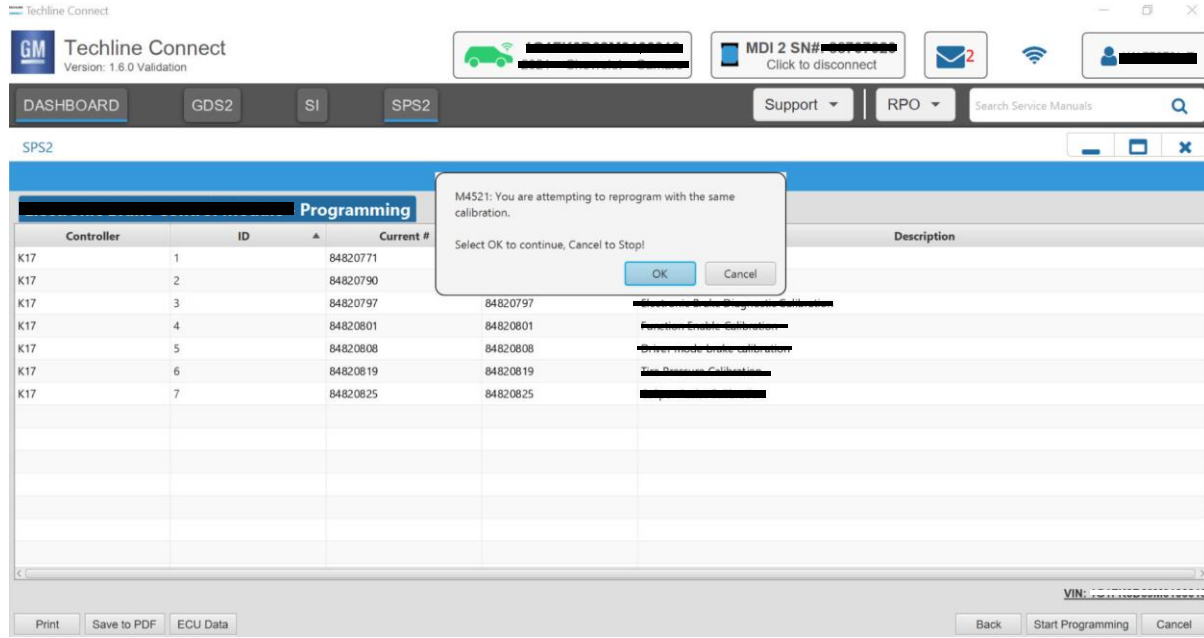
5644477

Important: Techline Connect screens shown above.

Important: If the same calibration/software warning is noted on the TLC Summary screen, select OK and follow screen instructions. After a successful programming event, the WCC is located in the Service Programming System dialogue box of the SPS Summary screen. No further action is required. Refer to the Warranty section of the bulletin.

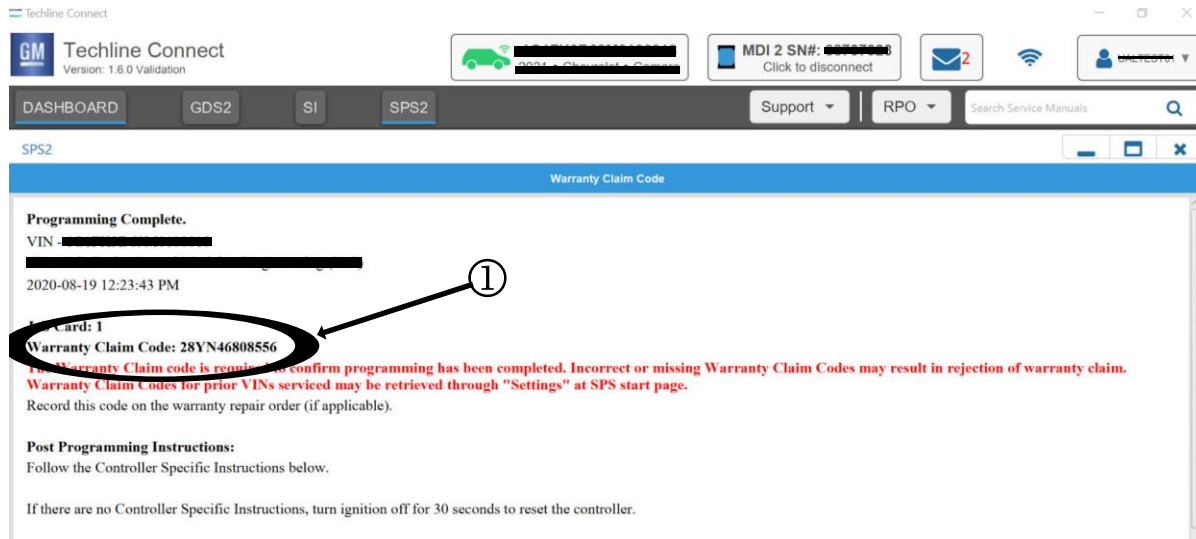
5644478

1. Reprogram the Body Control Module. Refer to *K9 Body Control Module: Programming and Setup* in SI.

Note: The screenshot above are an example of module programming and may not be indicative of the specific module that is being programmed. Module selection and VIN information have been blacked out.
