GROUP  
**Emissions Service  
Campaign**

MODEL  
**2019-2021  
Multiple Models  
with IVT**

NUMBER  
**SC199 (Rev 3, 08/18/2022)**

**IVT SOFTWARE LOGIC IMPROVEMENT  
AND/OR IVT REPLACEMENT (SC199)**

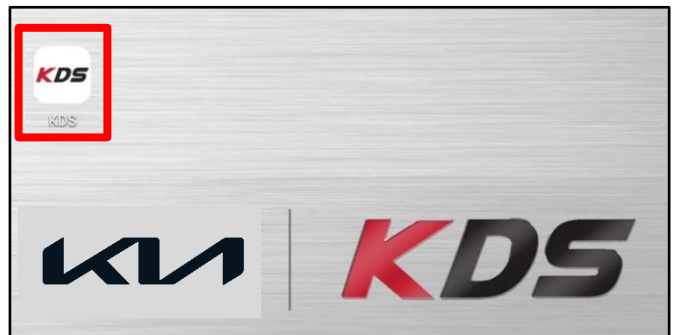
2. With the ignition ON, turn ON the KDS tablet. Select **KDS** from the home screen.

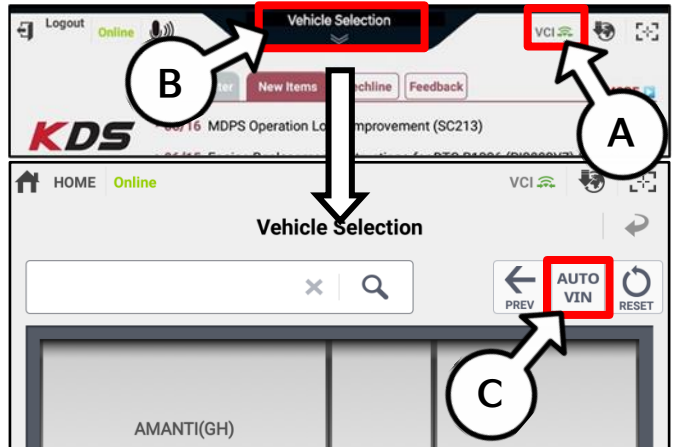
3. Confirm communication with VCI (A) and then configure the vehicle (B) using the **AUTO VIN** (C) feature.

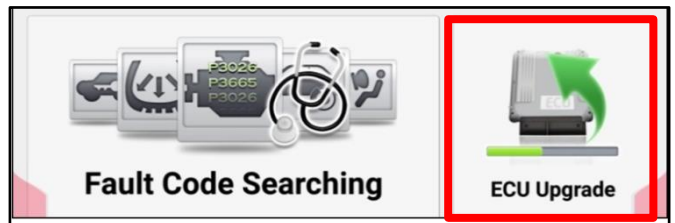
4. Select **ECU Upgrade**.

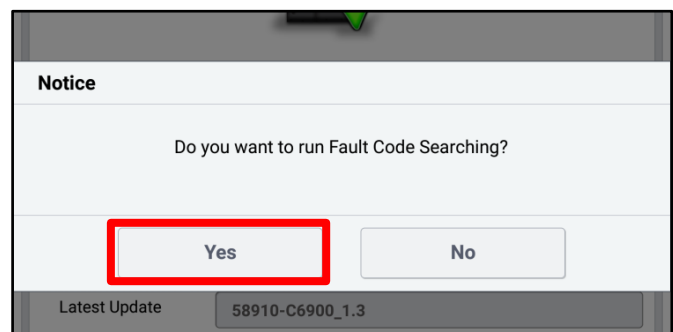
12. When prompted, select **YES** to check for Diagnostic Trouble Codes (DTC) and erase any DTCs stored such as EPS, ESC, and TPMS that may have been set during the upgrade.

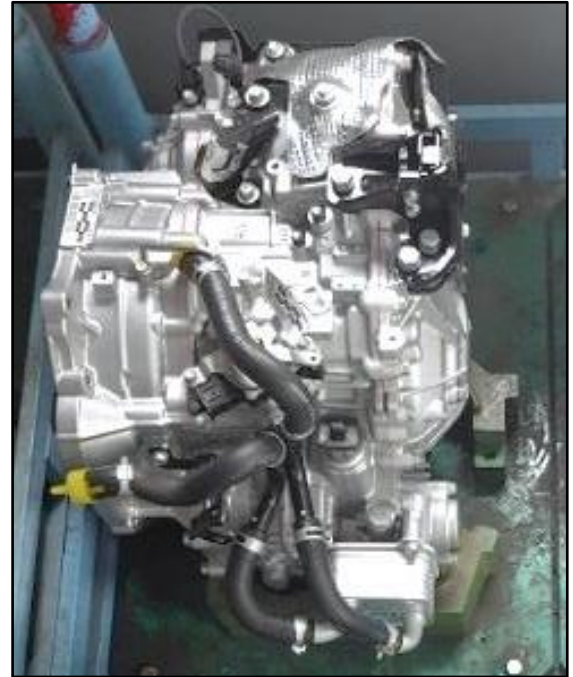
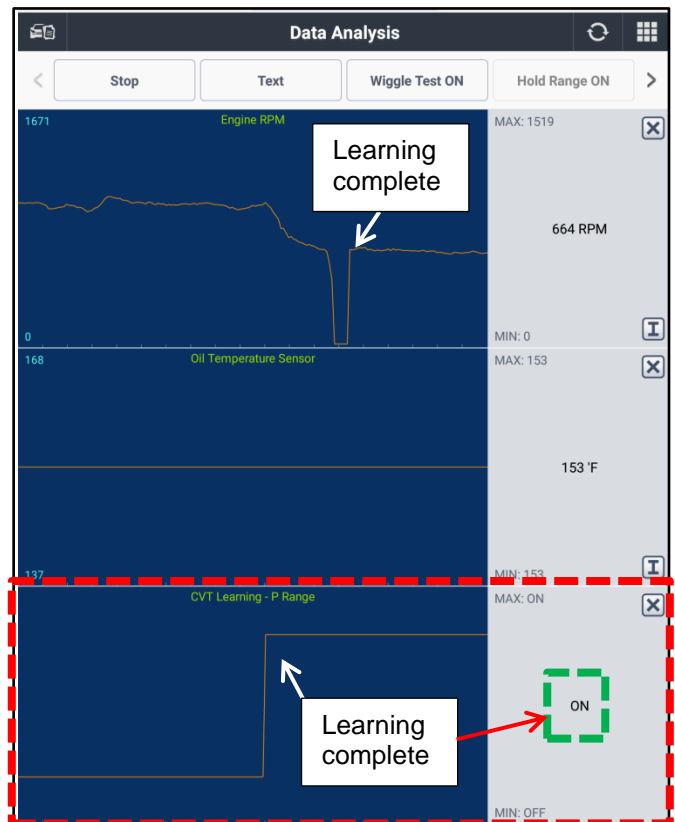
1. First initiate the ‘Resetting Auto Trans Adaptive Values’ procedure on the KDS.
2. Then, perform the ‘Oil-pressure Characteristics input (A/T Replacement)’ procedure on the KDS, select ‘OK’.
3. Complete the ‘Auto Trans Adaptive Values’ relearn procedure.
4. On the KDS home menu, enter the CVT module ‘Data Analysis’ screen and confirm the Adaptive Values have learned\*.

**Note:** The adaptive values learning procedure may require that the engine be shut OFF/ON multiple times until the values are fully learned; start the vehicle, confirm the vehicle is idling in ‘Park’ without accelerator or brake input and verify the ‘CVT Learning – P Range’ Current Data reads ‘ON’.

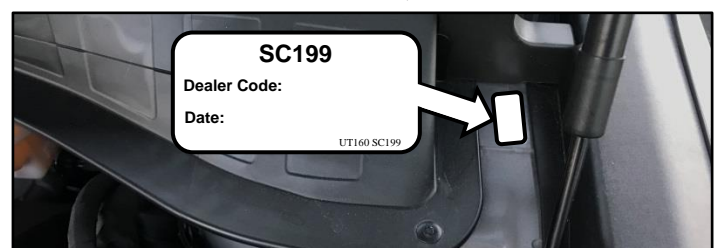
**CA and S.177 States Only:** Apply SC199 Campaign Completion Label onto the body in the area next to the shock tower, as shown.

**NOTE: Be sure to clean the mounting surface to ensure proper label adhesion.**
