Subject: N222369260 - Service Update

Parking Assist Driver Information Center Telltales May Not Illuminate

Models: 2022 Cadillac XT4

N222369260 Parking Assist Driver Information Center Telltales May Not Illuminate

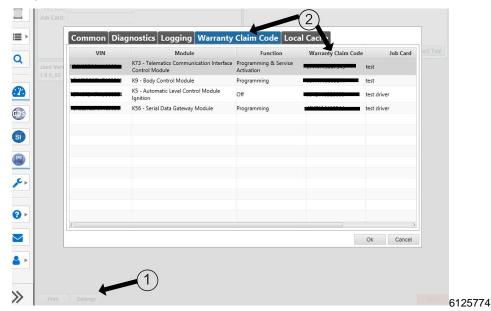
If the Warranty Claim Code was not recorded on the Job Card, the code can be retrieved in the SPS2 system as follows:

- 1. Open TLC on the computer used to program the vehicle.
- 2. Select and start SPS2.
- Select Settings (1).
- 4. Select the Warranty Claim Code tab (2).

The VIN, Warranty Claim Code and Date/Time will be listed on a roster of recent programming events. If the code is retrievable, dealers should resubmit the transaction making sure to include the code in the SPS Warranty Claim Code field.

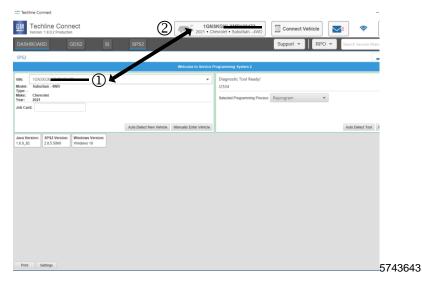
Caution: Be sure the VIN selected in the drop-down menu (1) is the same as the vehicle connected (2) before beginning programming.

Important: The service technician always needs to verify that the VIN displayed in the TLC left side drop down menu and the top center window match the VIN plate of the vehicle to be programmed prior to using Service Programming System 2 (SPS2) for programming or reprogramming a module.

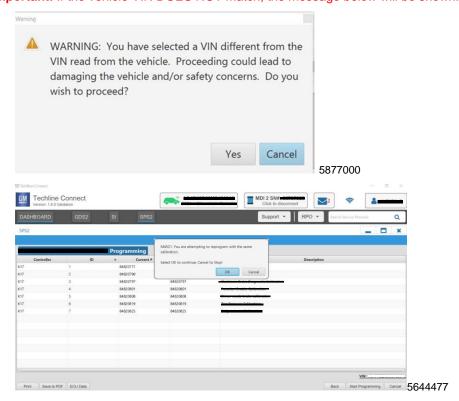
Important: If the vehicle VIN DOES NOT match, the message below will be shown.
