<b>HYUNDAI</b> <b>Technical Service Bulletin</b>	<b>GROUP</b> <b>CAMPAIGN</b>	<b>NUMBER</b> <b>22-01-059H</b>
	<b>DATE</b> <b>AUGUST, 2022</b>	<b>MODEL(S)</b> <b>SANTA FE (TMA)</b> <b>SONATA (DN8A)</b> <b>SANTA CRUZ (NXT)</b>
<b>SUBJECT:</b> TCU UPDATE – DRIVABILITY (SERVICE CAMPAIGN T8N)

**DESCRIPTION:** This bulletin provides the procedure to update the TCU software to improve drivability and shift quality.

**APPLICABLE VEHICLES:** Certain 2021~22 vehicles equipped with 2.5T engine and 8-speed DCT

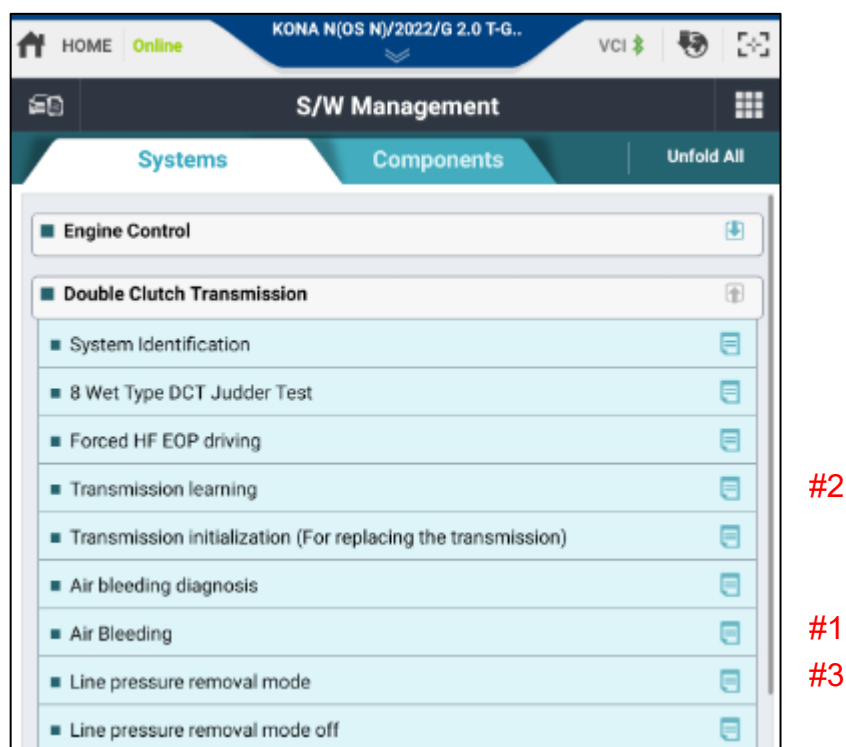
Attach a GDS and select **S/W Update** and **Double Clutch Transmission**.  
Perform the following procedures in the order shown.

**MANUAL UPDATE:** If the TCU Update starts but then fails in Auto Mode, perform the update in Manual Mode to recover:

Event	Model	Menu	Password
#840)	Santa Fe (TMa)	TMA PE THETA 2.5T 954A0-2N240	2240
#841	Sonata (DN8)	DN8A THETA 2.5T 954A0-2N060	2060
#842	Santa Cruz (NXT)	NX4AT THETA 2.5T 954A0-2N450	2450
		NX4AT THETA 2.5T 954A0-2N460	2460
