Customer Satisfaction Program

N212354522 Heated Vented Seats Retrofit Due to Chip Shortage - Front and Rear Seats

Release Date: August 2022

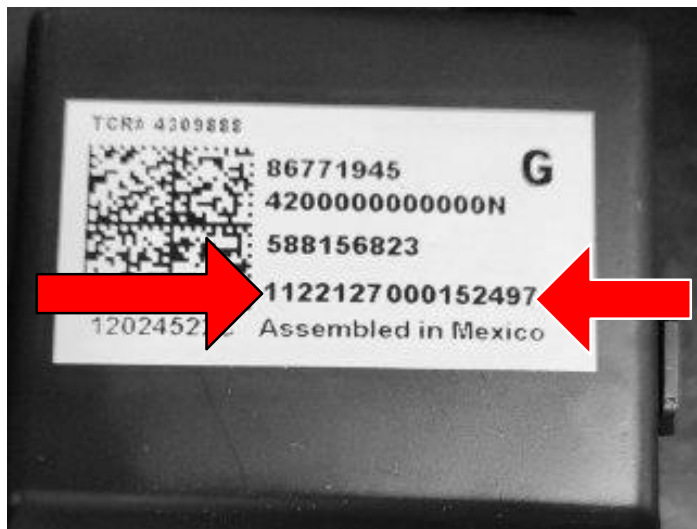
6098078

Record the serial number on the front and rear seat heater vent control module labels.

IMPORTANT: * (TECHNICIAN and WARRANTY ADMINISTRATOR) SERIAL NUMBER RECORDING REQUIREMENT. The replacement Front and Rear Seat Heater Vent Control Module serial numbers must be captured by the technician and recorded on the job card. The Warranty Administrator **MUST** enter the replacement Front and Rear Seat Heater Vent Control Module serial numbers in GWM (Global Warranty Management) or in DMS (Dealer Management System). Enter the serial number of the **replacement** Front and Rear Seat Heater Vent Control Modules in the '**General Comments**' comments section. Failure to enter this serial number will cause the claim to reject.

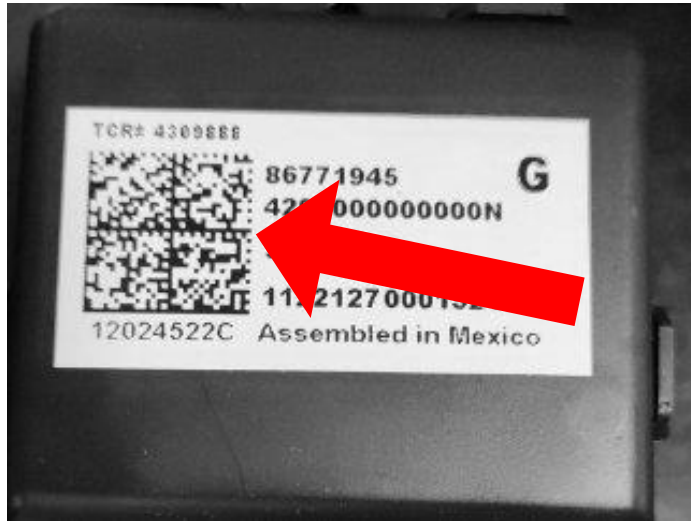
If the App is already loaded to your phone, simply:

1. Scan the VIN (door pillar QR code or windshield VIN barcode) and
2. Scan the new part (QR code) and
3. Check the information and if correct then, Submit.

Replacement Part Traceability (RPT) is a new dealer process to document and track critical part serial numbers via the Certified Service Mobile Toolbox (CSMT) application. A field action, service bulletin, or other communication will be issued any time there is a request for technicians to complete an RPT submission. Only critical parts will require an RPT, not every part replacement.
