TECHNICAL SERVICE BULLETIN

Classification:	Reference:	Date:
DA22-001	NTB22-038	May 19, 2022

RAB WARNING LIGHT ON IN INSTRUMENT PANEL AND/OR DTC B2724-23 STORED

APPLIED VEHICLES: 2019-2021 Altima (L34)
2019-2022 Murano (Z52)
2019-2021 Rogue Sport (J11)
2019-2021 Versa (N18)

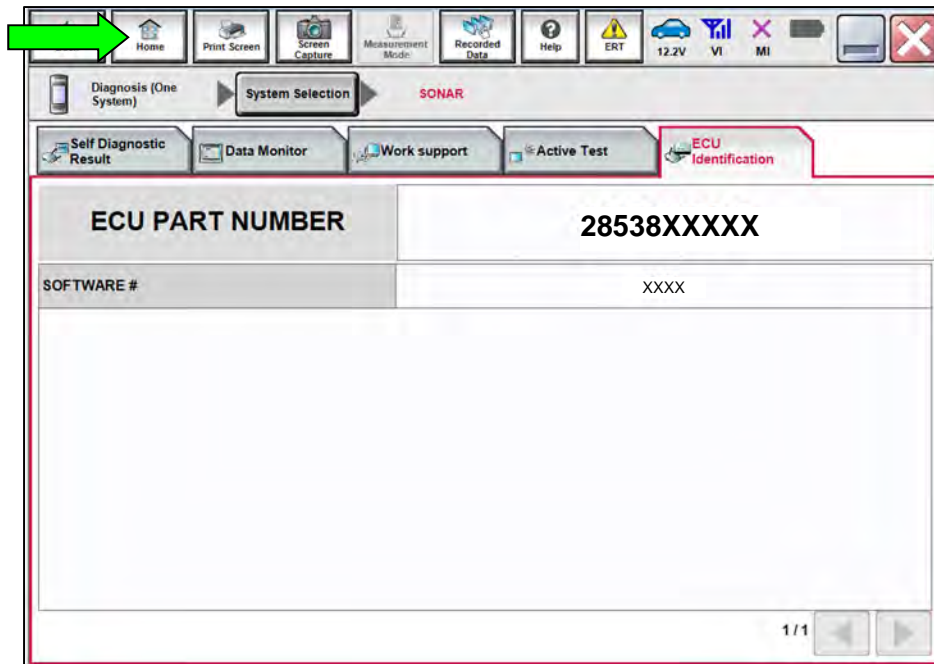
Figure 6

14. Select **Home**.

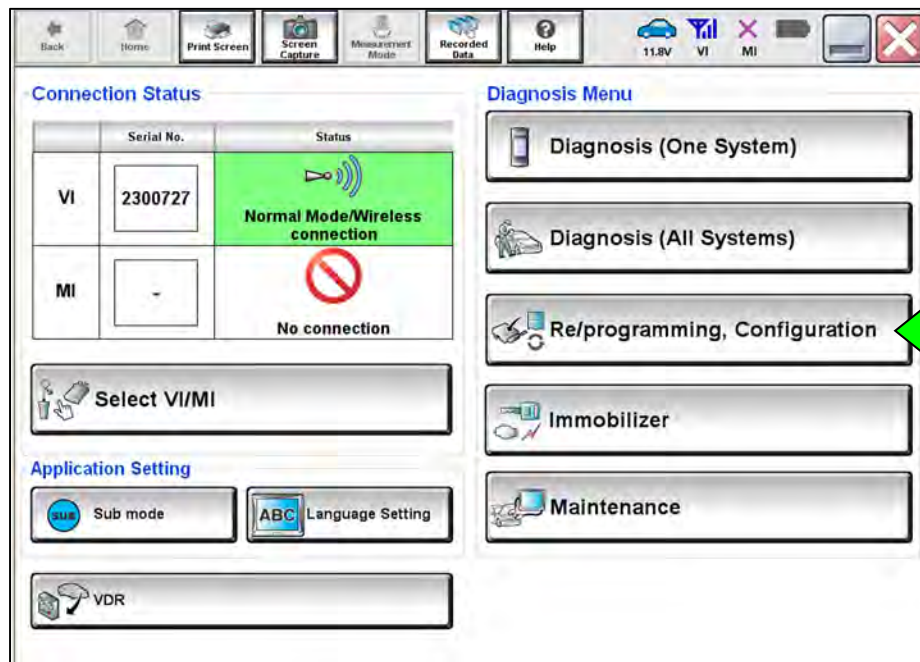
Figure 7

15. Select **Re/programming, Configuration**.

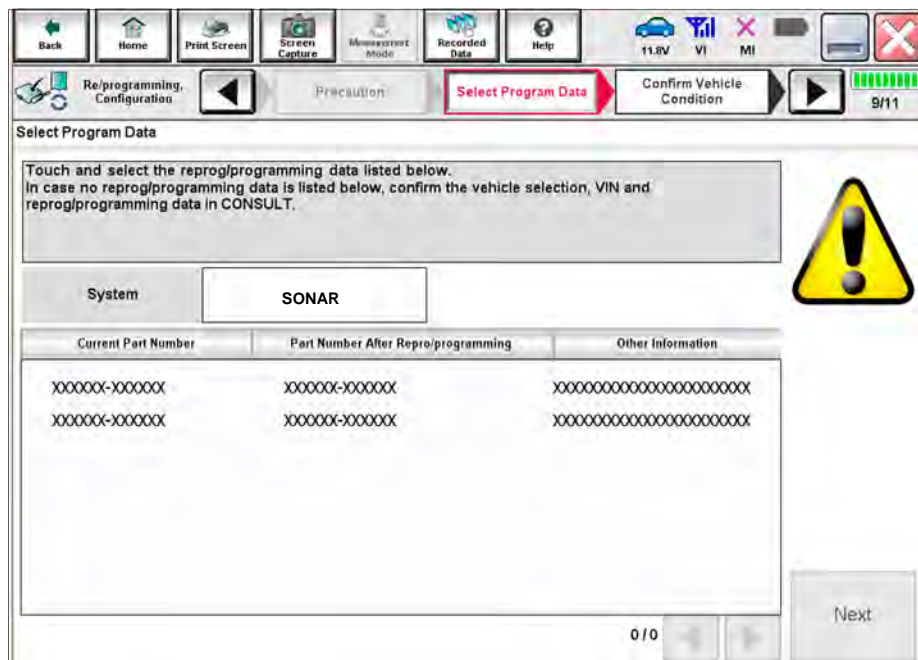
- In some cases, more than one new part number for reprogramming is available.
 - If more than one new part number is available, the screen in Figure 17 displays.
 - Select and use the reprogramming option that does not have the message “Caution! Use ONLY with NTBXX-XXX”.
- If you get this screen and it is blank (no reprogramming listed), it means there is no reprogramming available for this vehicle. Close CONSULT and refer back to the ESM for further diagnosis.

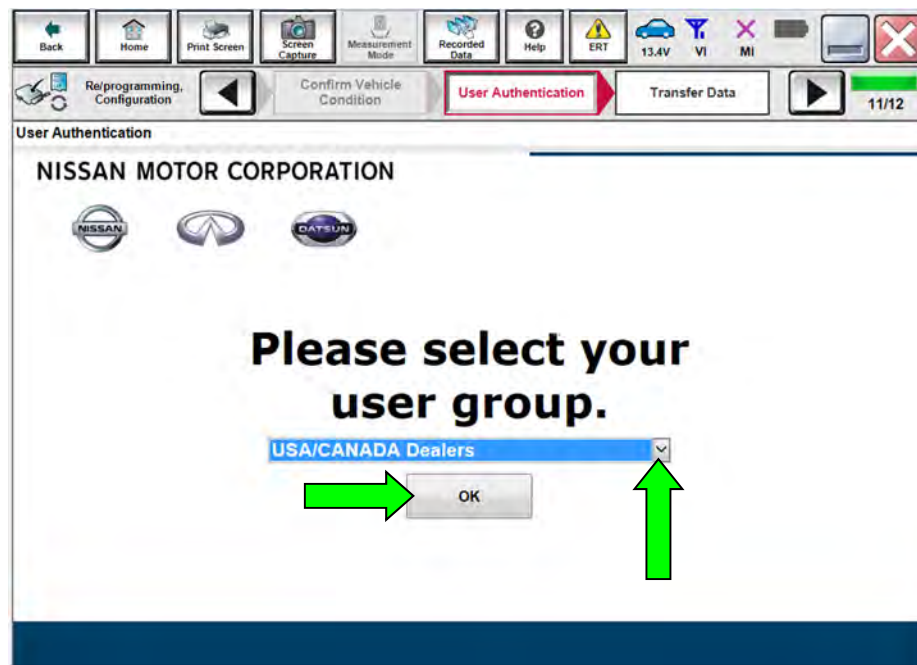
33. Select **USA/CANADA Dealers**.

34. Select **OK**.

- The screen in Figure 20 may not display if the CONSULT PC has remained ON since the last reprogramming.
- If the CONSULT PC is not connected to the internet, the screen in Figure 21 will display.

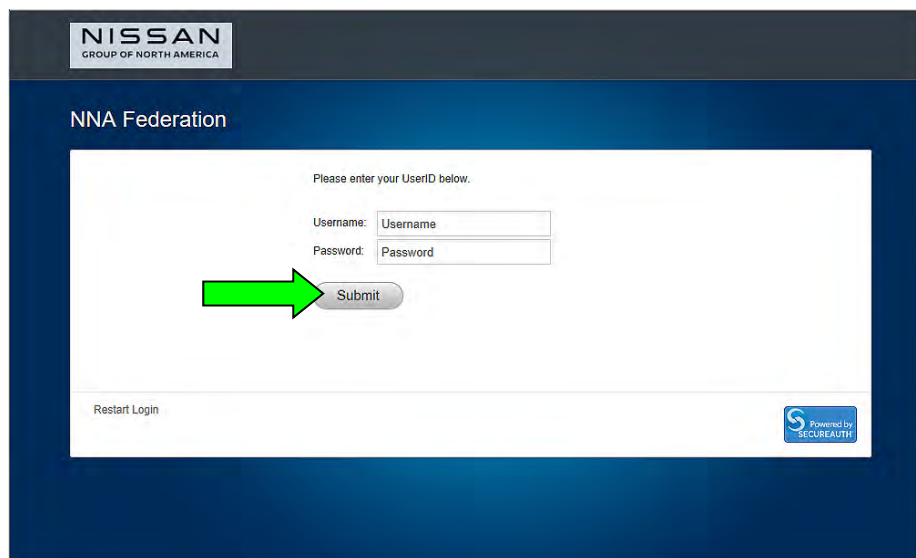
Figure 22

35. Enter your **Username** and **Password**.

- The CONSULT PC must be connected to the internet via cable or Wi-Fi.
- If you do not know your username and password, contact your service manager.

36. Select **Submit**.

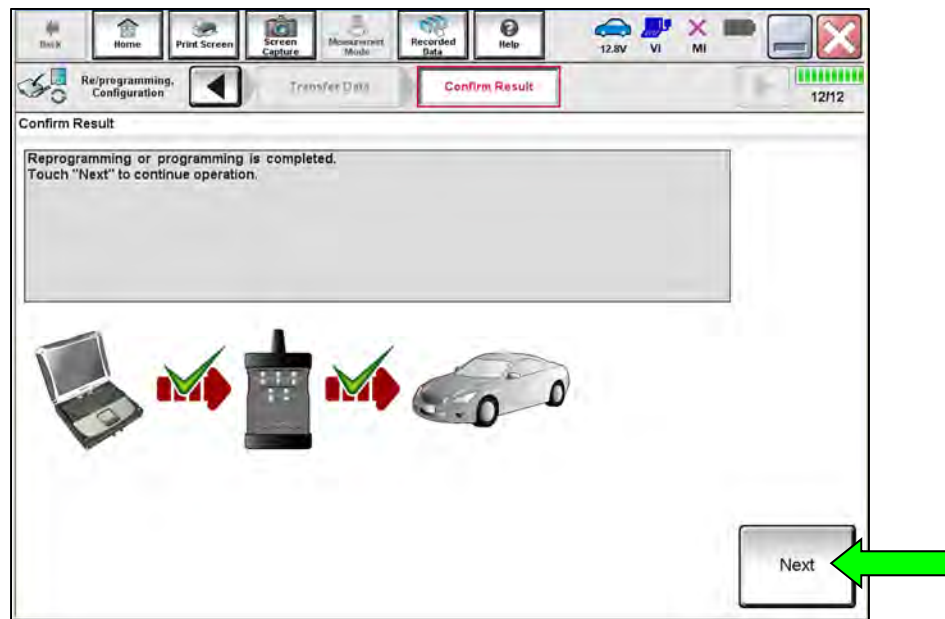
- When the screen in Figure 24 displays, the reprogramming is complete.
- If the screen in Figure 24 does not display (indicating that reprogramming did not complete), refer to **Sonar Control Unit Recovery** on the next page.

39. Select **Next**.

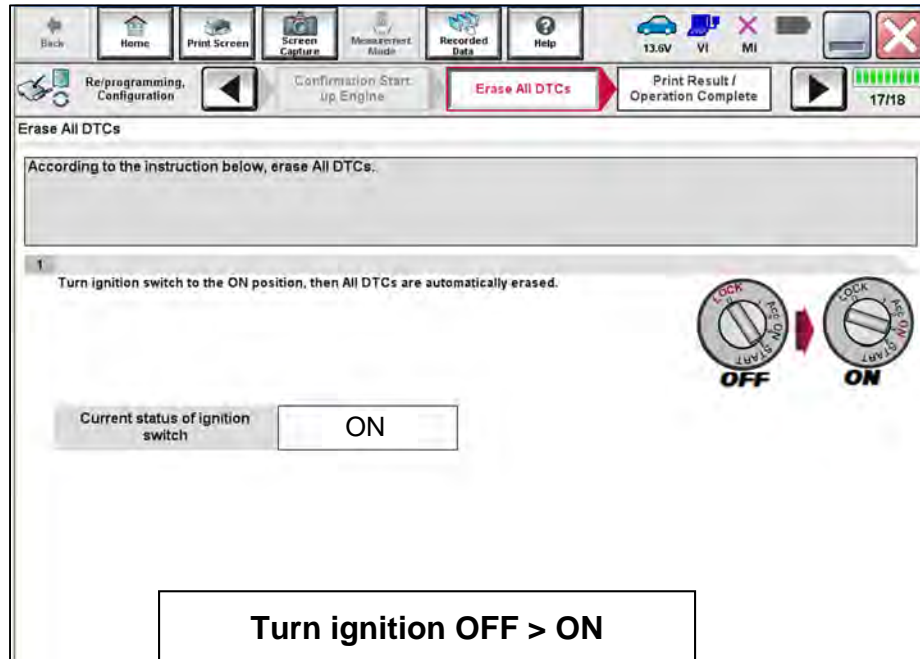
Figure 27

40. Perform **Erase All DTCs** as follows:

- a. Turn the ignition OFF.
- b. Turn the ignition ON.

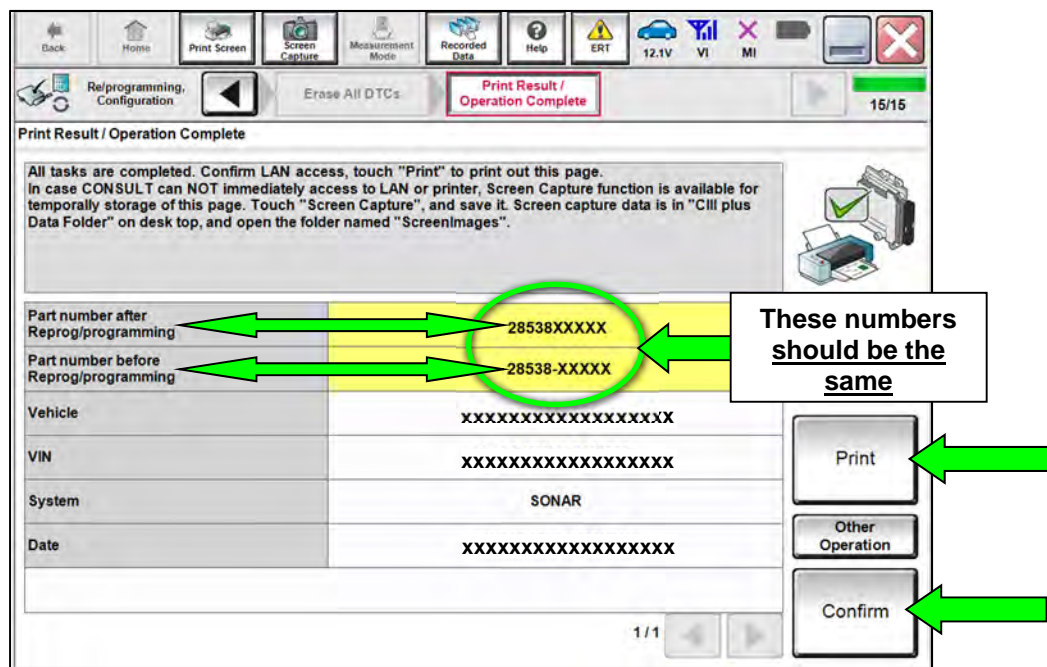
41. Verify the before and after part numbers **are the same**.

NOTE: For this reprogram, the before and after reprogramming part numbers should be the same. This is not an error.

42. Print a copy of the screen below (Figure 28) and attach it to the repair order for warranty documentation.

HINT: When the entire reprogramming process is complete, the screen in Figure 28 on page 19 will display.

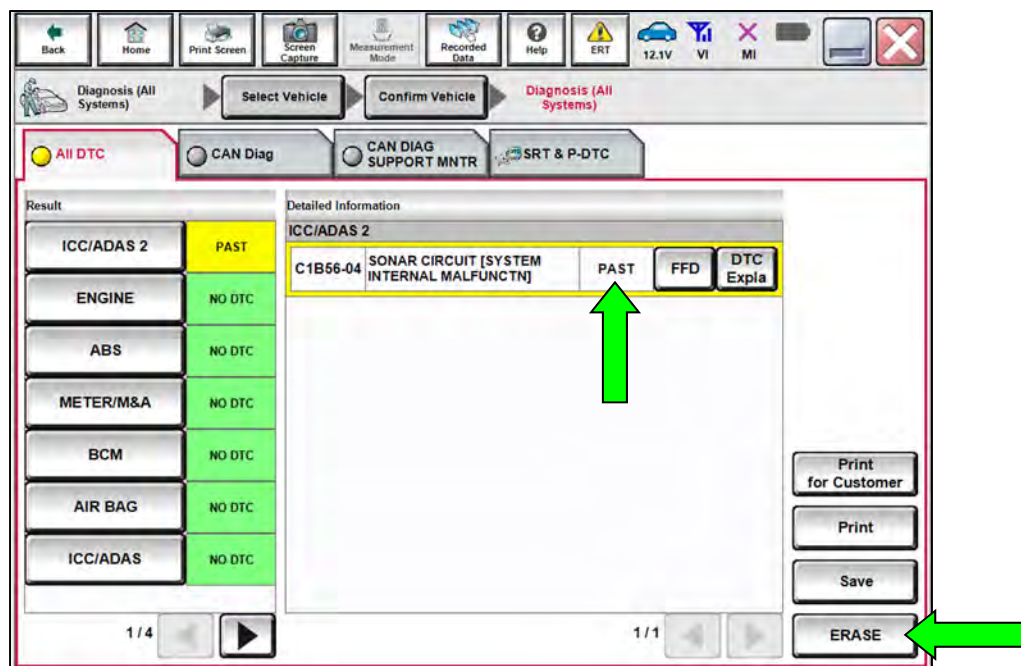
Figure 42

65. Select **Automatic Selection(VIN)**.
66. Select **Confirm**.
67. Select **Confirm** again.
68. Turn the ignition OFF, then turn the ignition ON.
69. Confirm DTC C1B56-04 is displayed as **PAST** (not **CRNT**) (Figure 42).
70. Select **ERASE**.
