TECHNICAL SERVICE BULLETIN

Classification: AN22-014	Reference: NTB22-044	Date: May 25, 2022
-----------------------------	-------------------------	-----------------------

SOFTWARE UPDATE FOR INFOTAINMENT ISSUES

APPLIED VEHICLES: 2020 Murano (Z52)
APPLIED DATES: Built after March 1, 2020

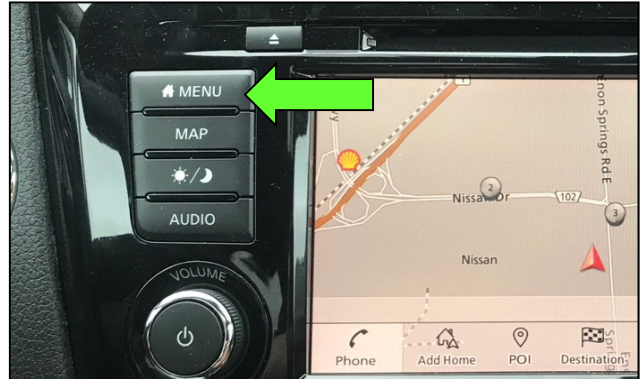
Figure 2

1. Push the **MENU** button.

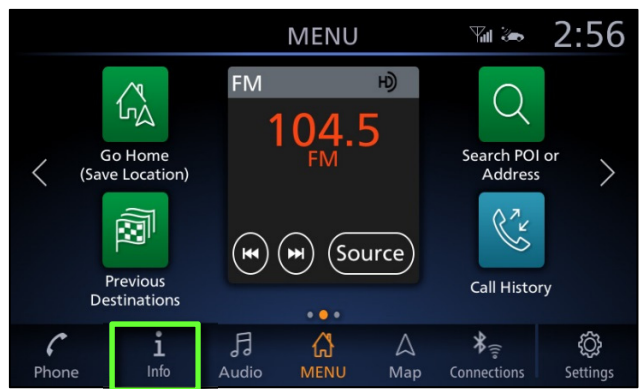
Figure 3

2. Select the **Info** icon.

- If the **Info** icon does not appear, as shown in Figure 3, this bulletin does not apply.

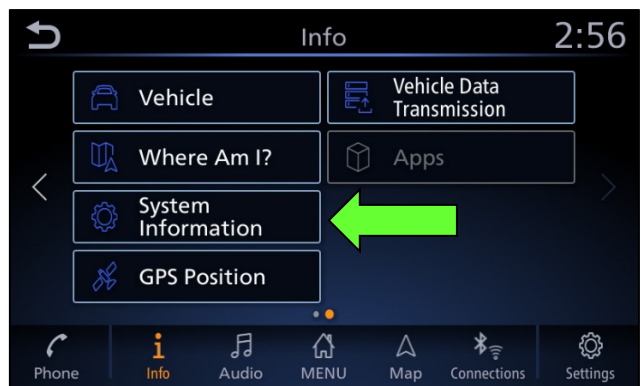
Figure 4

3. Select **System Information** to access the vehicle update menu.

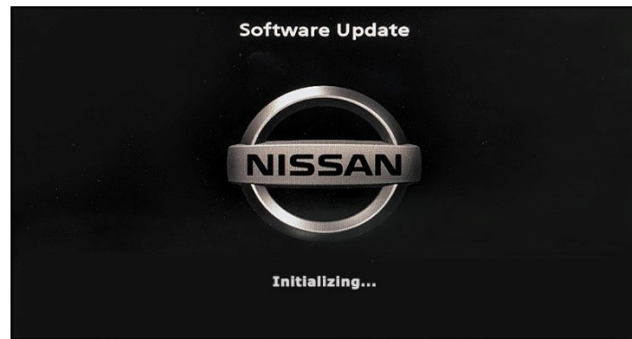
17. Wait approximately 10-30 seconds for the screen in Figure 14 to appear.

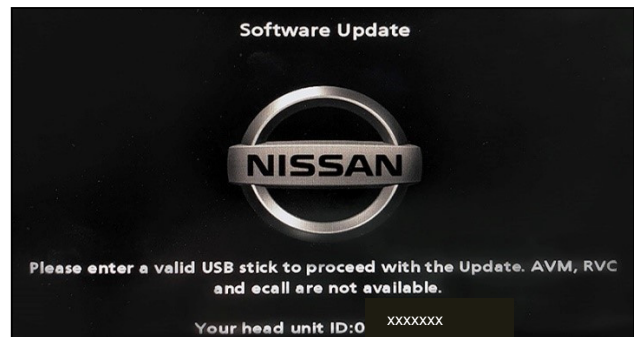
- The screen in Figure 15 may briefly appear. **Do not remove the USB drive.** The audio system will detect the USB and continue the update.

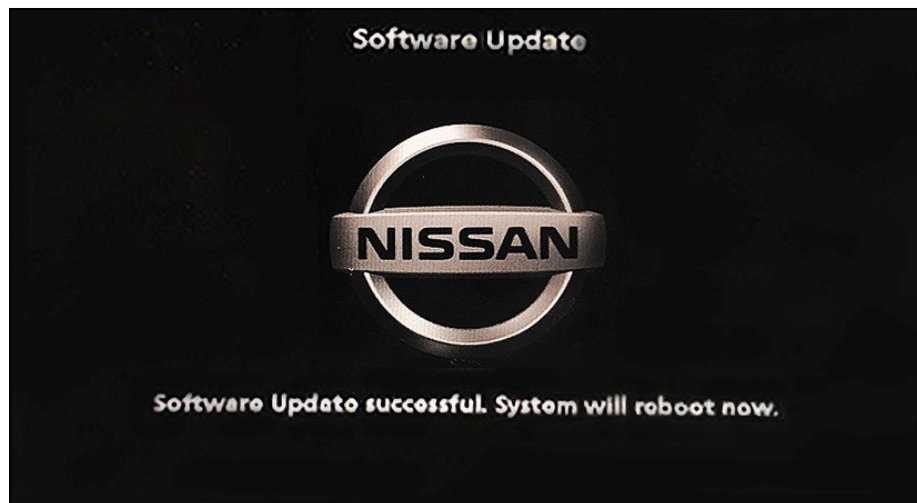
Figure 17

19. Once the update is complete (Figure 17), remove the USB drive; the system will reboot (restart).

HINT: The system will not reboot until the USB drive is removed.

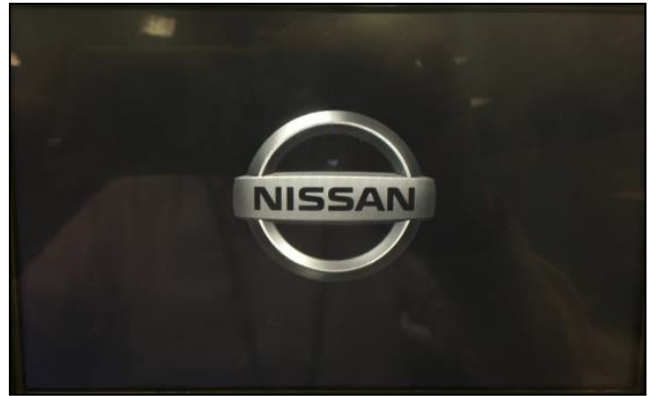
Figure 18

20. Allow the reboot to complete (approximately 30 seconds).
 - The Nissan logo will be displayed during the reboot.

24. Turn the ignition ON (engine OFF) and wait for the Nissan logo to appear (Figure 18).
 - If the Nissan logo does not appear (this might take up to 30 seconds), start over from step 21.

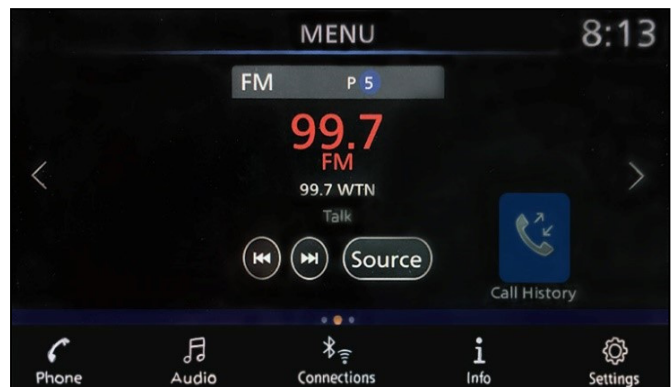
- The MENU (Home) screen in Figure 19 will be displayed.
