## Transfer Case Judder with Steering Input Applied

18-20MY F-PACE, XE, XF, Range Rover  
Velar**Customer Voice:**

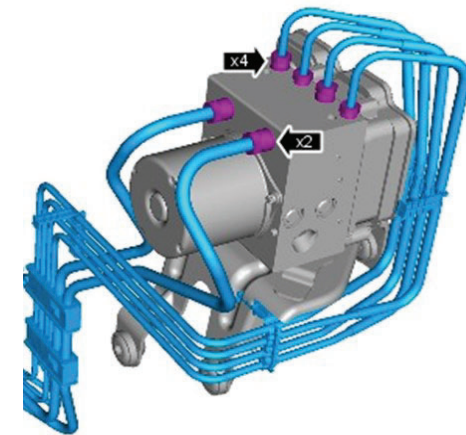
- Update the Anti-lock Brake System (ABS) and TCCM module software.
- This procedure requires TOPIx Cloud and alternatively minimum of Pathfinder build 366 loaded or later depending on vehicle.
- The issue is predominantly linked to older levels of ABS and TCCM software. TOPIx (Section 307-07 > Diagnosis and Testing > Transfer case) has been updated to reference the software update:
