TECHNICAL SERVICE BULLETIN

AN19-023F

SOFTWARE UPDATE FOR INFOTAINMENT ISSUES

APPLIED VEHICLES: 2018-2019 Rogue (T32)
2018-2019 Rogue Hybrid (T32H)
2019 Rogue Sport (J11)
2019 Titan (A61)
2019 Titan XD (A61)
2019 Versa Note (E12)

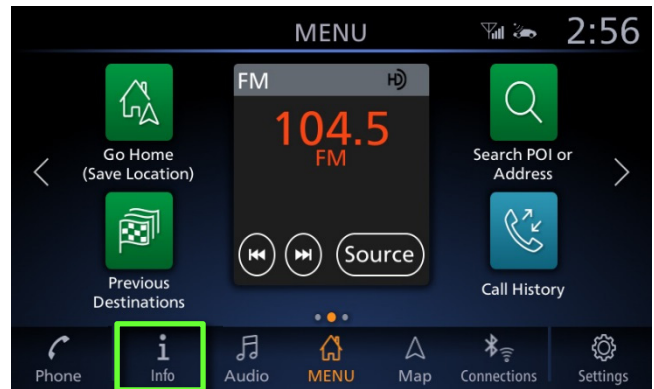
Figure 3

2. Select the **Info** icon.
 - If the **Info** icon does not appear as shown in Figure 3, this bulletin does not apply.

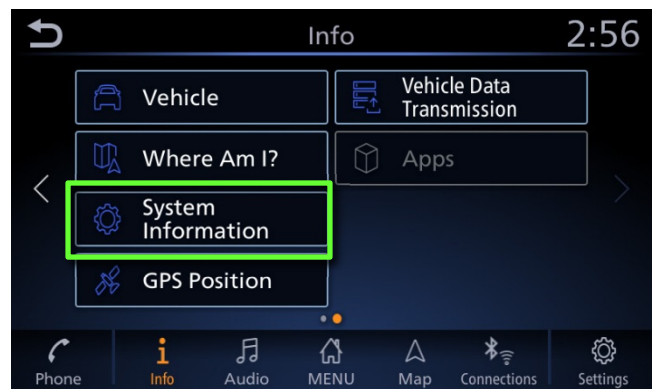
Figure 4

3. Select **System Information**.

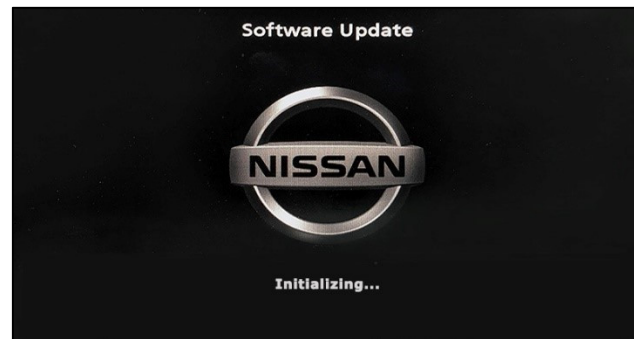
17. Wait approximately 10-30 seconds for the screen in Figure 14 to appear.

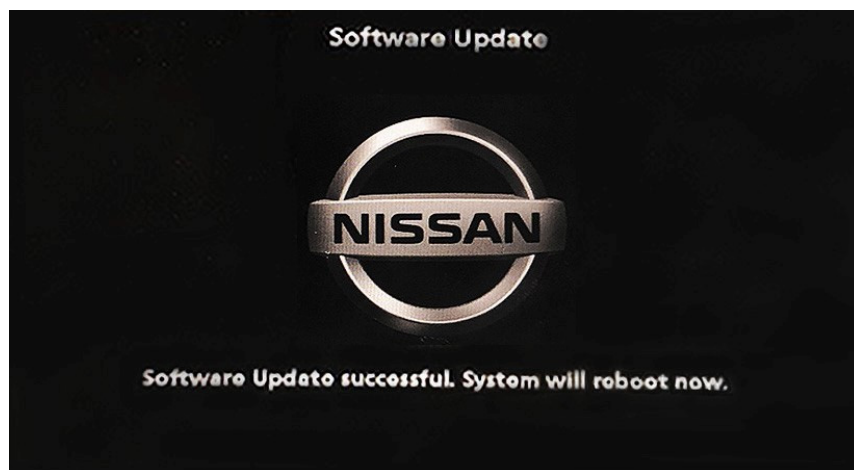
Figure 17

19. Once the update is complete (Figure 17), remove the USB drive; the system will reboot (restart).

HINT: The system will not reboot until the USB drive is removed.

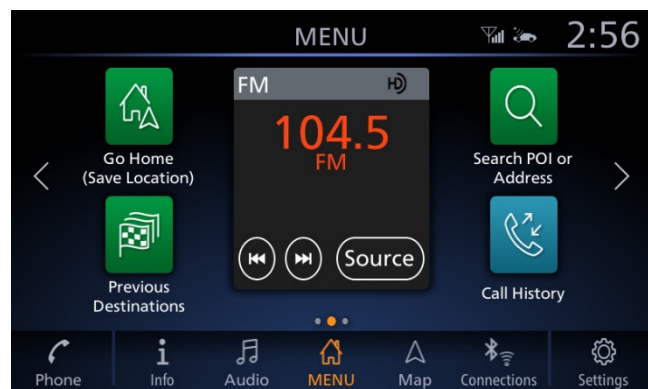
25. After the Nissan logo appears, wait about 1 minute.
 - The MENU (Home) screen in Figure 19 will be displayed.
