# TECHNICAL SERVICE BULLETIN

## INTELLIGENT KEY NOT DETECTED IN CENTER CONSOLE

**APPLIED VEHICLES:** 2021-2022 Sentra (B18)

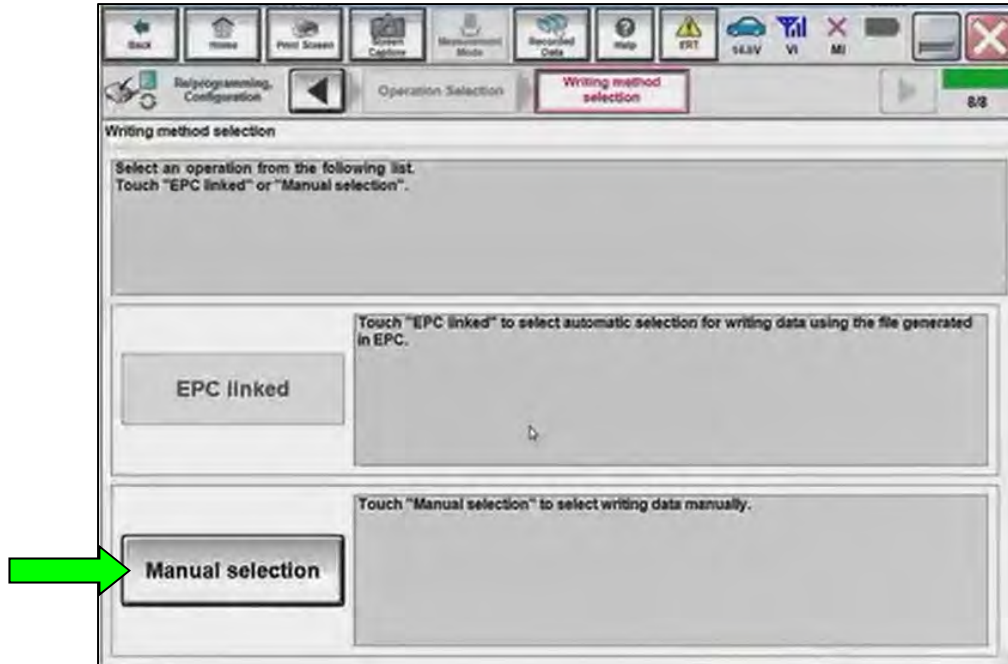
Figure 10

14. Select **Manual selection**.

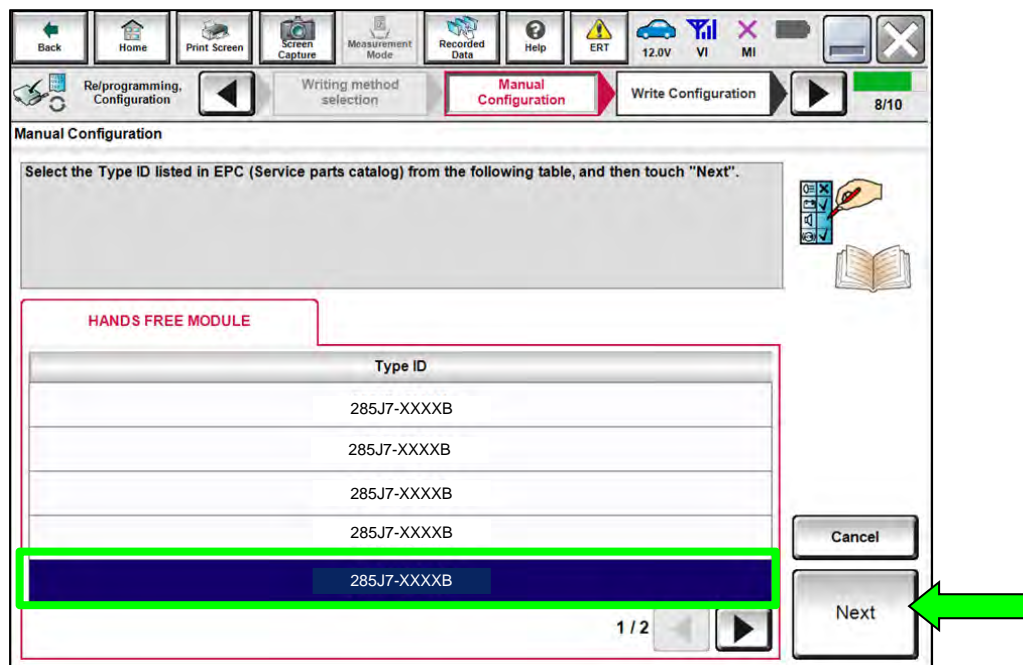
Figure 11

15. Select the grade specific **Type ID**, and then select **Next**.

- With Remote Engine Start (RES), select "285J7-6LE1B"
- Without RES, select "285J7-6LE4B"

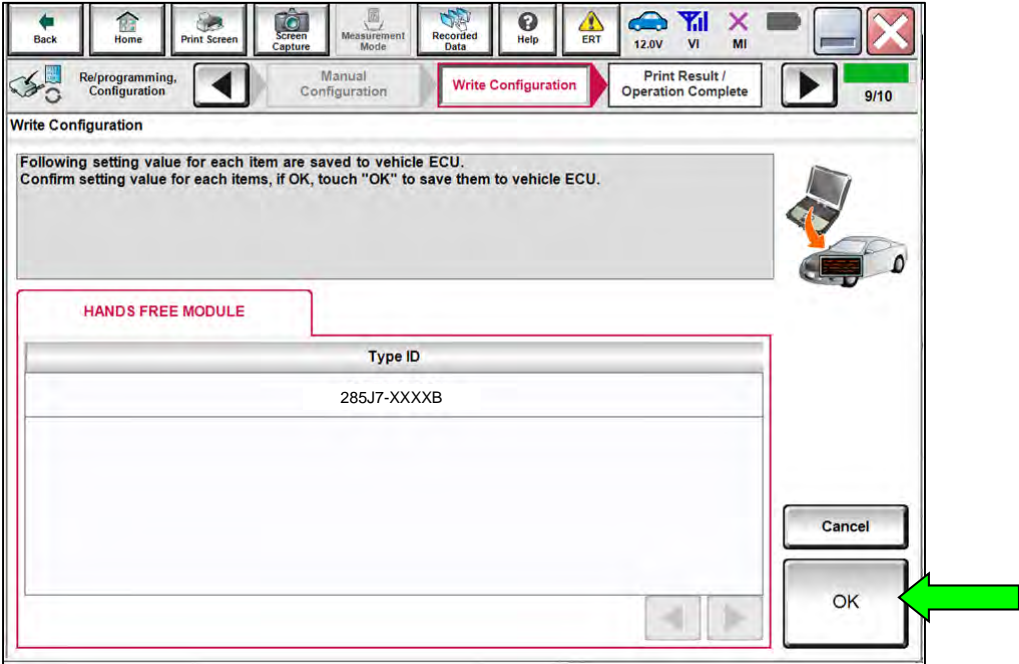
Figure 12

- 16. Verify the ignition is ON and the engine is OFF, and then select **OK** to write the configuration.

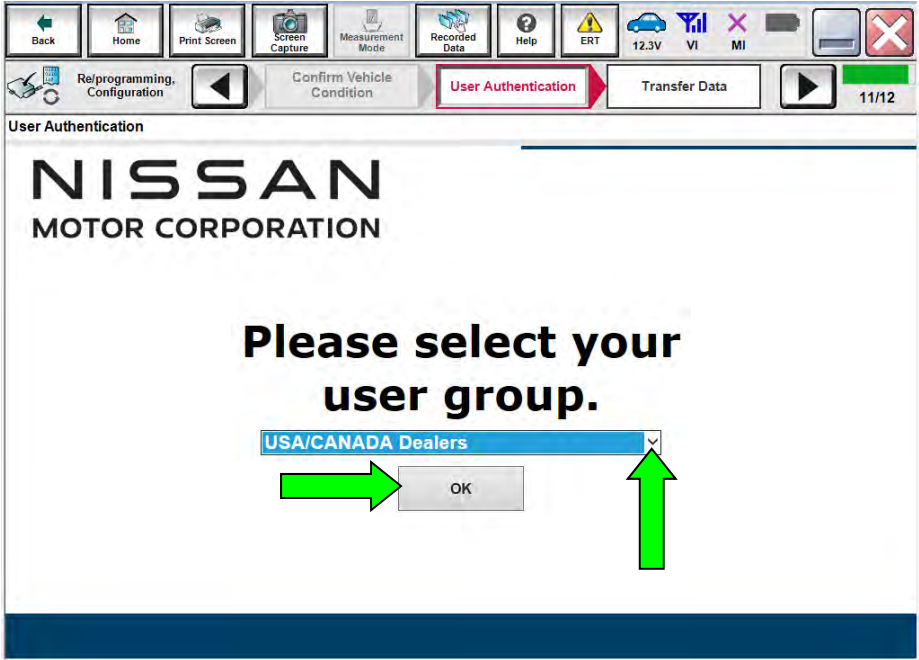
Figure 13

- 17. Select **USA/CANADA Dealers** from the drop down menu, and then select **OK**.

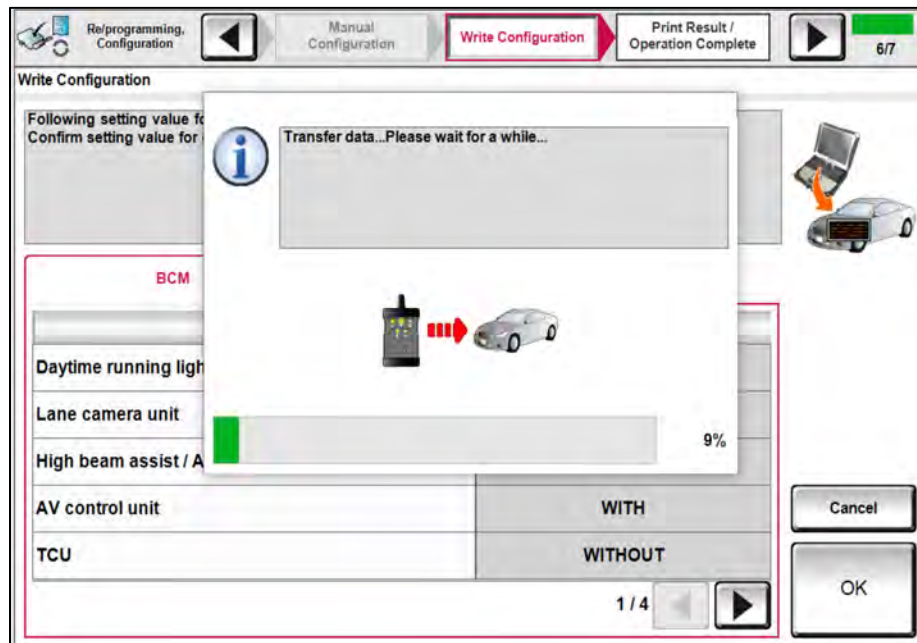
Figure 15

19. Allow the **Write Configuration** to complete.
