TECHNICAL SERVICE BULLETIN

Classification: AN21-003A	Reference: NTB21-029A	Date: August 31, 2022
------------------------------	--------------------------	--------------------------

SOFTWARE UPDATE FOR INFOTAINMENT ISSUES

APPLIED VEHICLES: 2019-2020 Rogue (T32)
2019 Rogue Hybrid (T32H)

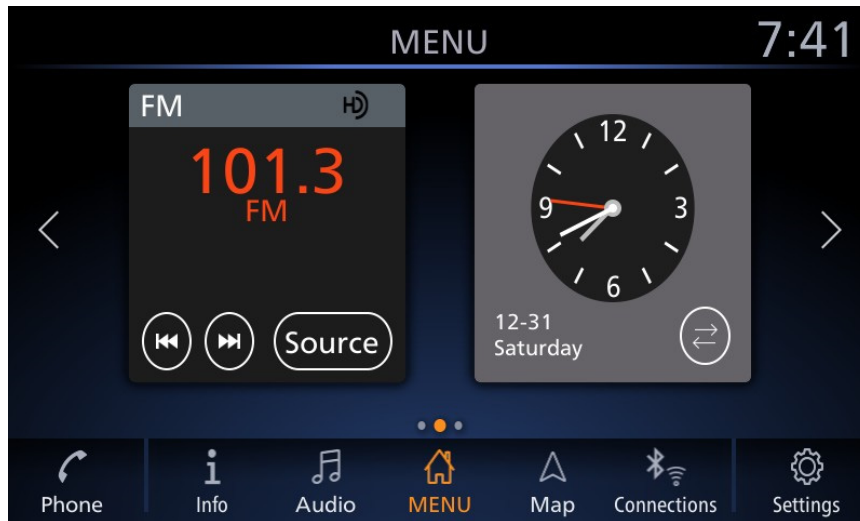
Figure 2

From the **MENU** page shown in Figure 2:

- Push and hold down the **MENU** button (not shown), and at the same time rotate the tuning knob more than three (3) clicks in each direction (back and forth) until the **System Diagnosis Menu**, shown in Figure 3, displays.

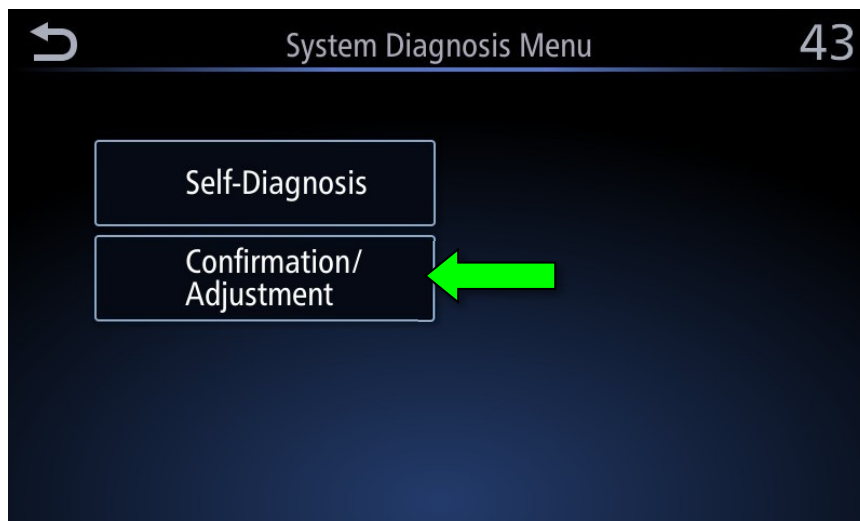
Figure 3

2. Select **Confirmation/Adjustment**.

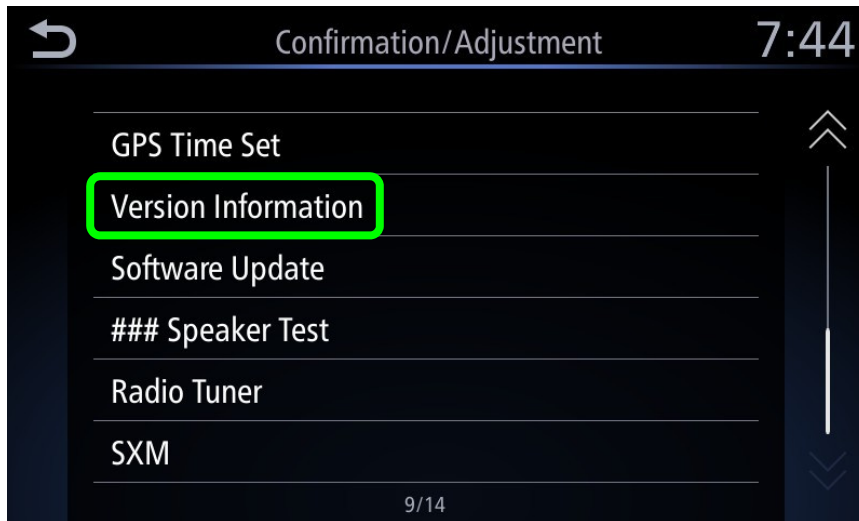
Figure 4

3. Select **Version Information**.

4. Is the **H/U Software** version “0810”?

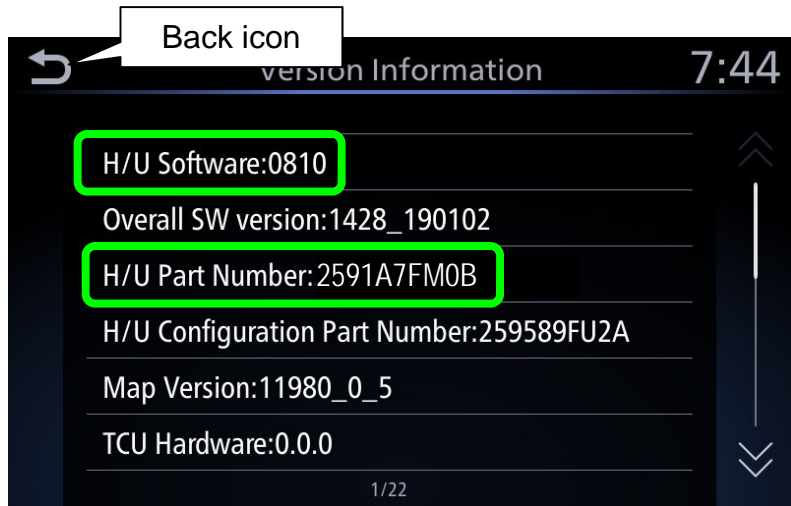
Figure 5

5. Is the **H/U Part Number** listed below?

- 2591A7FM0A
- 2591A7FM0B
- 2591A8FM0A
- 2591A8FM0B
- 259157FH0A
- 259157FH0B
- 259158FM0A
- 259158FM0B

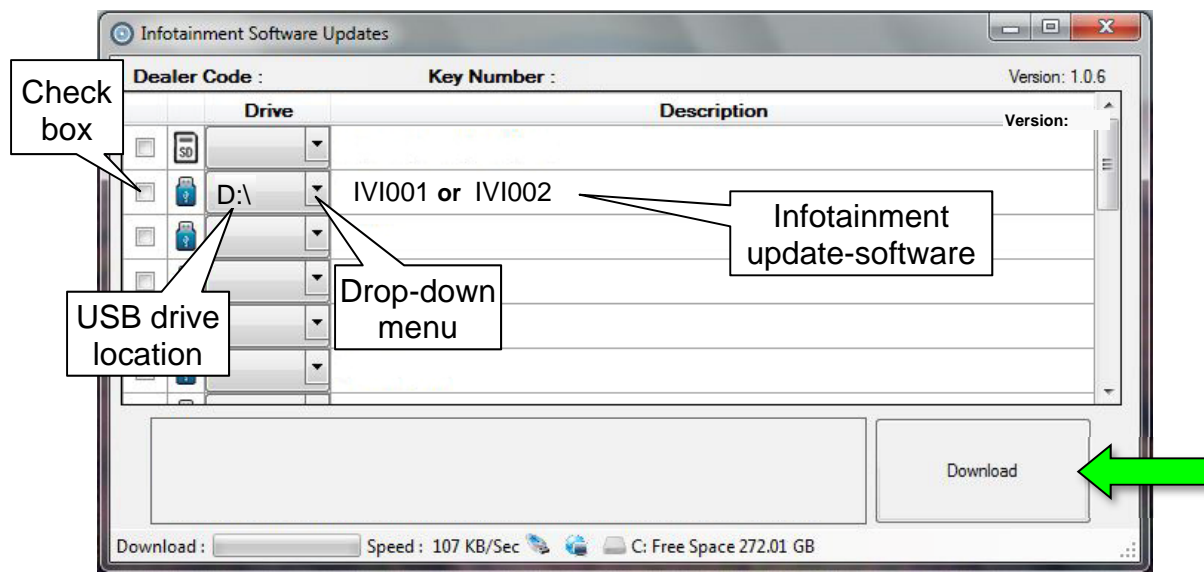
Figure 7

9. Select the check box to the left of the appropriate infotainment update-software (Figure 7).
 - Refer to **Table A** for the infotainment update-software.

10. Use the drop-down menu and select the location of the USB drive that was inserted into the CONSULT PC in step 6 on page 5.

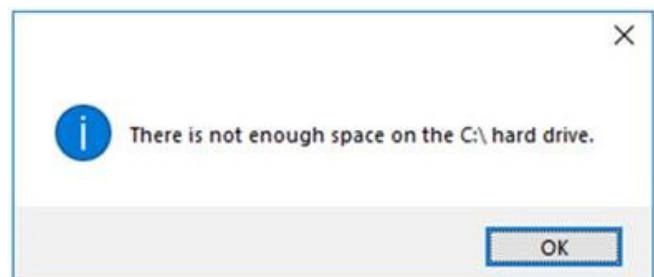
Figure 8

- The update-software is estimated to take 4 hours to download to the USB drive.
- If, while attempting to download the software to the CONSULT PC, you receive the message shown in Figure 8:
 - Attempt to clear space on the CONSULT PC hard drive.

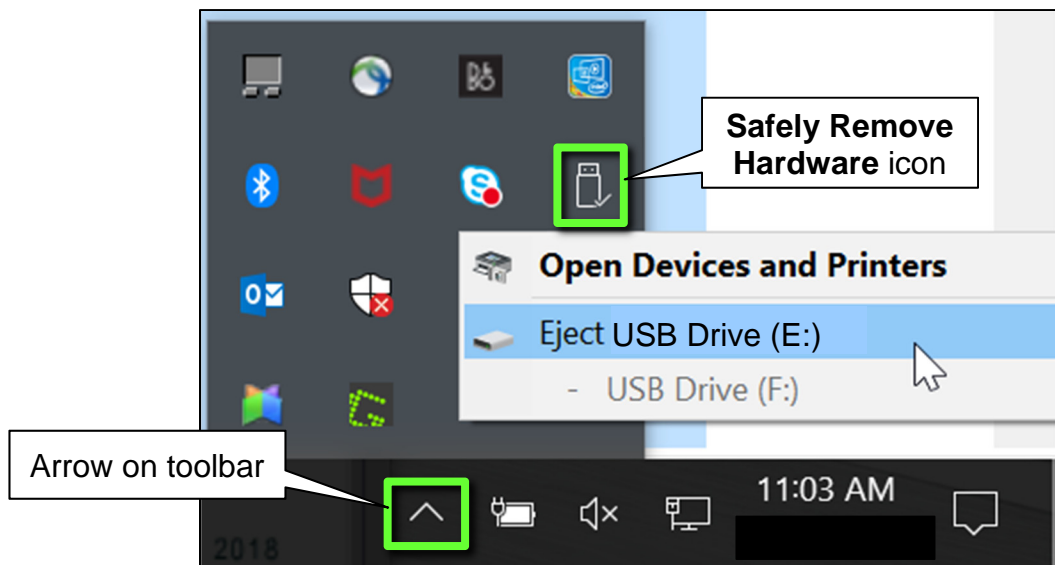
Figure 10

13. Once the transfer is complete, safely remove the USB drive from the ASIST station.
- From the PC toolbar, select the **Safely Remove Hardware** icon (Figure 10).
 - The icon is on the toolbar or can be found after selecting the arrow.
 - Select the USB drive to be removed, and then remove the USB drive from the CONSULT PC.

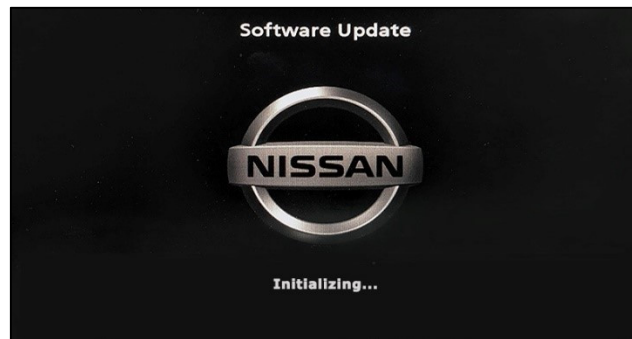
18. Wait approximately 10-30 seconds for the screen in Figure 13 to appear.
