# Service Bulletin

Bulletin No.: 20-NA-065

**Subject:** Information on Malfunction Indicator Lamp (MIL) Illuminated with Multiple Fuel Trim and/or Oxygen Sensor Codes Set

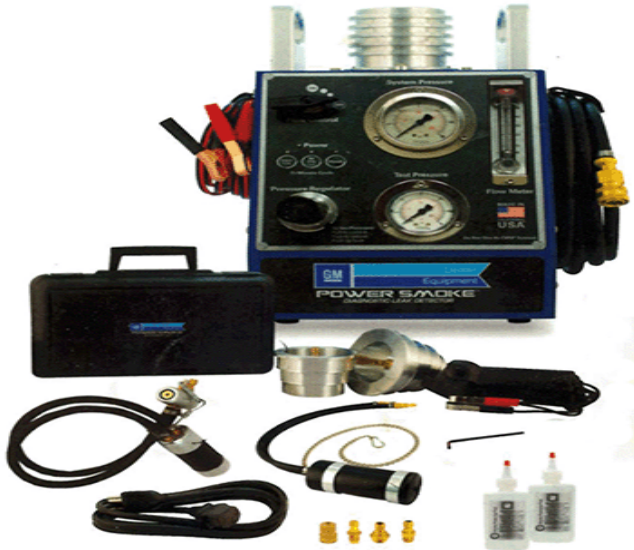
5418222

**Note:** The adapters may vary as the tool evolves.

GE-52250: Variable Pressure Leak Detector

The technician should start by following SI diagnostics. If no cause for the concern is found or during diagnosis, a leak check is required. The preferred and most effective method to detect the leak is by use of the GE-52250 Variable Pressure Leak Detector. GE-52250 is not currently an essential tool in the U.S. but it is available to dealers in the U.S. through the GM Tool Loaner Program. Service Bulletin 16-NA-158 outlines the U.S. dealer special tool loan program. For more information on use of the tool, refer to Component/System Leak Test (Document ID #5433806) in SI. The GE-52250 Variable Pressure Leak Detection tool was introduced to the U.S. dealer technicians during the December 2019 Service Know How Emerging Issues broadcast (10219.12V) and during the March 2020 TAC Talk program for dealers in Canada (52020.03-0D).
