October 2021
SF630A
REVISED NOTICE

Subject: Cascadia Lane Assist Software

Models Affected: Specific model year 2019-2021 Freightliner Cascadia model vehicles manufactured June 18, 2019 , through June 15, 2021.

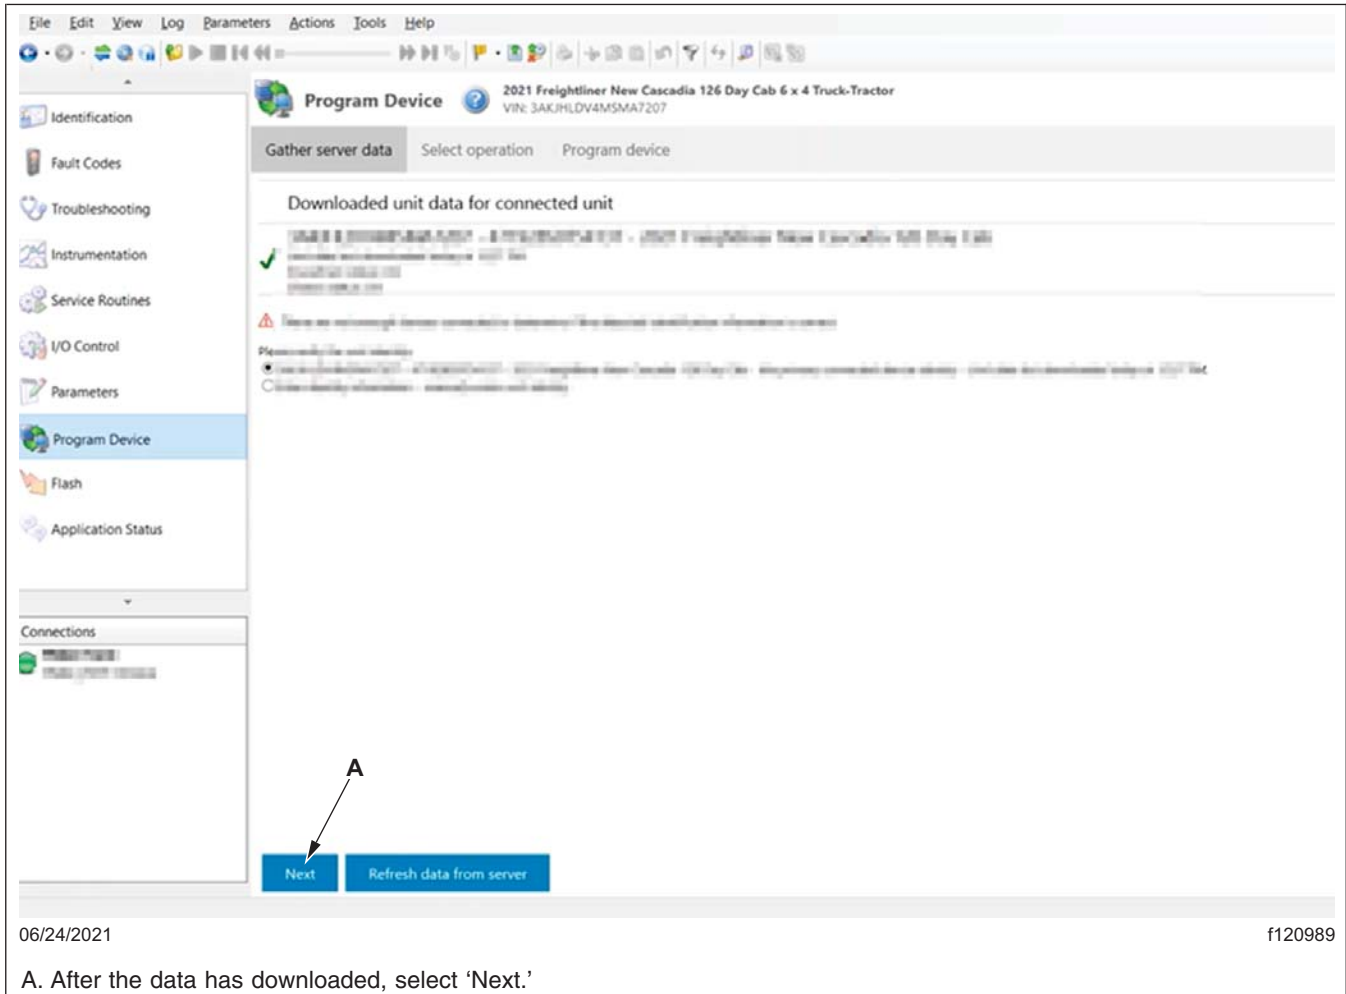
Fig. 3, Data Downloaded from Server

7. When the data has finished downloading, select 'Next.' See [Fig. 3](#).
