Service Bulletin

21-007

MIL Is ON with DTC P0455

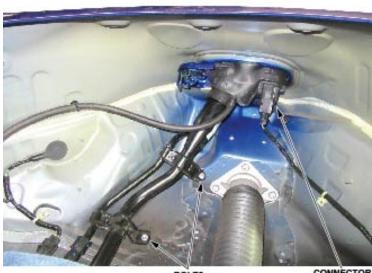
CONNECTOR

5. Disconnect the connector and remove the two fuel filler neck bolts.

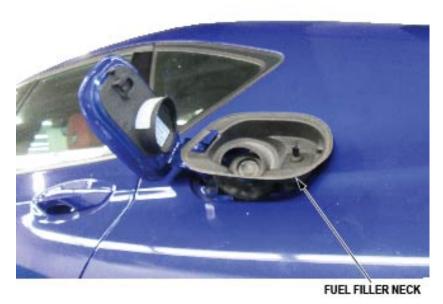
6. Unclip the fuel filler adapter assembly from around the filler door hinge.
