Entune Audio Head Unit Software Update (Panasonic)

Service Category Audio/Visual/Telematics

Section Navigation/Multi Info Display **Market** USA and Mexico

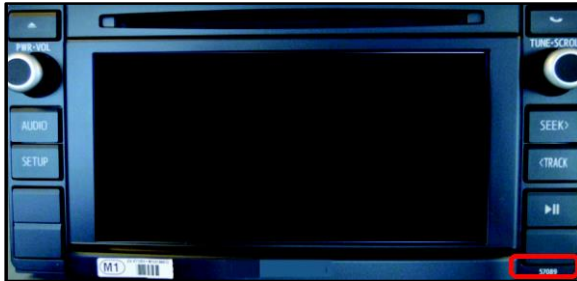
Figure 1. Avalon, Avalon HV, Highlander, Highlander HV, Prius, Prius Prime, Prius V, Sienna, Sequoia, Tacoma, Tundra, Yaris

1. Confirm the audio system type by checking the faceplate ID printed on the bottom-right or bottom-center of the head unit. See Table 1 for the applicable model faceplate ID number.

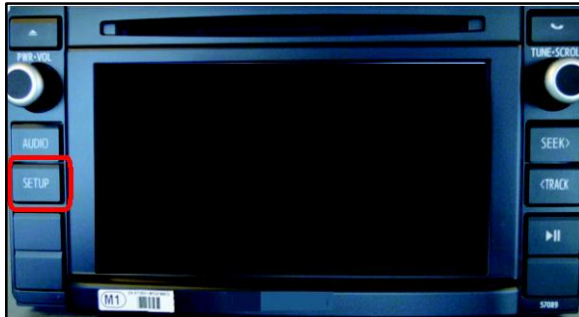
Figure 3. Tacoma, Prius, Prius Prime, Prius V, Yaris

- 4. Go to the Setup screen.
 - A. For Entune™ Audio: Press the Setup button on the panel.

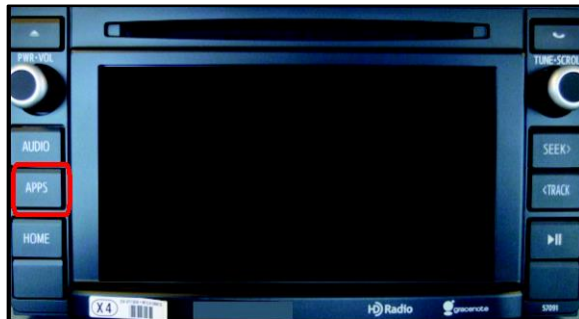
Figure 5. 4Runner, Avalon, Avalon HV, Highlander, Highlander HV, Prius, Prius Prime, Prius V, Sienna, Sequoia, Tacoma, Yaris

- B. For Entune™ Audio Plus and Entune™ Premium Audio: Press the Apps button on the panel.

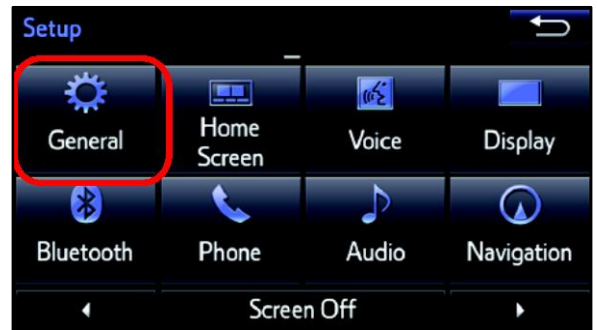
Figure 9.

6. Select General on the Setup screen.

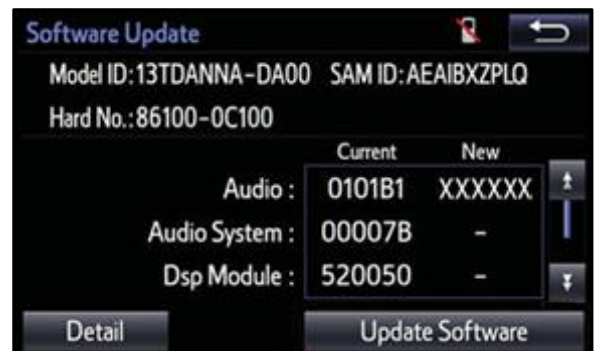
Figure 13.

9. Verify that the NEW software is up to date on the Software Update screen.

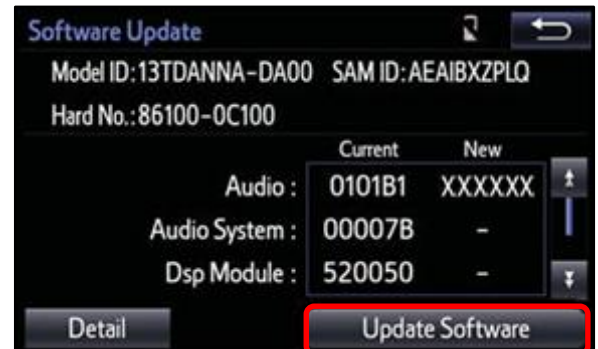
Figure 14.

10. Select Update Software on the Software Update screen.

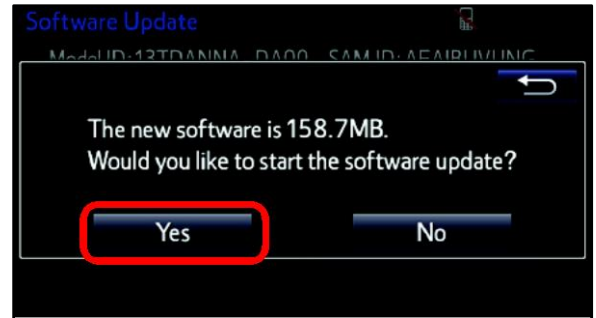
Figure 15.

11. Select Yes on the “Would you like to start the software update?” pop-up.

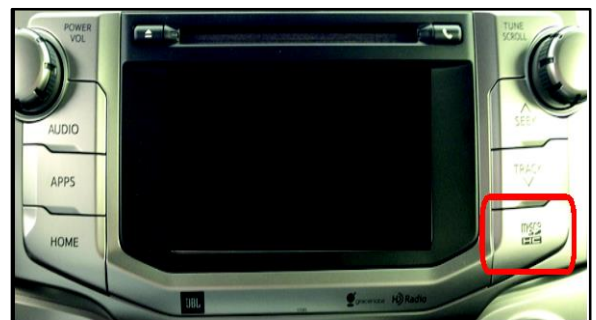
Figure 17.

- If the update fails and the error message “New software is not compatible with the system” displays, cycle the ignition OFF, remove the map micro SD card from the head unit, then repeat steps 3 – 12.
- A software update error is more likely to occur in areas with more traffic information.

Once the update is completed, reinsert the map micro SD card into the head unit, cycle the ignition OFF, then continue to step 13.

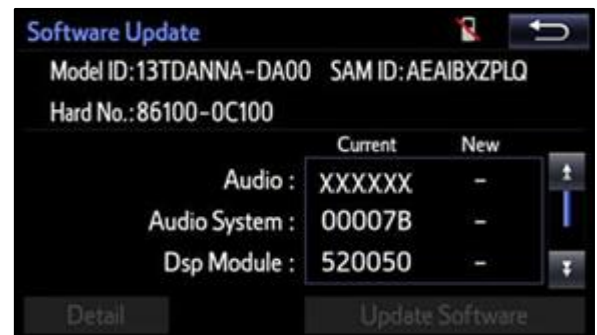
Figure 19.

- Perform steps 3 – 7 of the Software Update Procedure to re-enter the Software Update screen.
- Verify that the software information is updated on the Software Update screen. See Table 3 for the current software version.
