# Head Unit Software Update (Panasonic)

YEAR(S)	MODEL(S)	ADDITIONAL INFORMATION
2022	Tundra

A head unit software update is now available for 2022 model year Tundra vehicles equipped with Toyota Multimedia (version 1020 or earlier). This update provides improved performance and capability for the following:

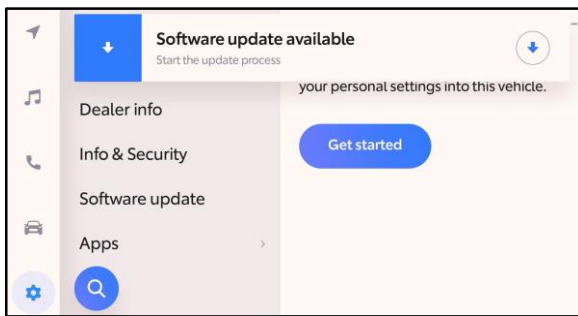
**Figure 1.**

Vehicle operators can perform this update directly by accepting the on-screen notification (see Figure 1) advising Software update available or by locating Software update from the Settings menu and initiating the available update (see Figure 2). The release notes text below will be displayed to the customer (see Figure 2):

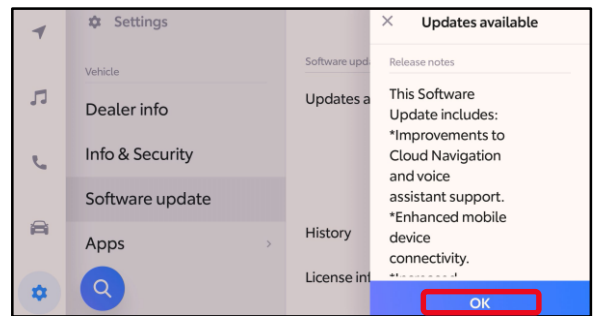
**Figure 2.**

“This Software Update includes: \*Improvements to Cloud Navigation and voice assistant support. \*Enhanced mobile device connectivity. \*Increased performance resulting in a better experience.”

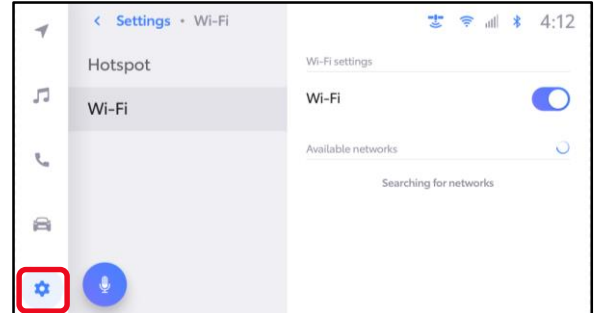
**Figure 3.**

1. Turn ON the ignition.
2. Select the gear icon in the lower left corner of the radio screen.

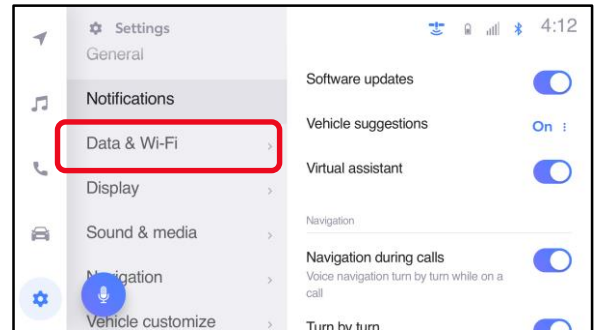
**Figure 4.**

3. Select Data & Wi-Fi.

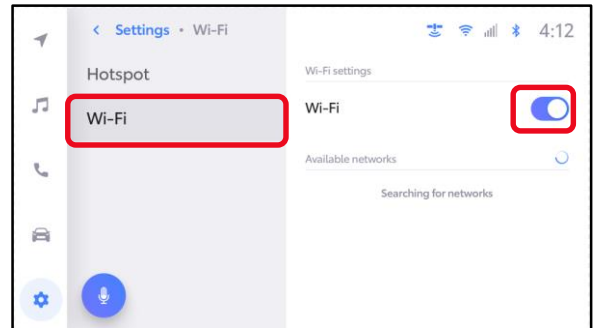
**Figure 5.**

4. Select Wi-Fi and turn the Wi-Fi toggle to ON.

- This step is used to connect the vehicle to an EXTERNAL Wi-Fi source.
- Wi-Fi connection is NOT required for updates that are delivered through DCM data.

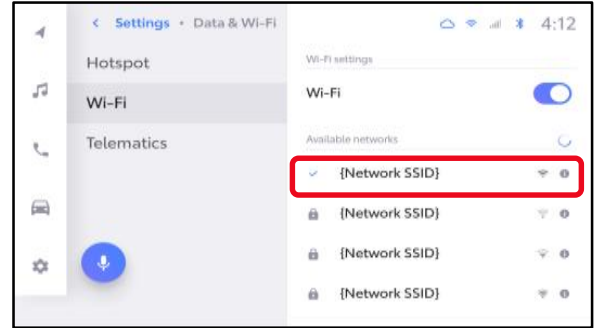
**Figure 6.**

- Select the Wi-Fi network desired to connect.

**NOTE**  
It is NOT possible to connect to a Wi-Fi source that requires a username and password to be entered in a browser.

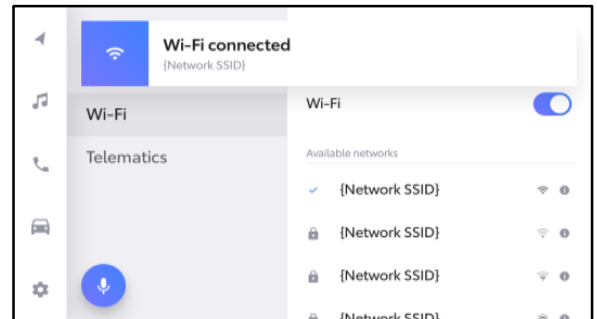
**Figure 7.**

- Follow the on-screen instructions. A message will appear confirming that the vehicle is successfully connected to the network.

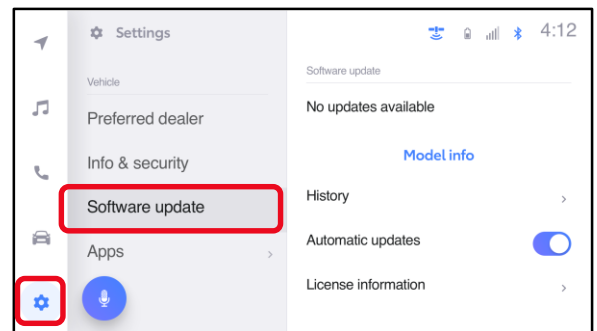
**Figure 8.**

- Select the gear icon, scroll down, and select Software update.

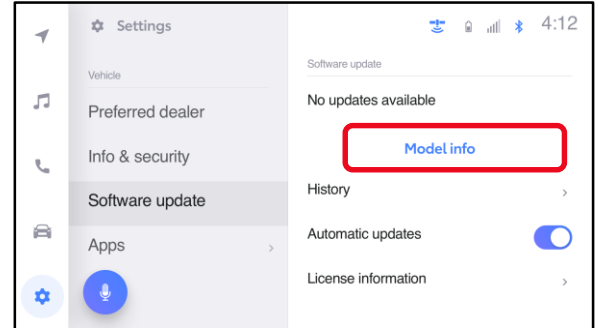
**Figure 9.**

2. Are software updates available?
  - **YES** — Continue to step 3 to update the vehicle.
  - **NO** — This bulletin does NOT apply, continue diagnosis using the applicable Repair Manual.

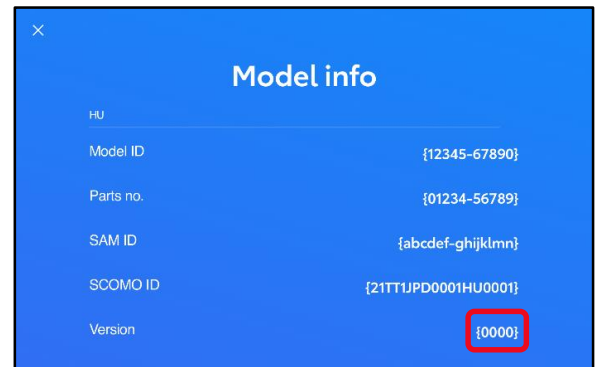
**Figure 10.**

3. Is the software up to date? (Refer to Table 1 below.)
  - **YES** — This bulletin does NOT apply, continue diagnosis using the applicable Repair Manual.
  - **NO** — Continue to step 4.
4. Is the software version in the vehicle one of the previous versions listed in Table 1?
  - **YES** — Continue to step 5.
  - **NO** — The version is five or more versions old. Go to the [USB Update Procedure](#) subsection.

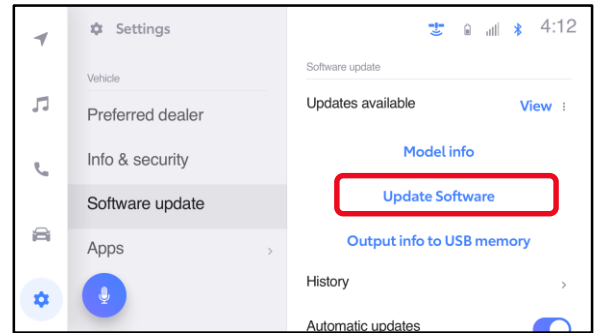
Figure 11.

6. Select Update Software.

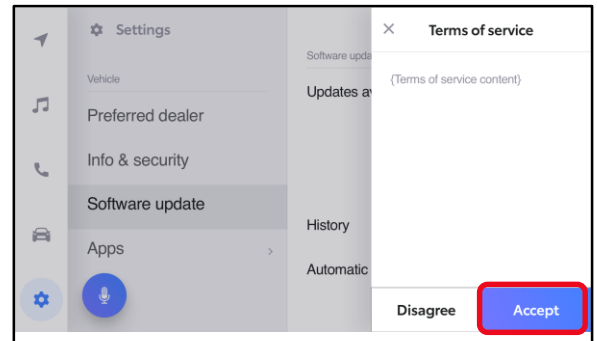
Figure 12.

7. Select Accept on the Terms of service screen.

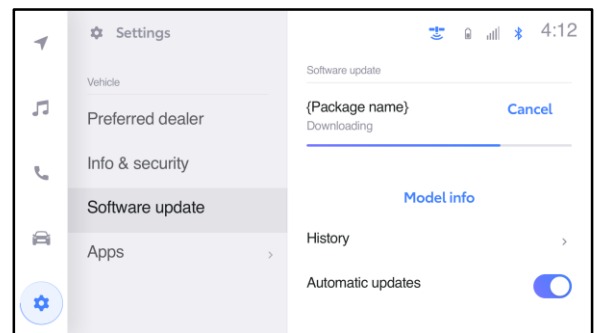
Figure 13.

8. Wait for the update to download.

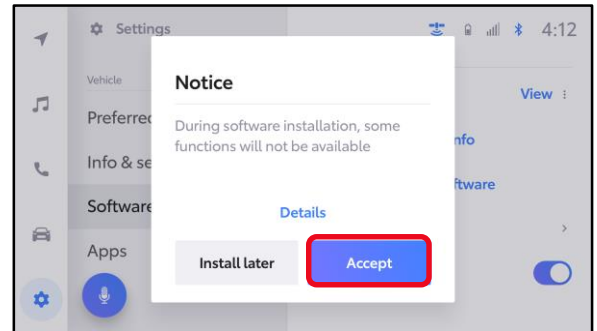
**Figure 14.**

9. Select Accept on the Notice pop-up message if it appears.

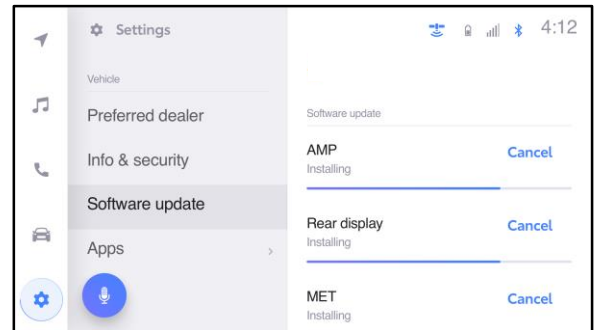
**Figure 15.**

10. Wait for the update to download. Once the head unit begins installation, the update will take 10 minutes or less.

- Do NOT turn OFF the engine or ACC BEFORE the software is ready for updating.
- Selecting Cancel will cancel the installation of the specific component, but it can be installed manually later.

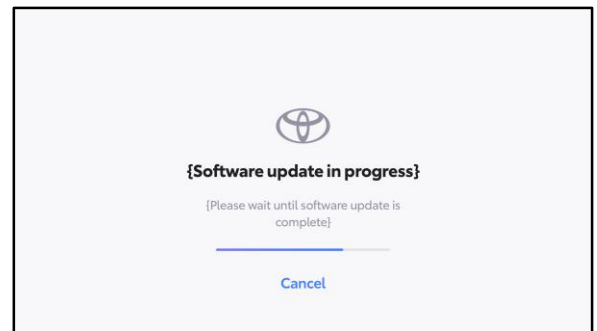
**Figure 16.**

11. If a major update is being installed the message "{Software update in progress}" will be displayed.

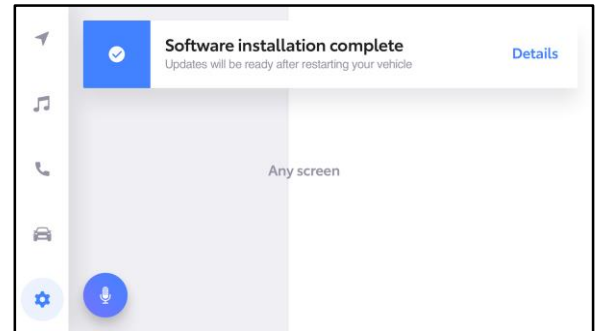
**Figure 17.**

- The software installation is complete when either a “Software installation complete” banner (Figure 17) or the “Software update complete” screen (Figure 18) is displayed.

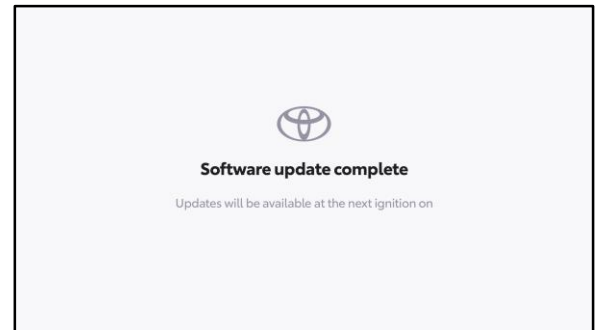
**Figure 18.**

If the vehicle has installed a major update, and the “Software update complete” screen is displayed, then an IG-OFF/ON will need to be performed prior to attempting to operate any of the infotainment functions.

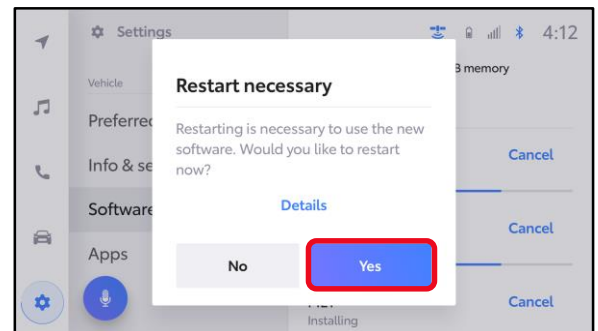
**Figure 19.**

- If a restart is necessary, select Yes to restart the head unit.

If No is selected or the vehicle is switched to IG-OFF, the installation will occur at the next IG-ON.

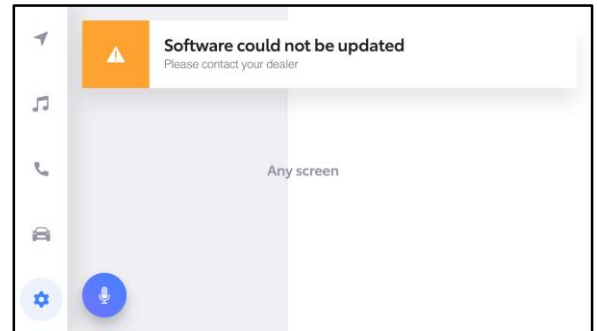
**Figure 20.**

- If after IG-OFF/ON a “Software could not be updated” banner appears, continue to the [USB Update Procedure](#) subsection.

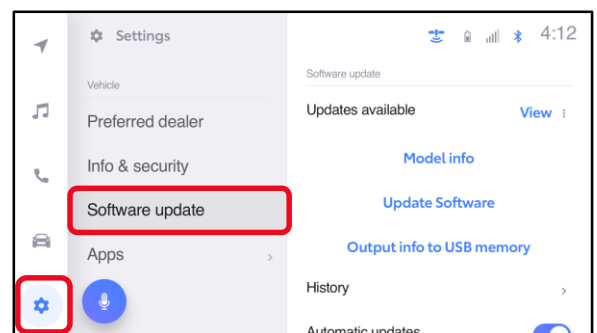
**Figure 21.**

- Select the gear icon and scroll down to Software Update.

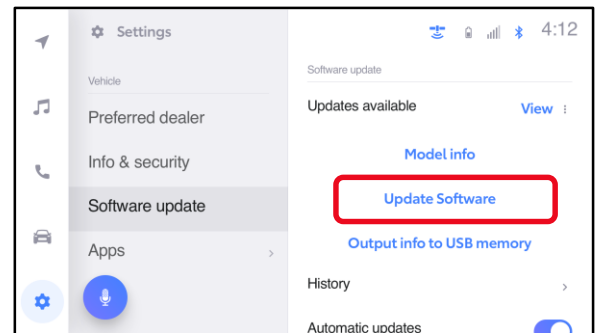
**Figure 23.**

The "Update Software" button may not be available immediately after inserting the USB flash drive. The head unit is unzipping the software update file, and it may take up to 10 minutes for this button to become available to press.

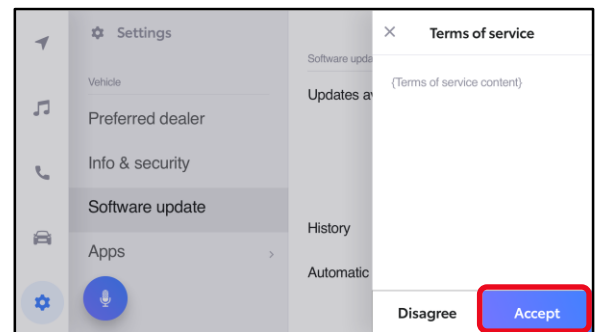
**Figure 24.**

5. Select Accept on the Terms of service screen.

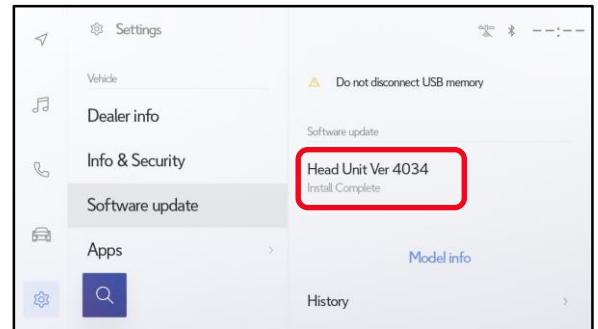
**Figure 26.**

- A. When the update is complete, “Install Complete” will show on the head unit, as shown in Figure 26.
- B. The “Software update” pop-up message may also appear, as shown in Figure 27.
