ECU Flash Reprogramming With Security Signature

YEAR(S)	MODEL(S)	ADDITIONAL INFORMATION
2022	LS500, LS500H, LX600, NX250, NX350, NX350H, NX450H+

Flash reprogramming allows the Electronic Control Unit (ECU) software to be updated without replacing the ECU. Flash calibration updates for specific vehicle models/ECUs are released as field-fix procedures described in individual Service Bulletins. This bulletin details the Techstream ECU flash reprogramming process and outlines use of TIS and the Calibration Update Wizard (CUW). To ensure the correct ECU software is installed, ECUs will require a Security Signature before the ECU will initialize the flash reprogramming sequence. This bulletin also details the process for acquiring a Security Signature from TIS during the Techstream ECU flash reprogramming process.

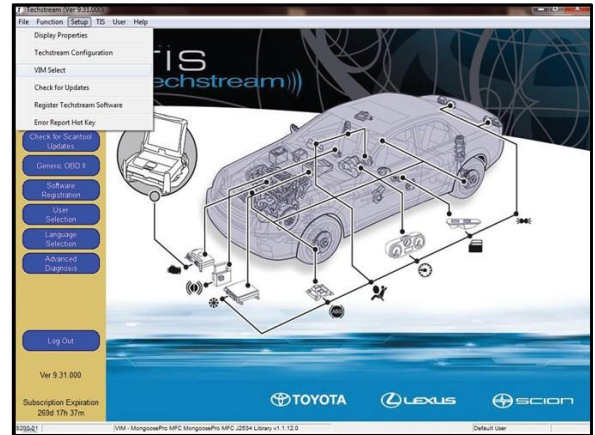
Figure 2.

1. Select Setup from the Techstream main menu screen.
2. Select VIM Select from the Setup dropdown menu.

3. Select the correct interface setup from the dropdown list.
 - If using Techstream ADVi, select MongoosePro MFC2.
 - If using Techstream 2.0, select MongoosePro MFC.
 - If using Techstream Lite, select Mongoose MFC (blue or updated clear case) or MongoosePro MFC2 (green case) depending on the cable being used.

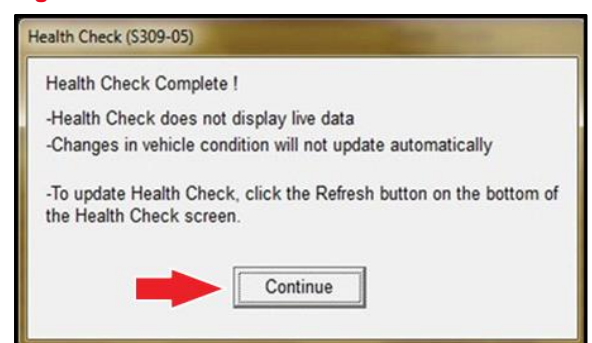
Figure 7.

- D. Click Continue to view the Health Check results.

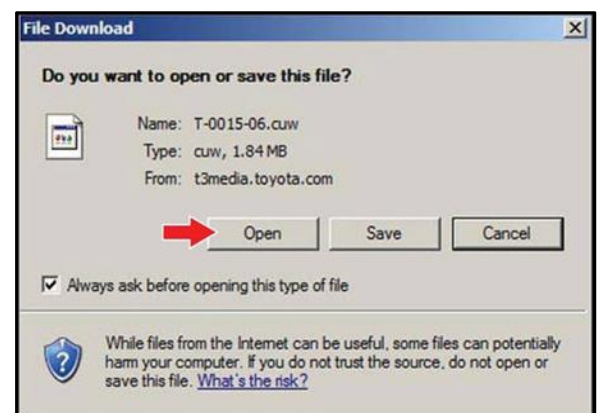
Figure 11.

- B. Click Open to load the calibration file information.

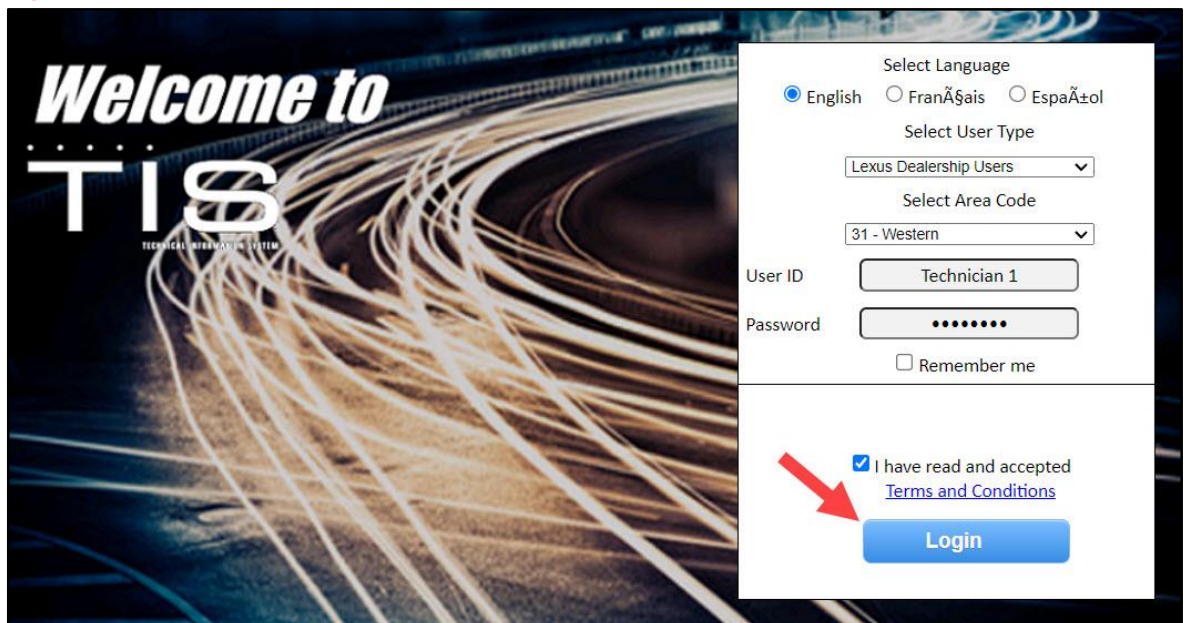
Figure 18.

- I. Input TIS login credentials and select Login.

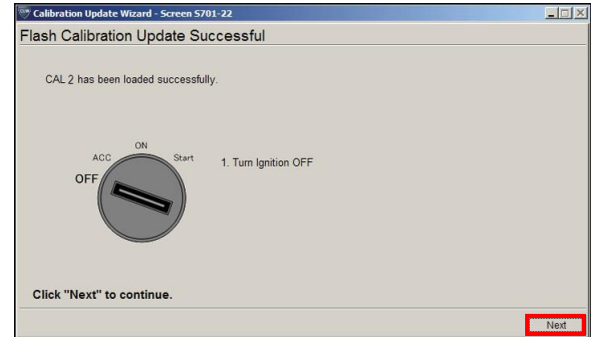
Figure 27.

- Q. Turn the ignition OFF for a minimum of 10 seconds, then click Next.
