TECHNICAL SERVICE BULLETIN

Classification: AN22-001A	Reference: NTB22-028A	Date: September 6, 2022
------------------------------	--------------------------	----------------------------

SOFTWARE UPDATE FOR INFOTAINMENT ISSUES

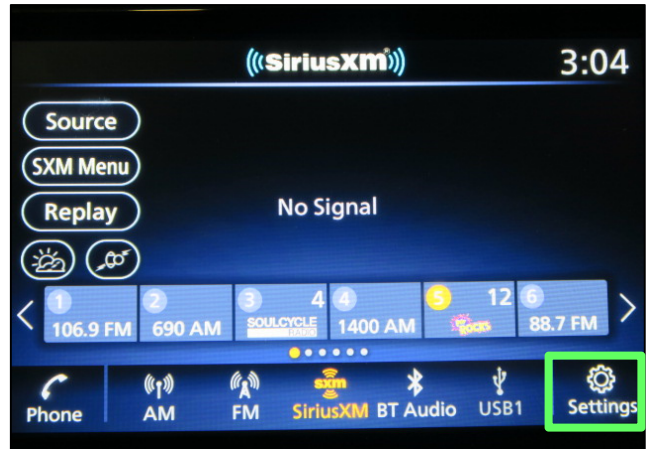
Figure 2

1. Select **Settings**, located in the lower right hand corner of the Audio Control Unit display (Figure 2).

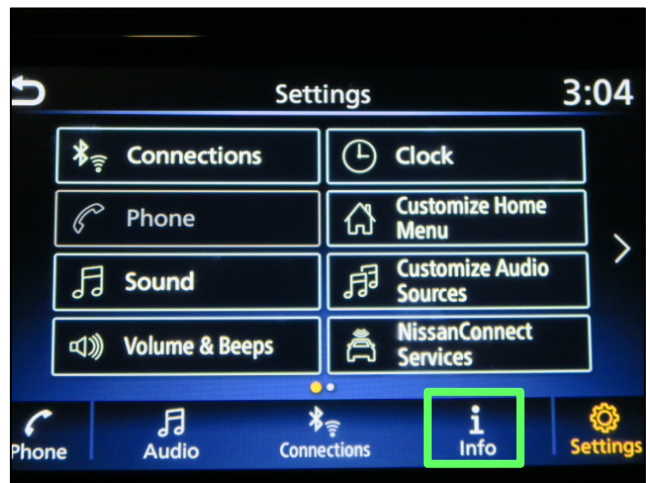
Figure 3

2. Select **Info**.

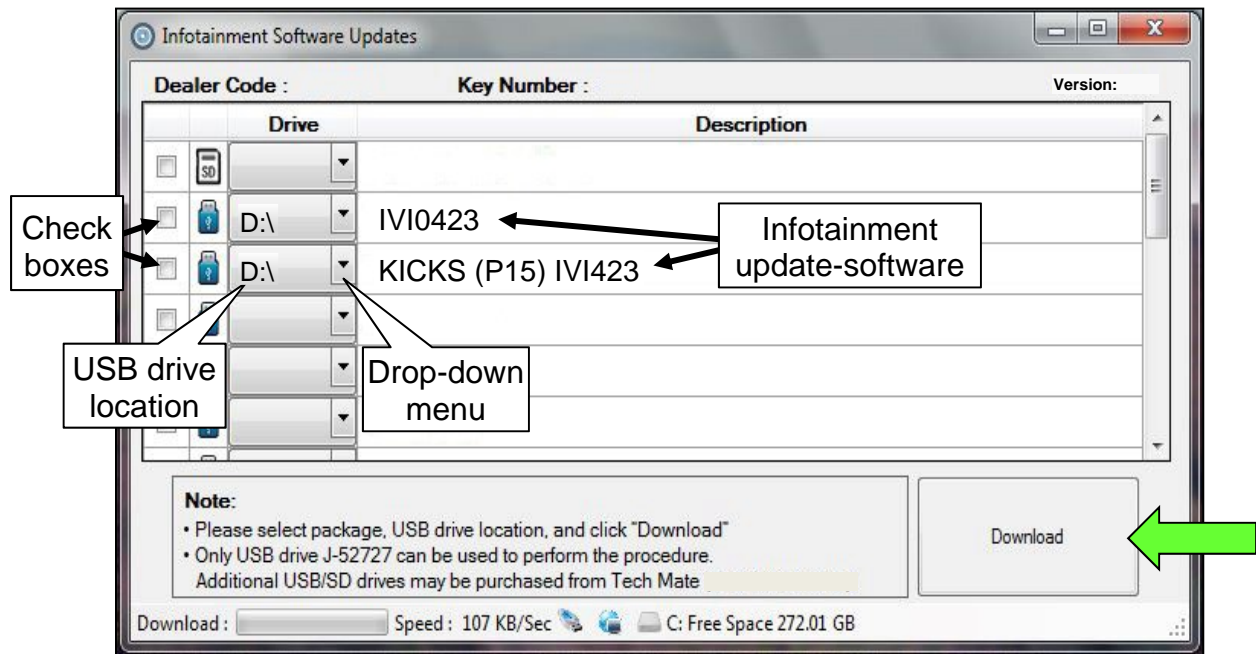
Figure 8

9. Select the check box next to one of the following model specific infotainment update-software descriptions:
 - For Sentra – **IVI0423**
 - For Kicks – **KICKS (P15) IVI423**
10. Use the drop-down menu and select the location of the USB drive that was inserted in step 6 on page 5.

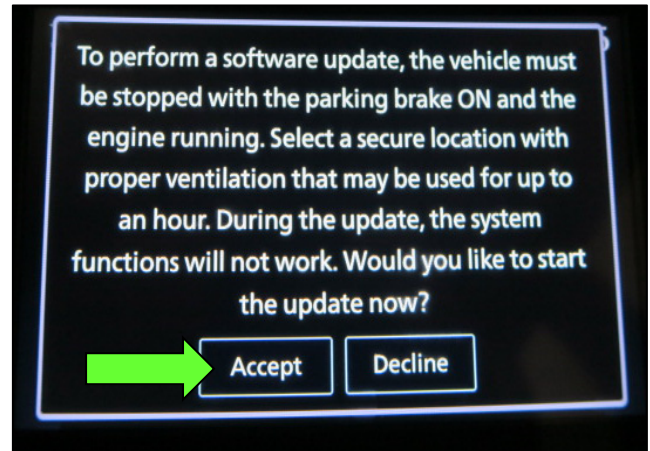
Figure 14

19. Review the software update requirements, shown in Figure 14, and then select **Accept** to start the reprogramming.

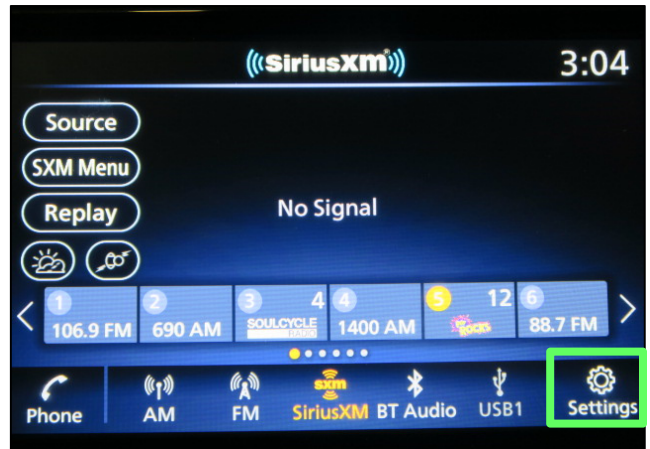
Figure 17

25. Select **Settings**, located in the lower right hand corner of the Audio Control Unit display (Figure 17).

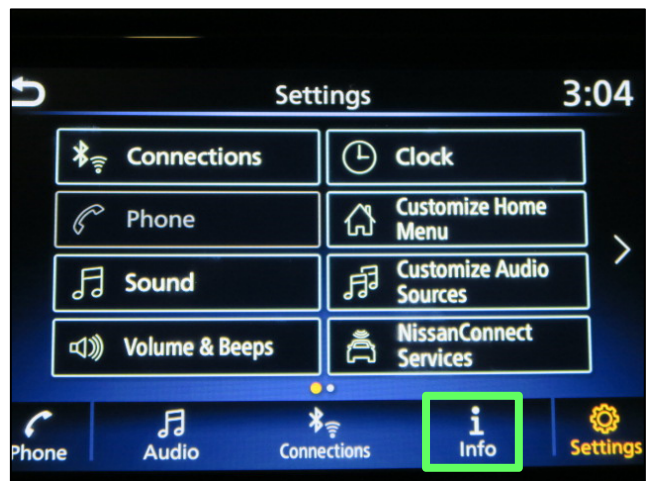
Figure 18

26. Select **Info**.

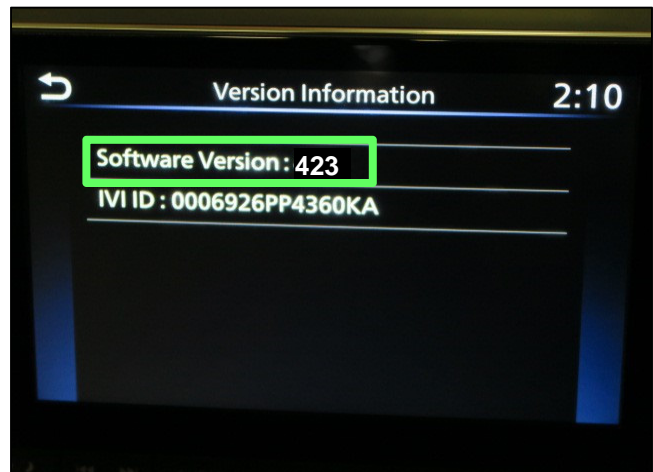
Figure 21

29. Verify the **Software Version** is now **423**.

- If the **Software Version** is NOT **423**, start this procedure over and verify that the correct software shown in step 9 on page 6 is downloaded.
- If the **Software Version** is 423, the reprogramming is complete. Proceed to **CLAIMS INFORMATION** on the next page.
