GROUP	MODEL
ELE	2023MY Carnival (KA4)
NUMBER	DATE
267	September 2022

TECHNICAL SERVICE BULLETIN

SERVICE ACTION: 3.5L GDI ECM LOGIC IMPROVEMENT (SA508)

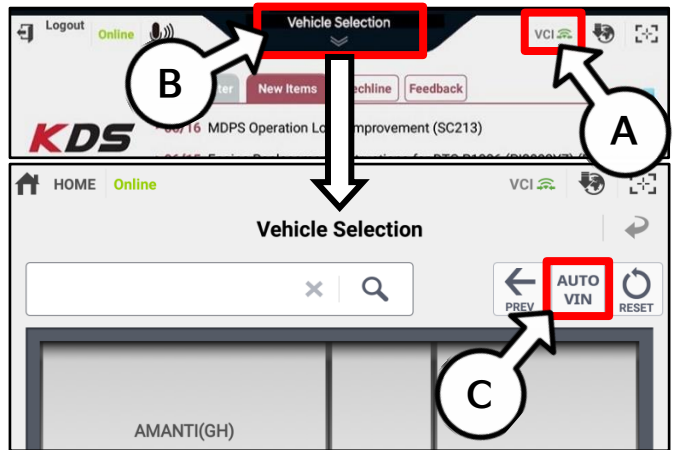
3. Confirm communication with VCI (A) and then configure the vehicle (B) using the 'AUTO VIN' (C) feature.

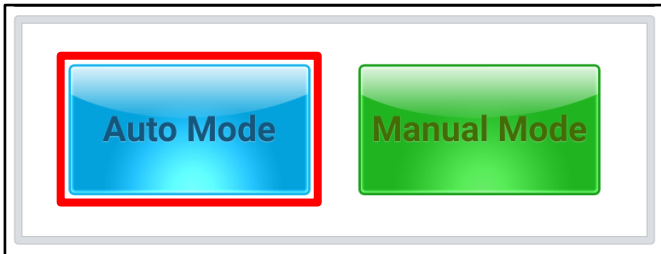
- Select Auto Mode.

Do NOT attempt to perform a Manual Mode upgrade UNLESS Auto Mode fails. Always follow the instructions given on the KDS in either Auto or Manual mode.

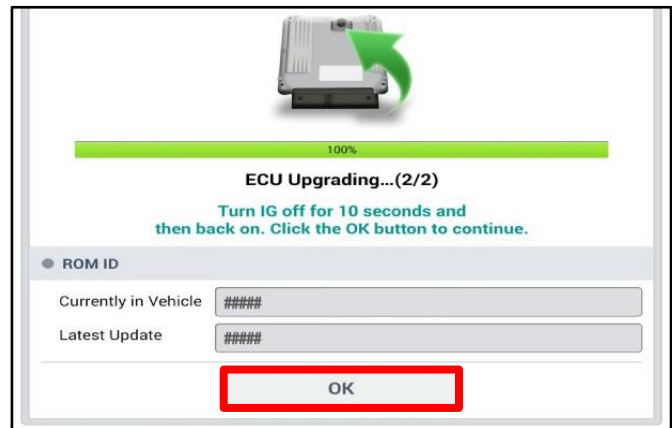
- When instructed on the KDS, turn the ignition OFF for ten (10) seconds then back on. Select 'OK' to continue.

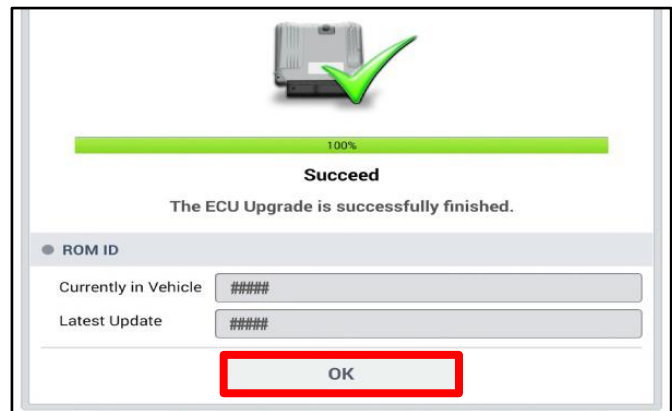
- Once the upgrade is complete, select 'OK' to finalize the procedure.

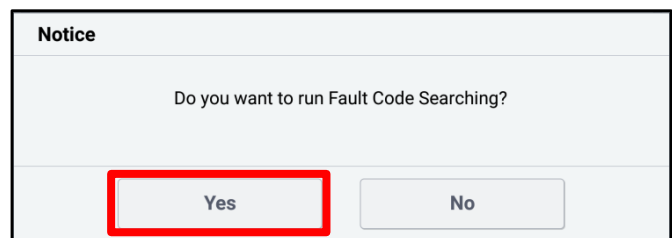
- When prompted, select 'YES' to check for Diagnostic Trouble Codes (DTC) and erase any DTCs stored such as EPS, ESC, and TPMS that may have been set during the upgrade.
