## Audio Sound Stops and "No Audio Connection" Message Appears

### AFFECTED VEHICLES

## REPAIR PROCEDURE

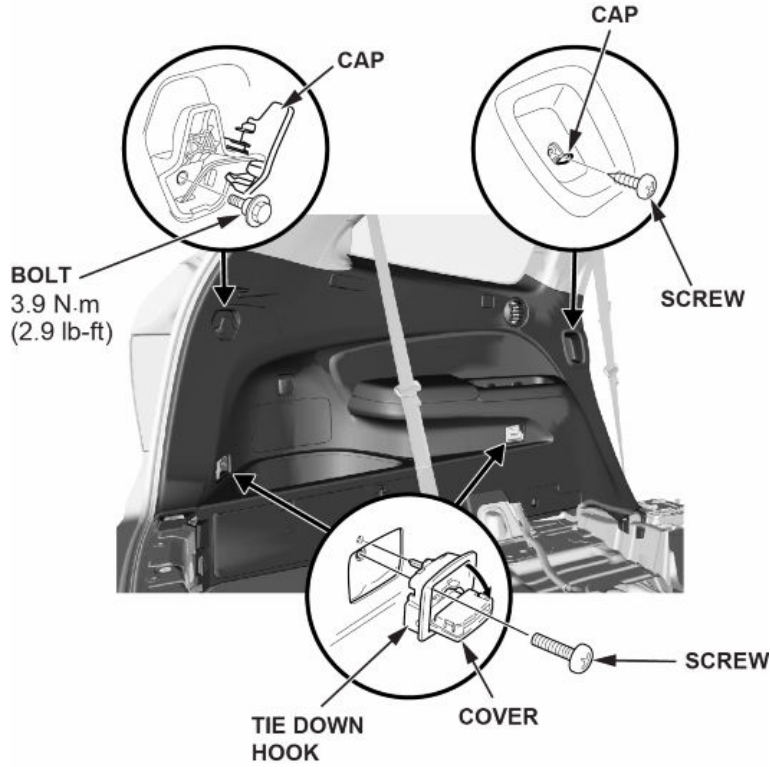
**LEFT SIDE SHOWN**

1. Open the caps, and remove the bolt and screw in the right rear side panel.
2. Pry out the covers, and remove the screws.
3. Remove the tie down hook.

NOTE: Illustration shown is left side. Remove the right side.

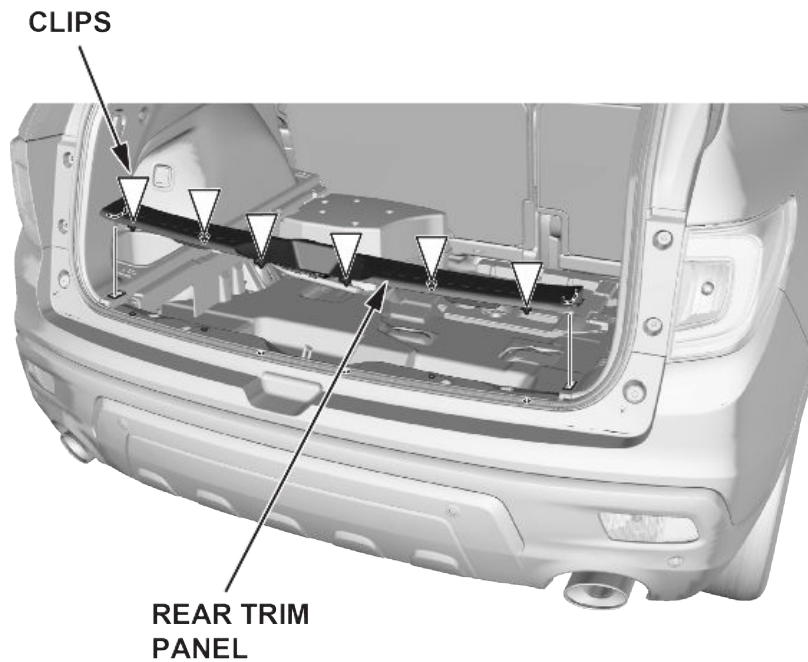
1. Remove the rear trim panel cover.

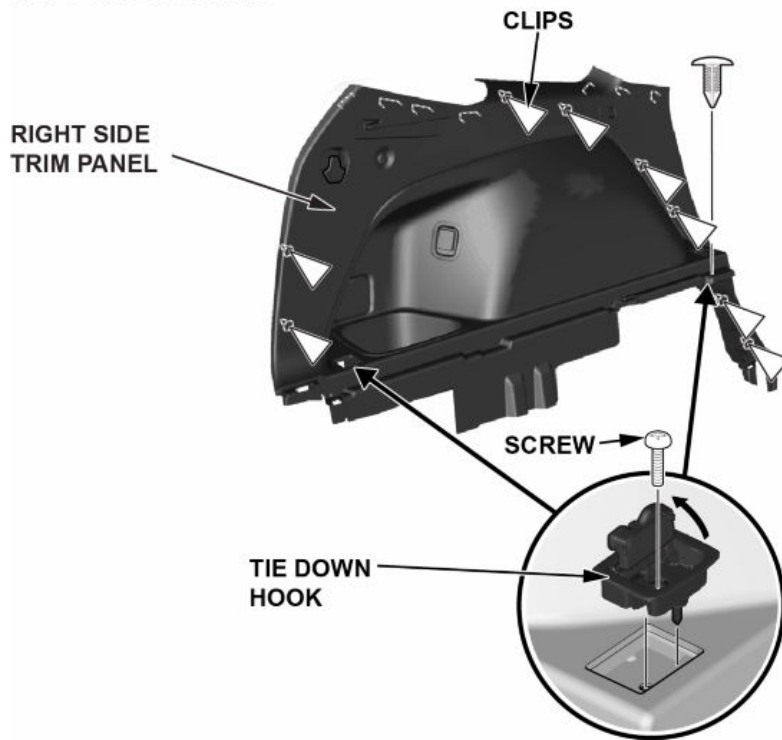
**LEFT SIDE SHOWN**

4. Remove the tie down hook in the right rear side trim panel.

5. Remove the clips.

NOTE: Illustration shown is left side. Remove the right side.
