RDX PGM-FI Idle Stop Software Update

Engine does not auto restart after entering into auto Idle Stop.

The Idle Stop criteria was incorrect and allowed Idle Stop to engage when battery health is insufficient.

Update the PGM-FI Software.

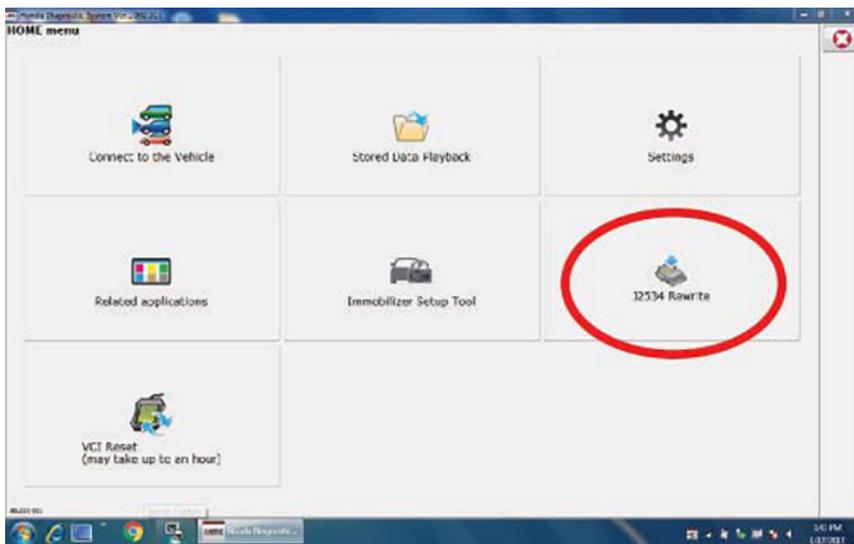
2. From the HOME menu, select the **J2534 Rewrite**.

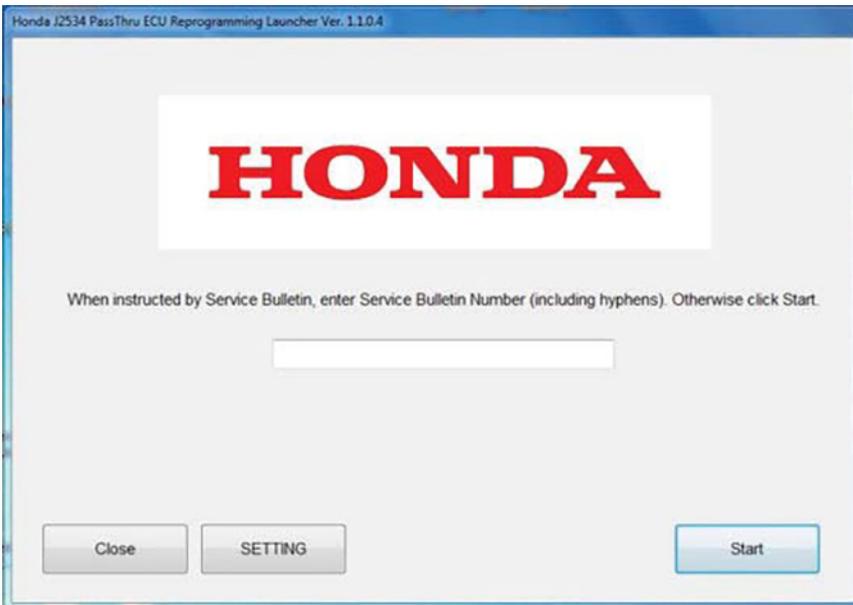
3. When prompted, select **Start**, and do not enter a service bulletin number.

NOTE: Under certain conditions the **HOME** menu screen may come up. If it does, just minimize it to show the screen under it.

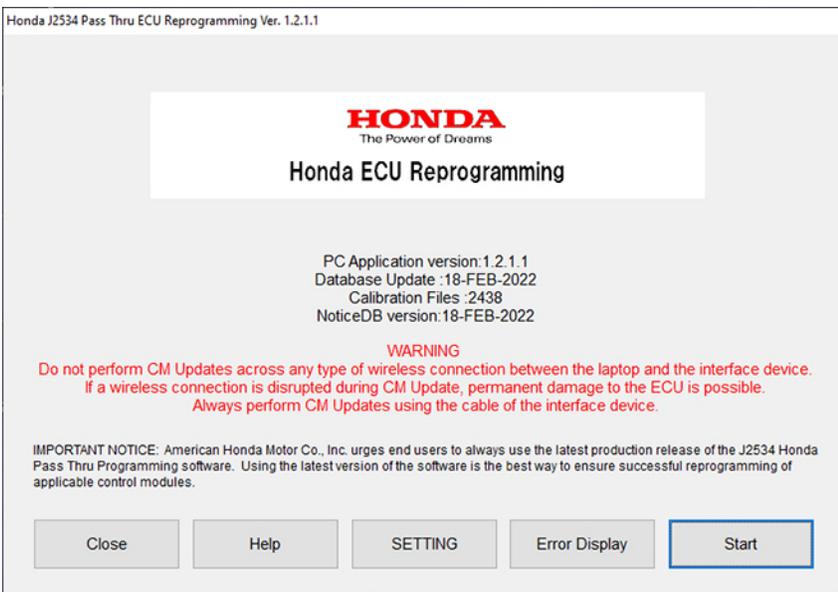
4. Connect the i-HDS to the vehicle and select **Start** to begin reprogramming.

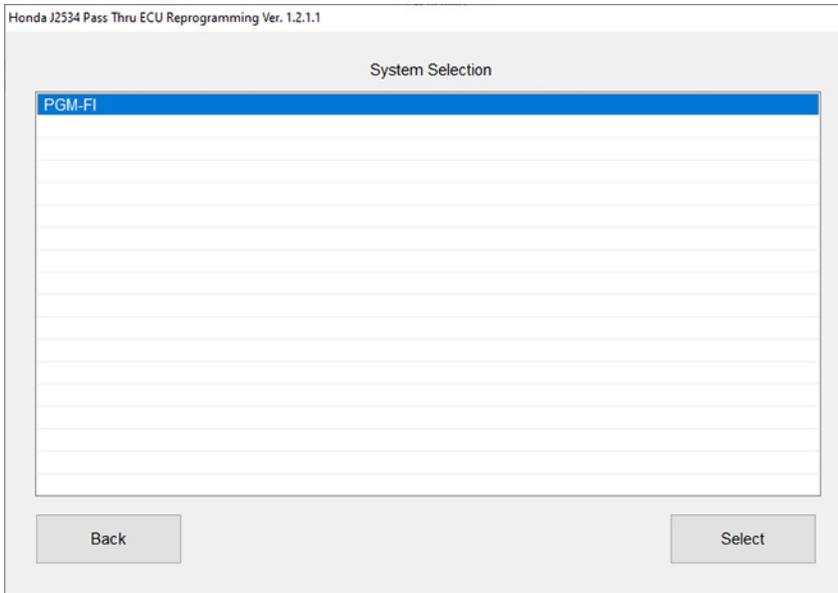
7. Select the **PGM-FI**, and then **Select**.

NOTE: Wait until vehicle communication has completed.

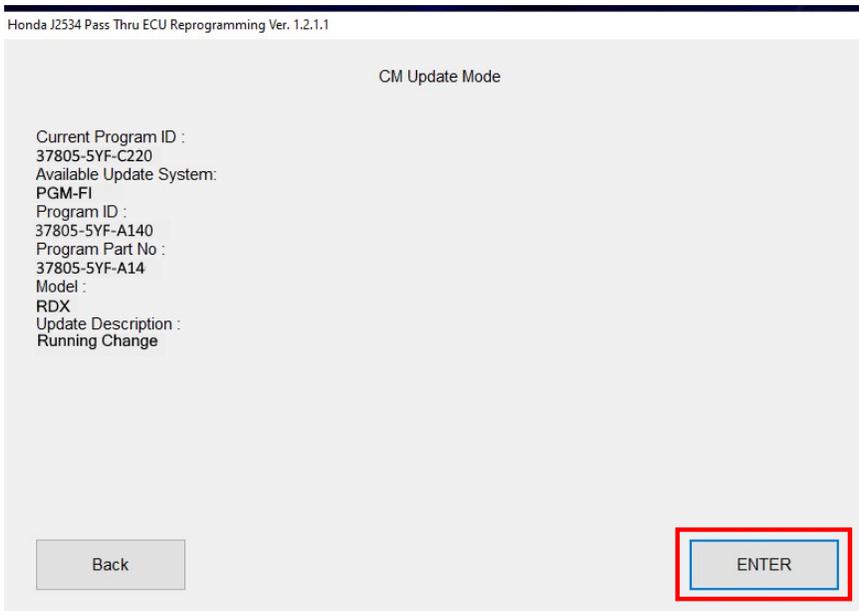
8. Confirm the update information, then select **ENTER** to proceed.

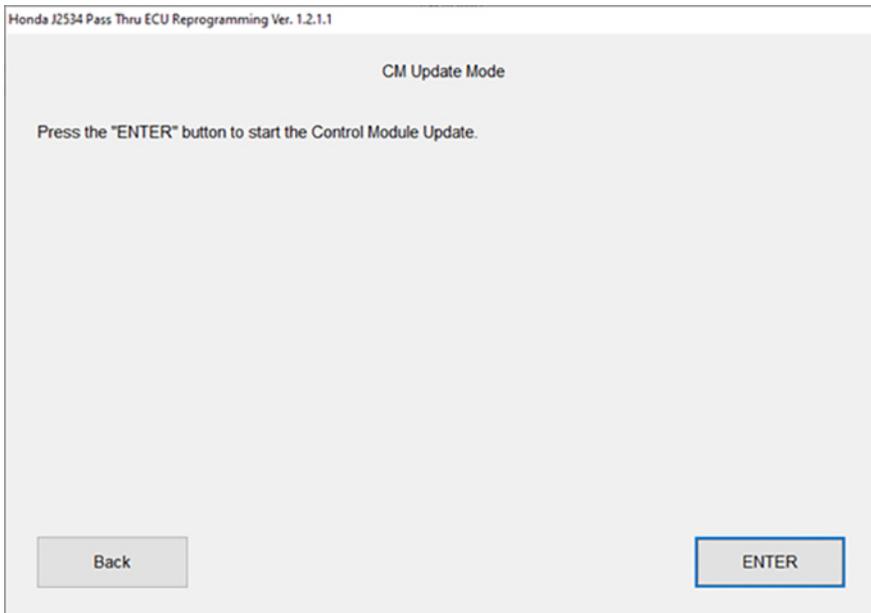
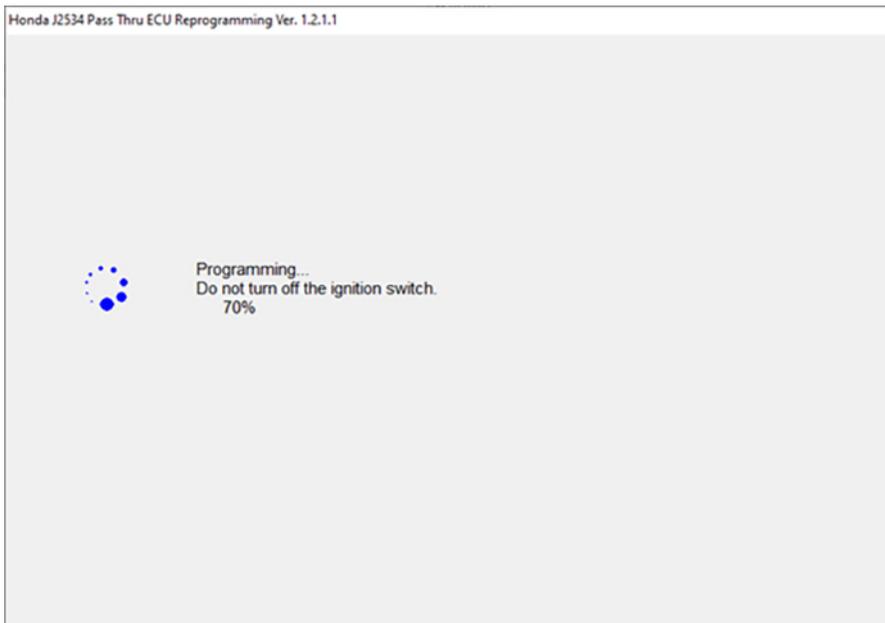
9. Select **ENTER** to begin reprogramming, and follow the screen prompts.

PGM-FI
Completed.
Turn the ignition switch OFF.

Turn the ignition switch ON within 60 seconds.

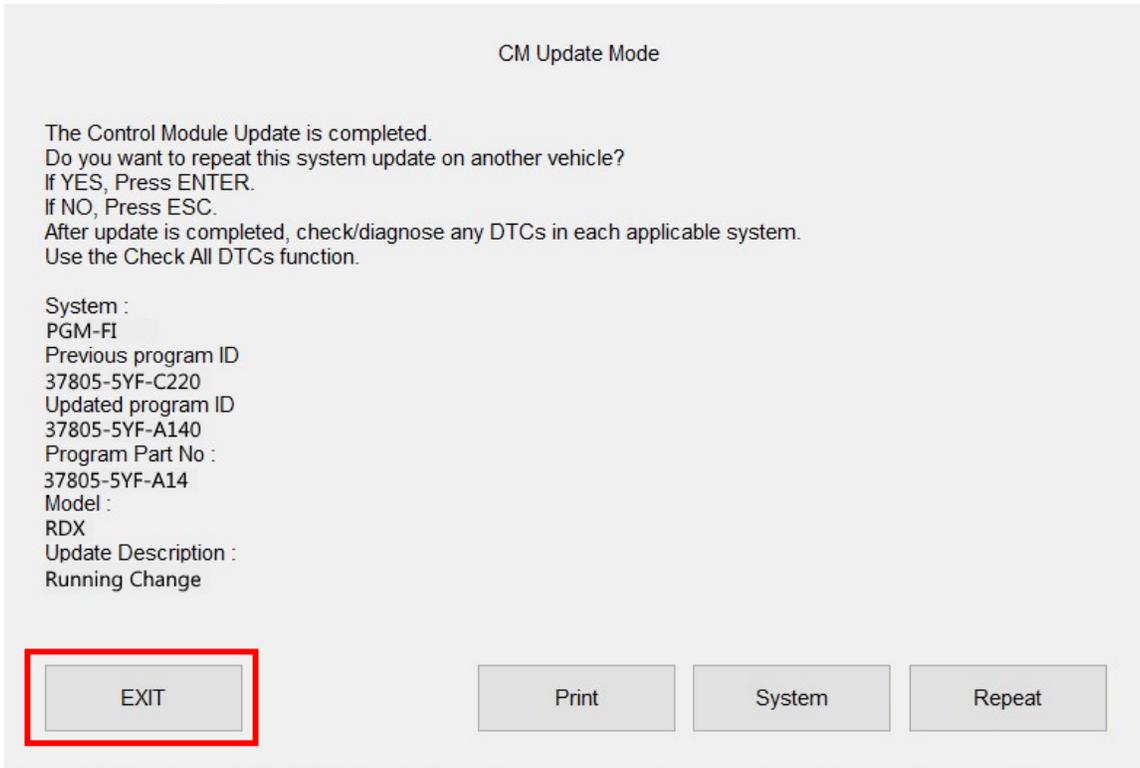
10. Once the module is updated, select **EXIT**, and the following screen appears.
