Release Date	09/23/2022	Technical Service Bulletin		
24HV UPDATE

Engine Control Module Software Update – (FED_EMS)

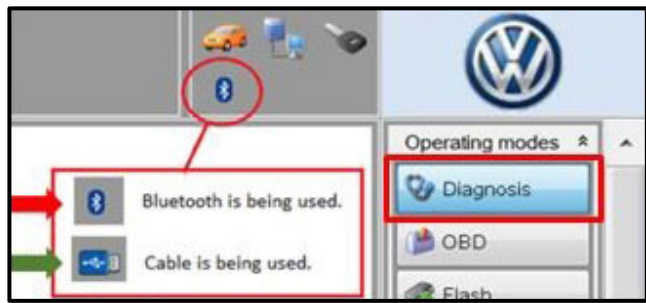
- Confirm that scan tool is communicating with the diagnostic head by USB <Green Arrow>.
 - If the Bluetooth symbol is shown <Red Arrow> then disconnect the diagnostic head from the vehicle and reconnect the USB cable to the diagnostic head and then reattach to the vehicle.
- Upon ODIS startup, verify the “Diagnosis” operating mode is selected <as shown>.
- Once the GFF scan is complete, select “Special functions” <arrow 1>, then “Adapting software” <arrow 2>, then select “Perform test” <arrow 3>.
