June 2022
SF657A
REVISED NOTICE

Subject: Freightliner and Western Star CTP Software Update

Models Affected: Specific model years 2019-2022 Freightliner and Western Star 47X and 49X vehicles manufactured July 11, 2019, through March 9, 2022.

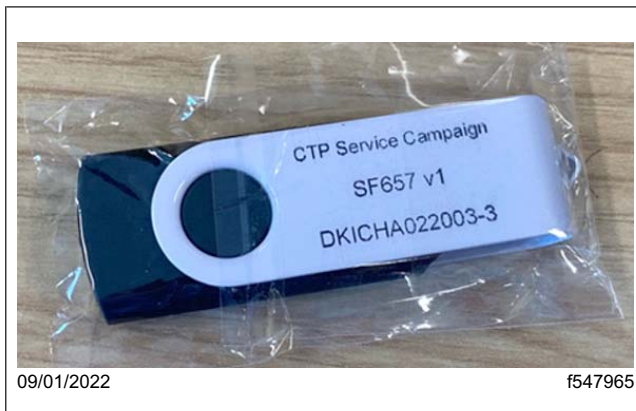
**Fig. 1, USB Stick with SF657 V1 (DDE
DKICHA022003-3)**

REVISION: New tools are required. The USB stick with SF657 software already loaded, along with the USB stick to CTP adaptor harness that is On-the-Go (OTG) protocol compliant, now have part numbers that can be purchased through the parts distribution center (PDC). See [Fig. 1](#) and [Fig. 2](#). It is recommended to purchase and use these tools listed in [Table 1](#), on page 2, to program the CTP. The software on the USB Stick, and the adaptor harness, can be used to update multiple vehicles.

14. Locate the CTP on the upper shelf in the electronics bay. Using a USB mini to USB A adapter (DKICHA022003-1), connect the USB drive (DKICHA022003-3) containing the SF657 software to the CTP at the large blue USB mini connector. See [Fig. 11](#). Some vehicles may already have a harness connected at the large blue CTP connector, which must be disconnected for this procedure. Make sure the USB adapter and the USB stick are completely inserted.

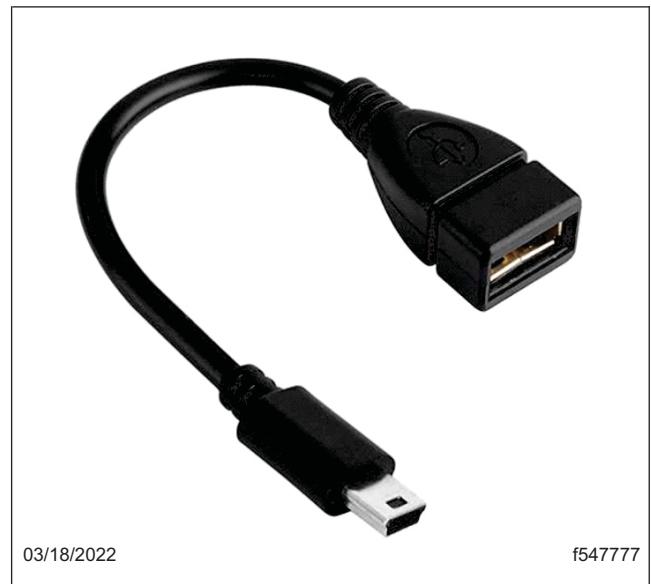
**Fig. 2, USB to CTP Adaptor Harness (DDE
DKICHA022003-1)**

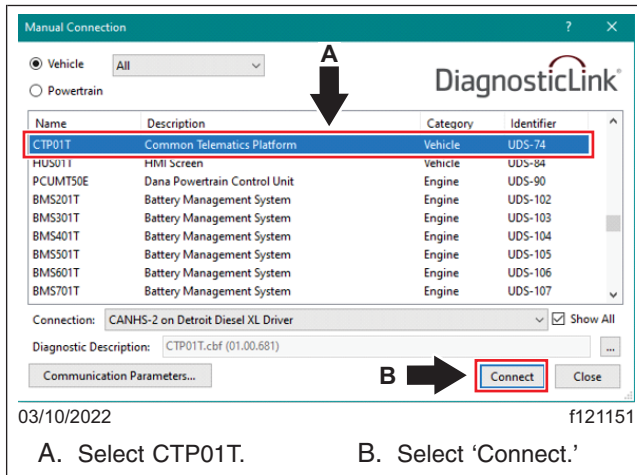
Fig. 6, Manual Connection Window

9. In the 'Manual Connection' window that appears, select 'CTP01T,' then select the 'Connect' button. See [Fig. 6](#). Wait until the CTP01T connection turns green, as shown in [Fig. 7](#).
10. Go to 'Action,' 'Telematics,' then select 'CTP USB Stick Flashing.' See [Fig. 8](#).

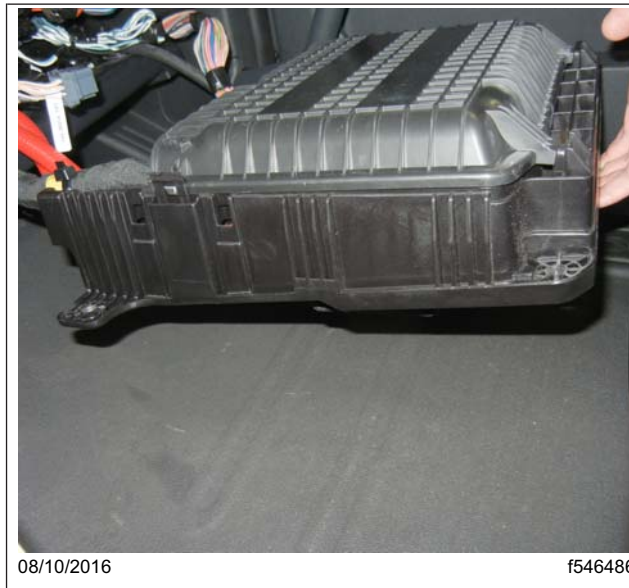
Fig. 10, Lowering the VPDM to the Cab Floor

IMPORTANT: The VPDM is positioned on the mounting tabs to assist with retaining the VPDM in position while mounting fasteners are removed. Care should be taken so the VPDM does not fall to the floor after all four mounting fasteners have been removed.

13. Remove the four VPDM mounting fasteners, then gently lower the VPDM on to the cab floor. See **Fig. 10**.
