Service Update

N222375000 Heater Auxiliary Coolant Pump Not Functional During Engine Auto Stop Events

Models: 2020-2021 Chevrolet Silverado
2022 Chevrolet Silverado LTD
2020-2021 GMC Sierra
2022 GMC Sierra Limited
Equipped with HVAC SYSTEM-AIR CONDITIONER FRT,
SEMI-AUTOMATIC, ELECTRONIC CONTROLS (RPO C4P)

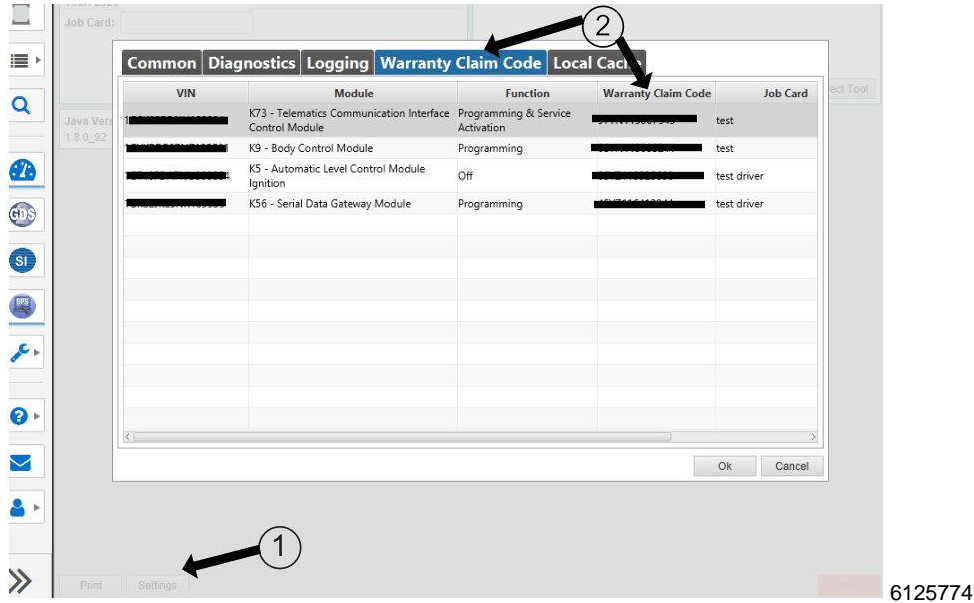
Warranty Claim Code Information Retrieval

If the Warranty Claim Code was not recorded on the Job Card, the code can be retrieved in the SPS2 system as follows:

1. Open TLC on the computer used to program the vehicle.
2. Select and start SPS2.
3. Select Settings (1).
4. Select the Warranty Claim Code tab (2).

The VIN, Warranty Claim Code and Date/Time will be listed on a roster of recent programming events. If the code is retrievable, dealers should resubmit the transaction making sure to include the code in the SPS Warranty Claim Code field.

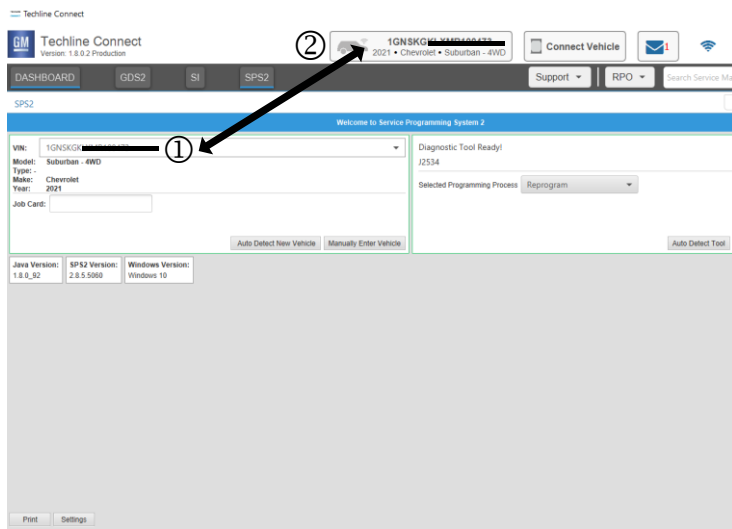
5743643

Caution: Be sure the VIN selected in the drop down menu (1) is the same as the vehicle connected (2) before beginning programming.

Important: Techline Connect screens shown above.

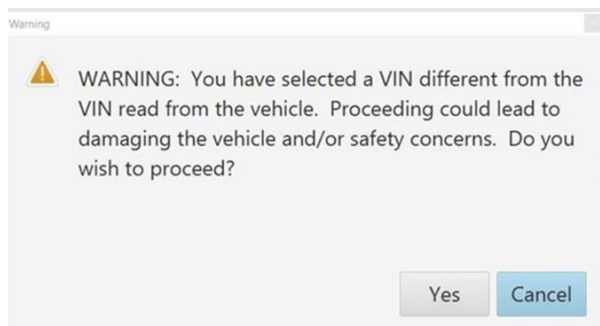
5877000

Important: If the vehicle VIN DOES NOT match, the message below will be shown.

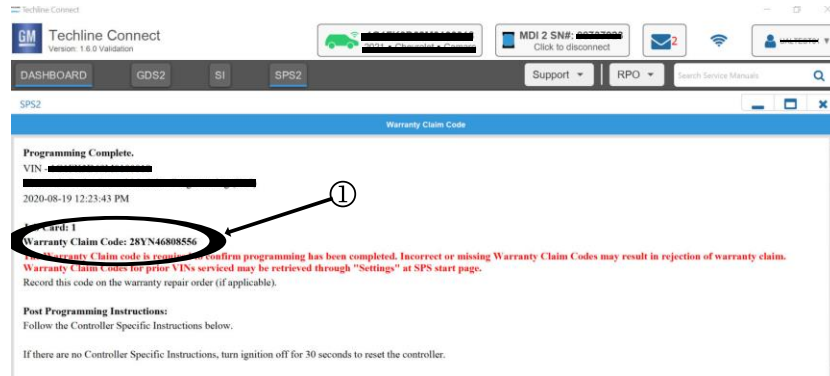
5644478

1. Reprogram the HVAC Module. Refer to *K33 HVAC Control Module: Programming and Setup* in SI.

Note: The screenshot above is an example of module programming and may not be indicative of the specific module that is being programmed. Module selection and VIN information have been blacked out.
