SERVICE BULLETIN

APPLICABILITY: 22MY WRX Models **NUMBER:** 15-301-22
SUBJECT: Reprogramming File Availability for Optimization of Gen 4 Denso CP1 Infotainment Systems **DATE:** 09/09/22

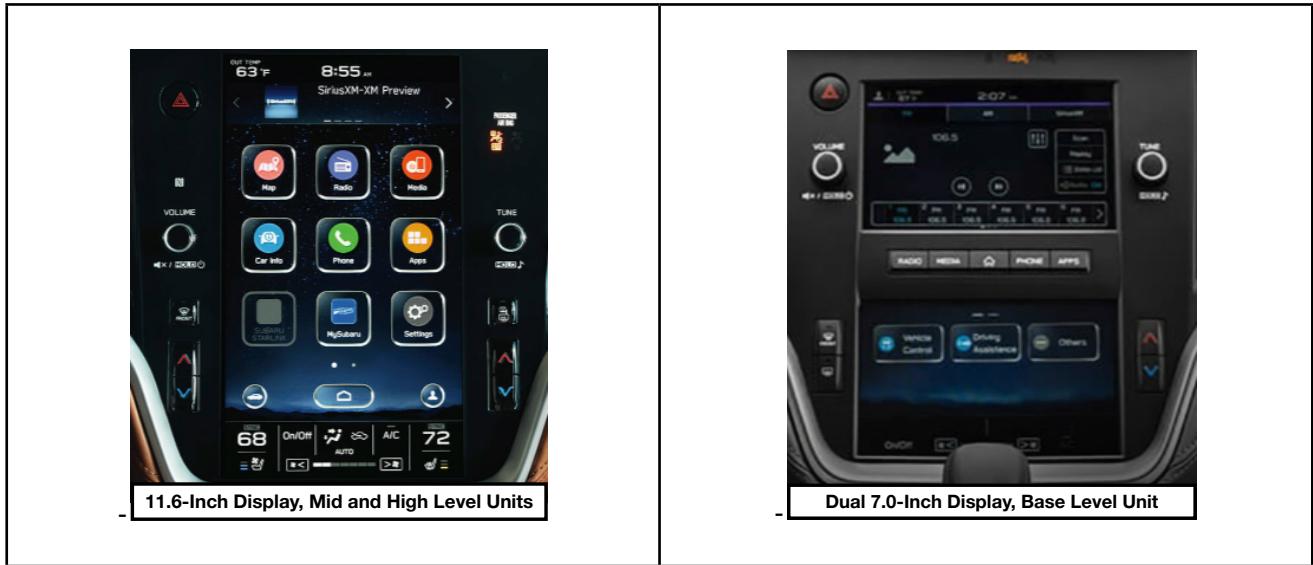
PART INFORMATION:

NOTE: High Level unit is equipped with Navigation option (Map icon on Home screen)

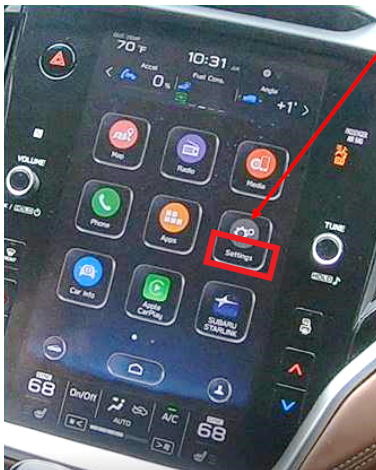
1a) After starting the engine and system boot-up completes, from the HOME screen, touch the

Settings button.

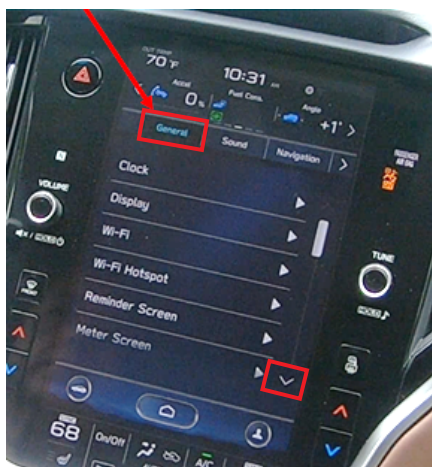
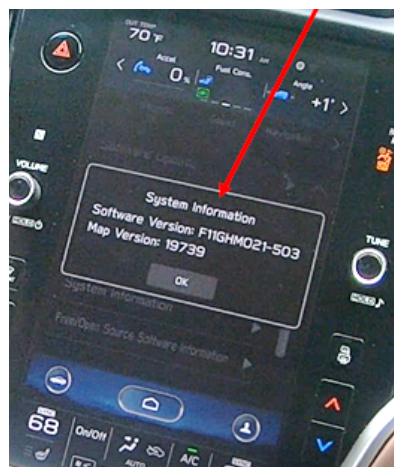
1b) Press the **General** button. Use the down arrow to scroll to **System Information** then press to display the System Information / Version information.

The examples below identify the head unit model and the last 6 digits signify the software version number. Examples:

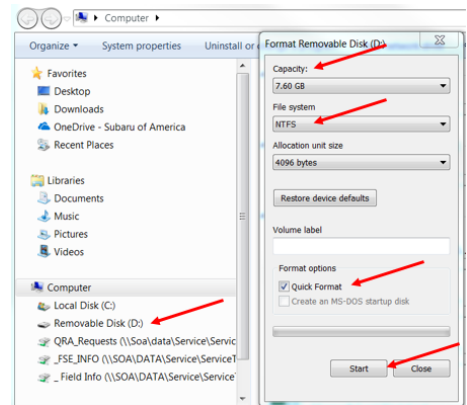
- Make sure the USB flash drive contains no other files.
- Right click on the corresponding “Removable Disk”.
- Select “Format”.
- From the File System drop-down menu, select “**NTFS**”
- Check the “Quick Format” box (if not already done).
- Click on “Start” to format the USB flash drive.

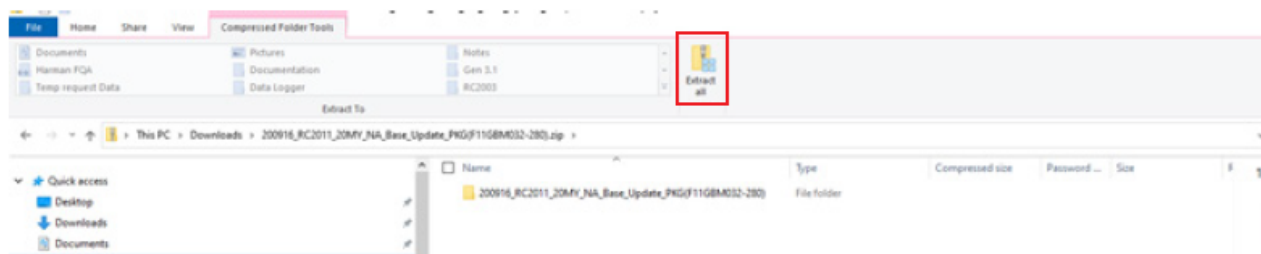
- Go to Downloads.
- **CAUTION:** After download is complete, **NEVER** change the file or folder names.
- Open / display the contents of File folder, for example: “File name TBD”.
- Click on “Extract All Files”.

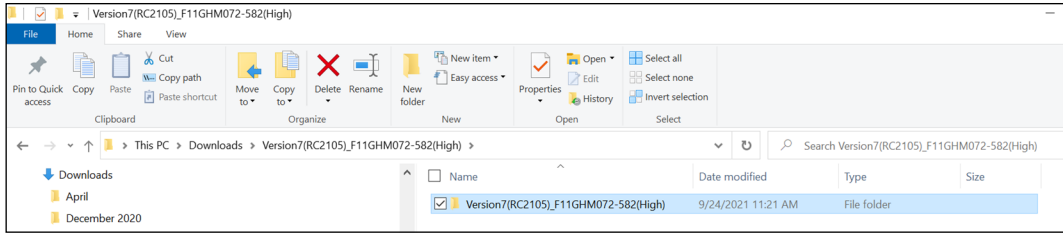
- Double-click on the required folder (for this example, used folder titled “Version7(RC2105)_F11GHM072-582(High)”).

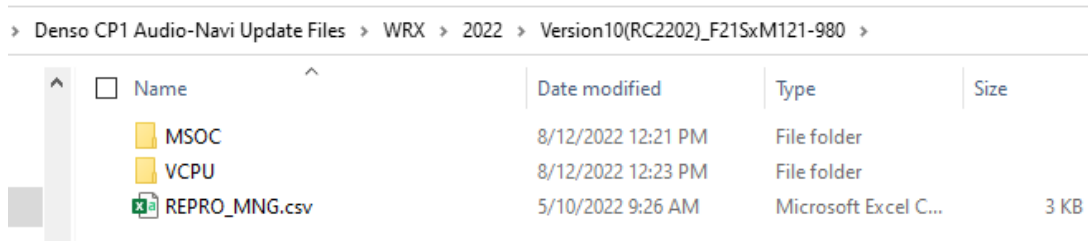
- **CAUTION:** After download is complete, **NEVER** change the file or folder names.
- Double-click on the required folder (for this example, select the file entitled “BASE”) and the update file will display as shown.

Name	Date modified	Type	Size
MSOC	8/12/2022 12:21 PM	File folder	
VCPU	8/12/2022 12:23 PM	File folder	
REPRO_MNG.csv	5/10/2022 9:26 AM	Microsoft Excel C...	3 KB

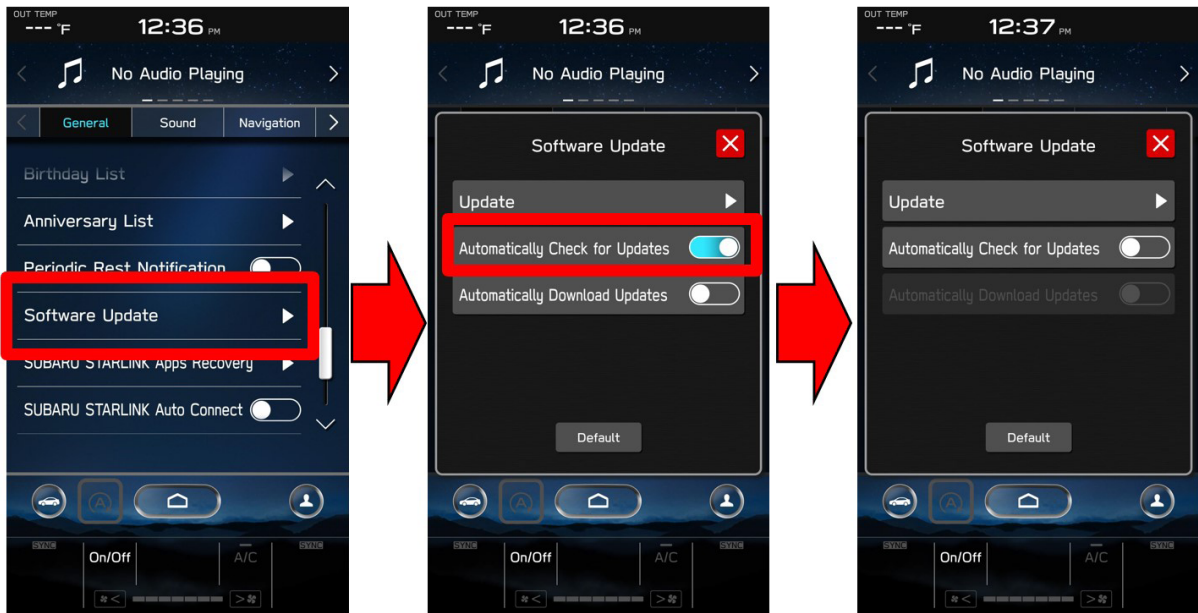
Best practice is to prevent USB software update conflicts with FOTA software update. Please confirm “Automatically Check for Update” setting is turned off following the steps below, prior to starting the software update via USB.

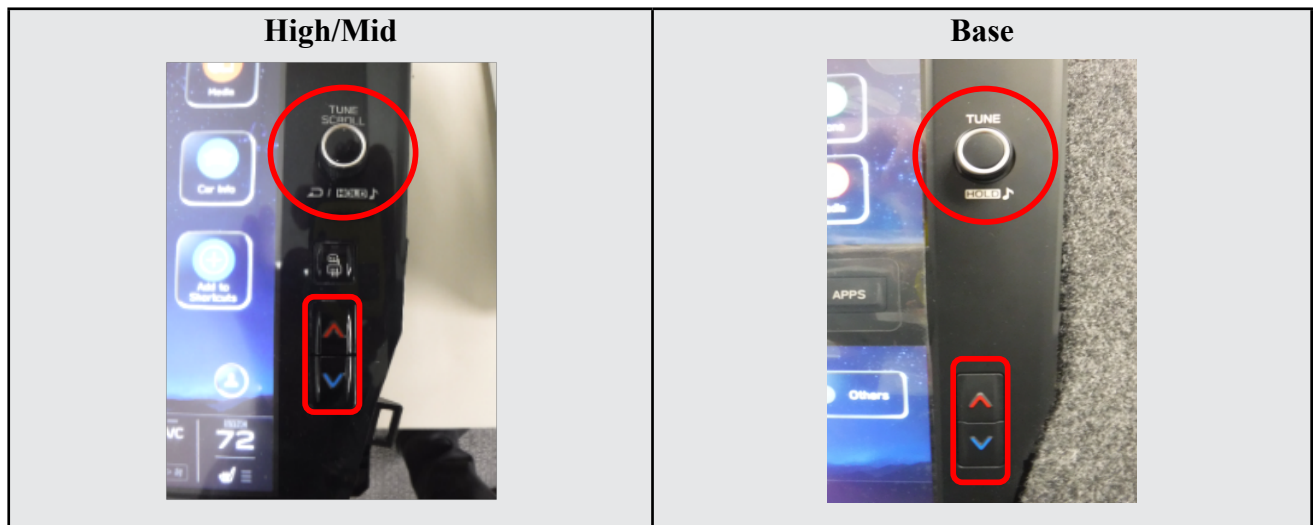
- 4a) Perform the update in a well ventilated location if updating with the engine running OR with the ignition ON and a battery charger connected.
- 4b) PRESS and HOLD the RIGHT-side temperature control buttons (both up and down) and press the Tune / Scroll knob 6 times then release all to display the Dealership Mode Menu.

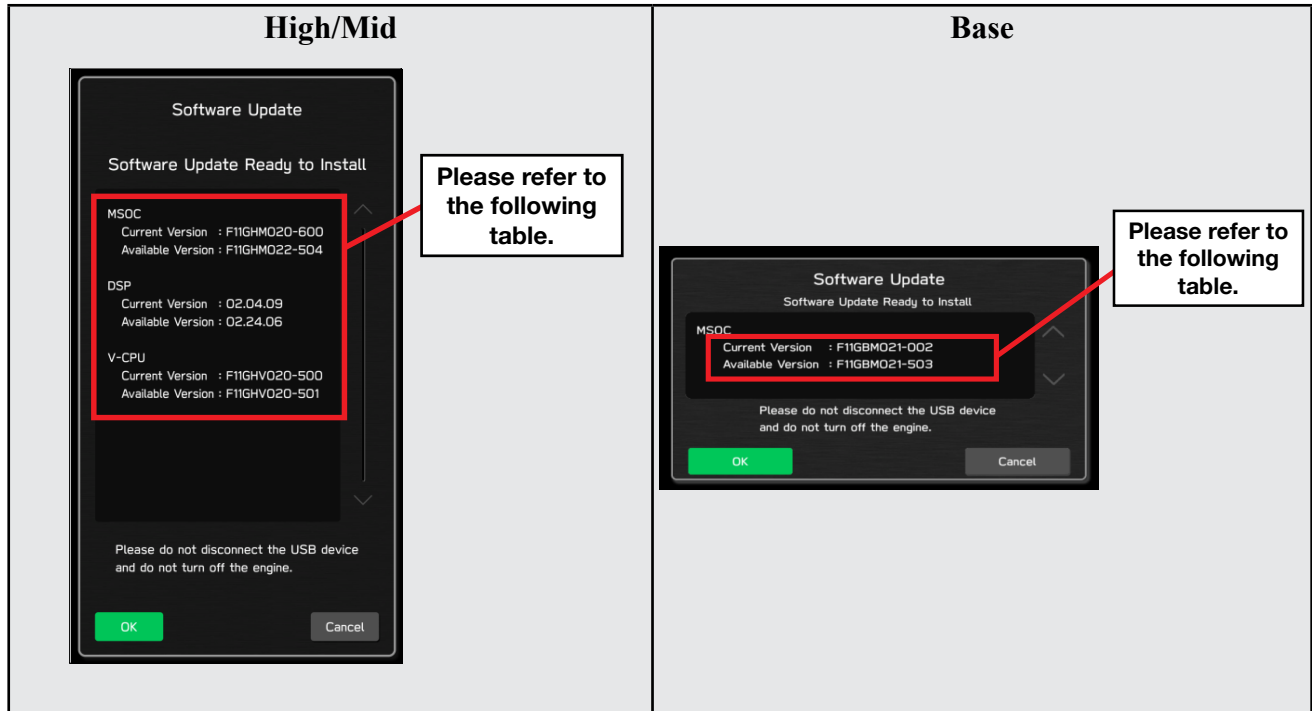
- 4f) The screen below will be displayed. Press **OK** to start the software update.
NOTE: The actual software version displayed will be different from the picture shown below.

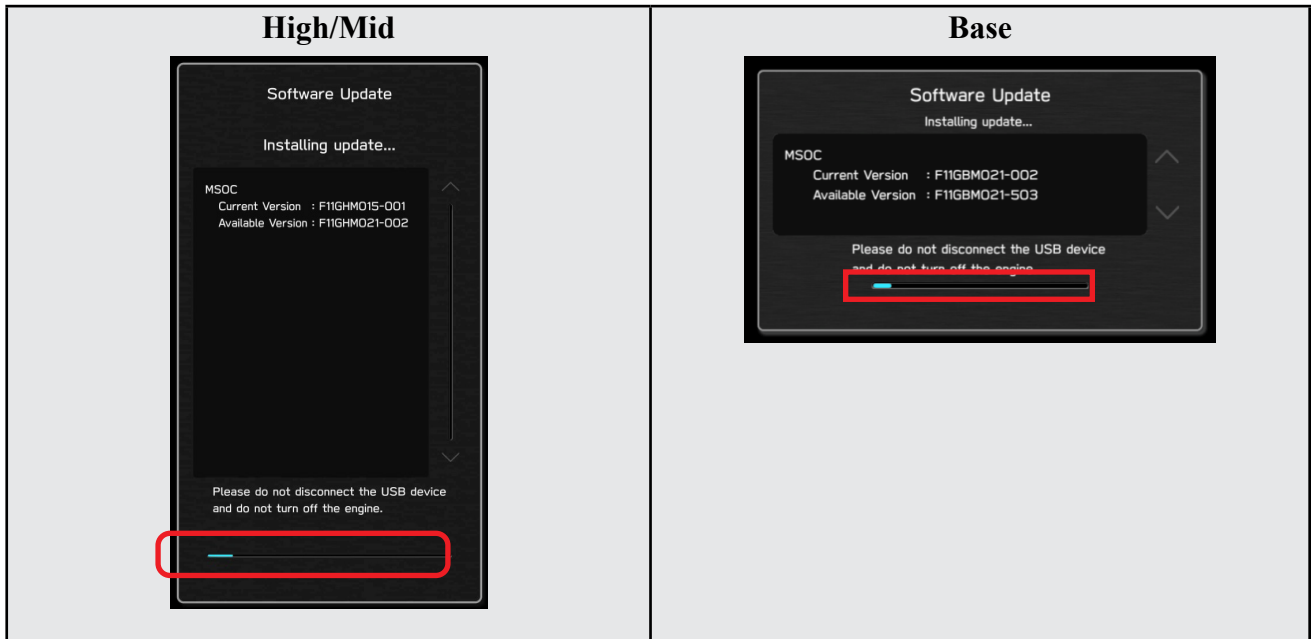
4g) Once the update begins, the screen below will be displayed with a progress bar. It takes about 15 to 20 minutes for the update to complete.

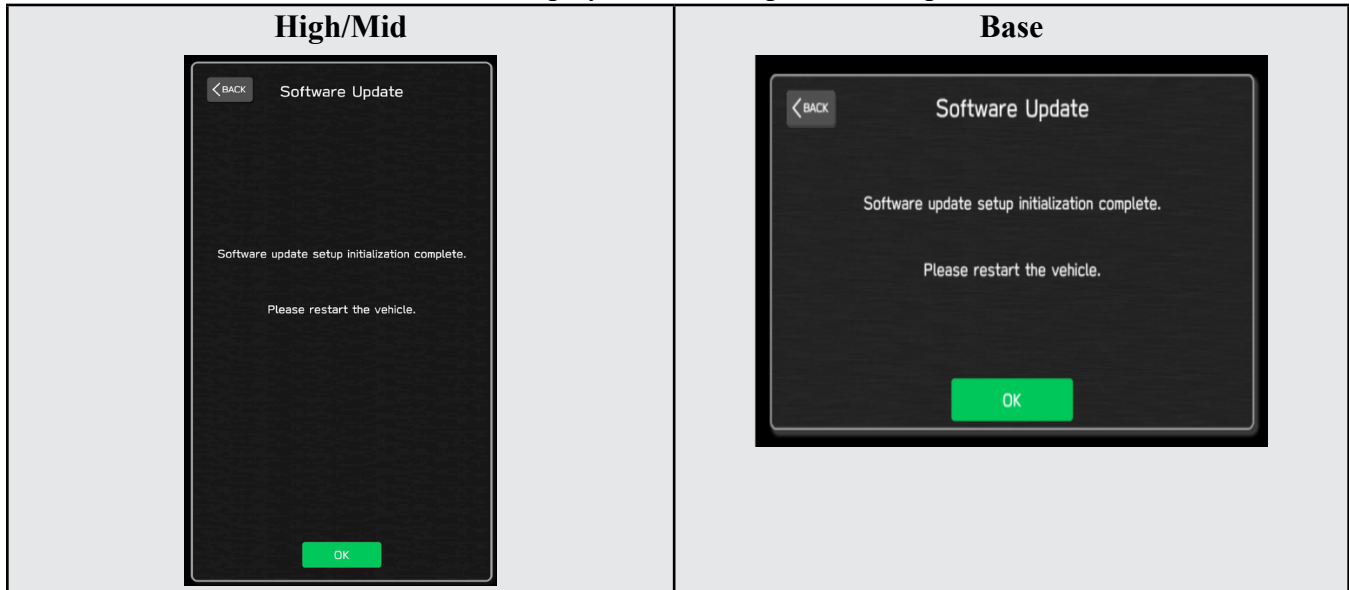
- The screens shown below will be displayed when the process completes.

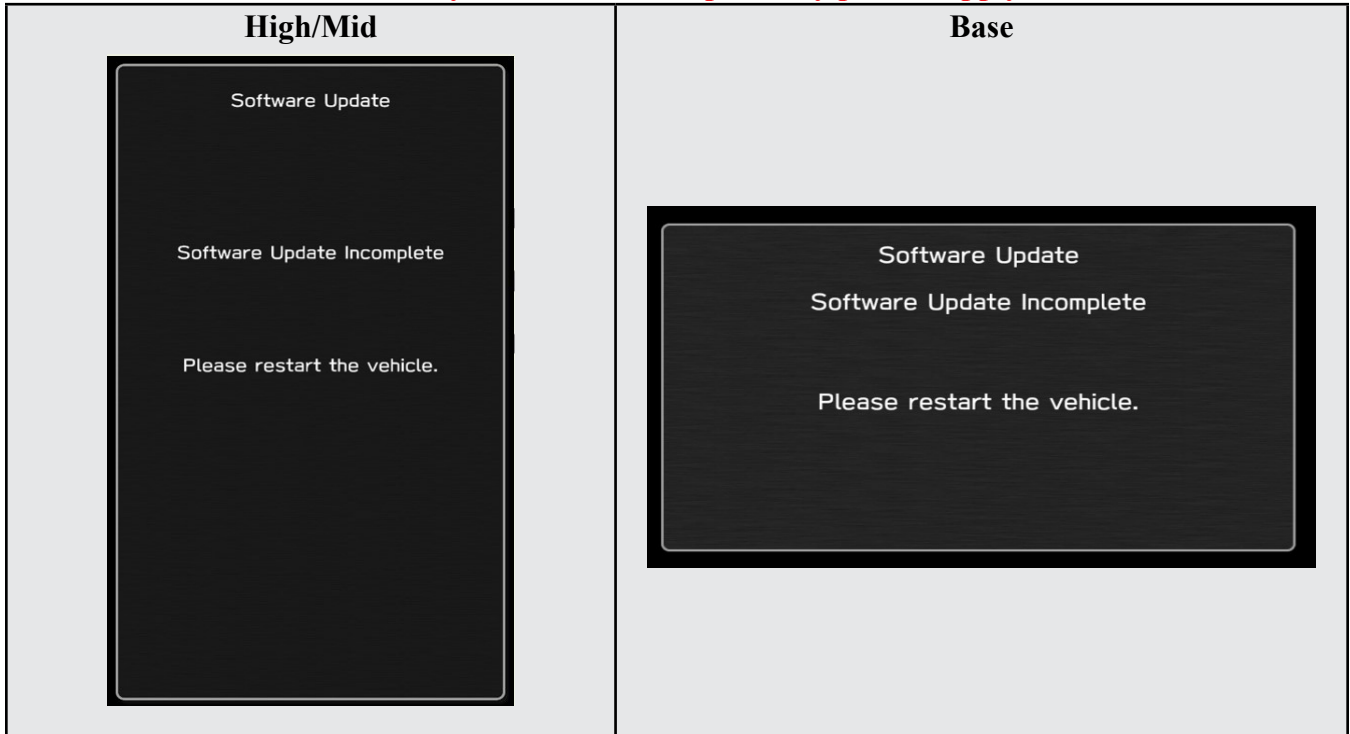
1-2. Turn the ignition switch or the engine OFF, and turn it ON again.

Caution: Do not remove battery terminal and keep battery power supply.

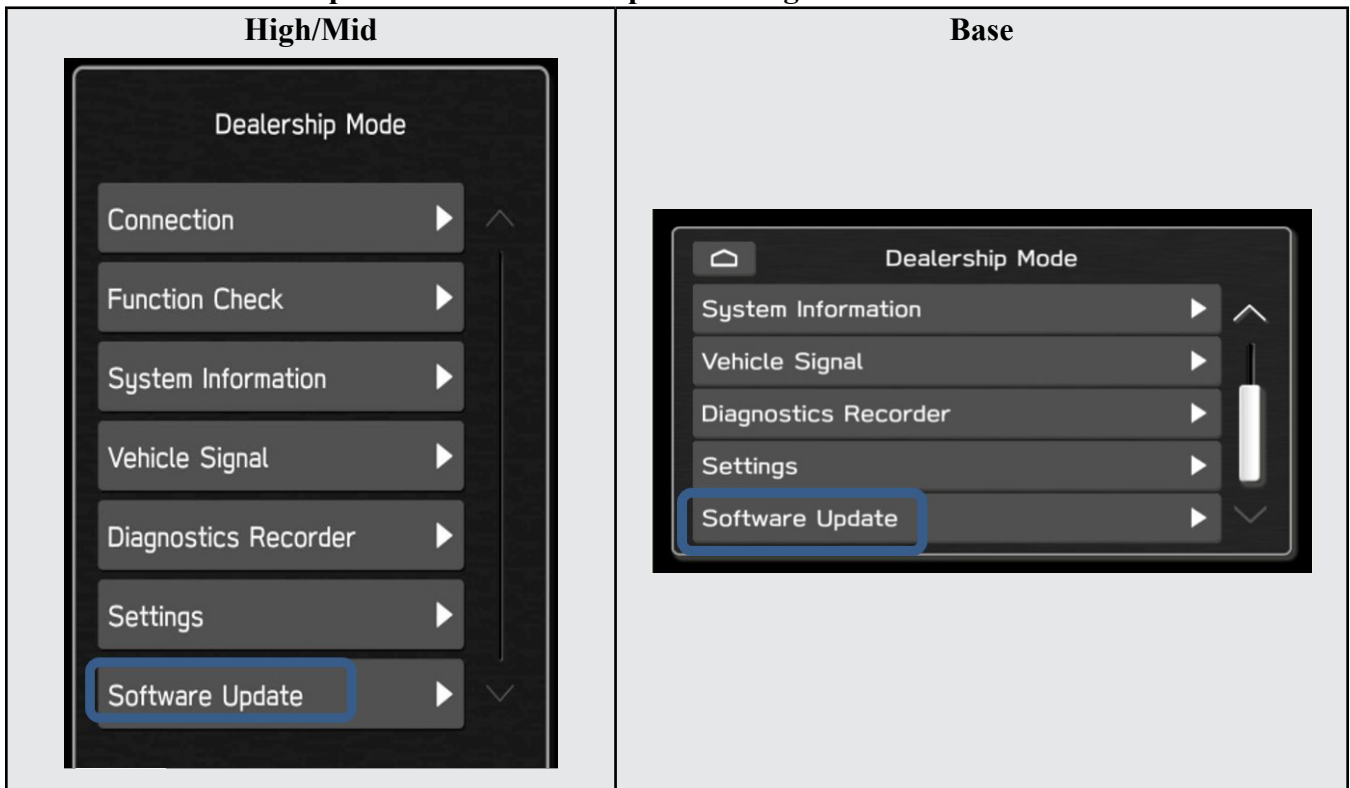
1-3. Select Software Update in the Dealership Mode diagnostics screen.

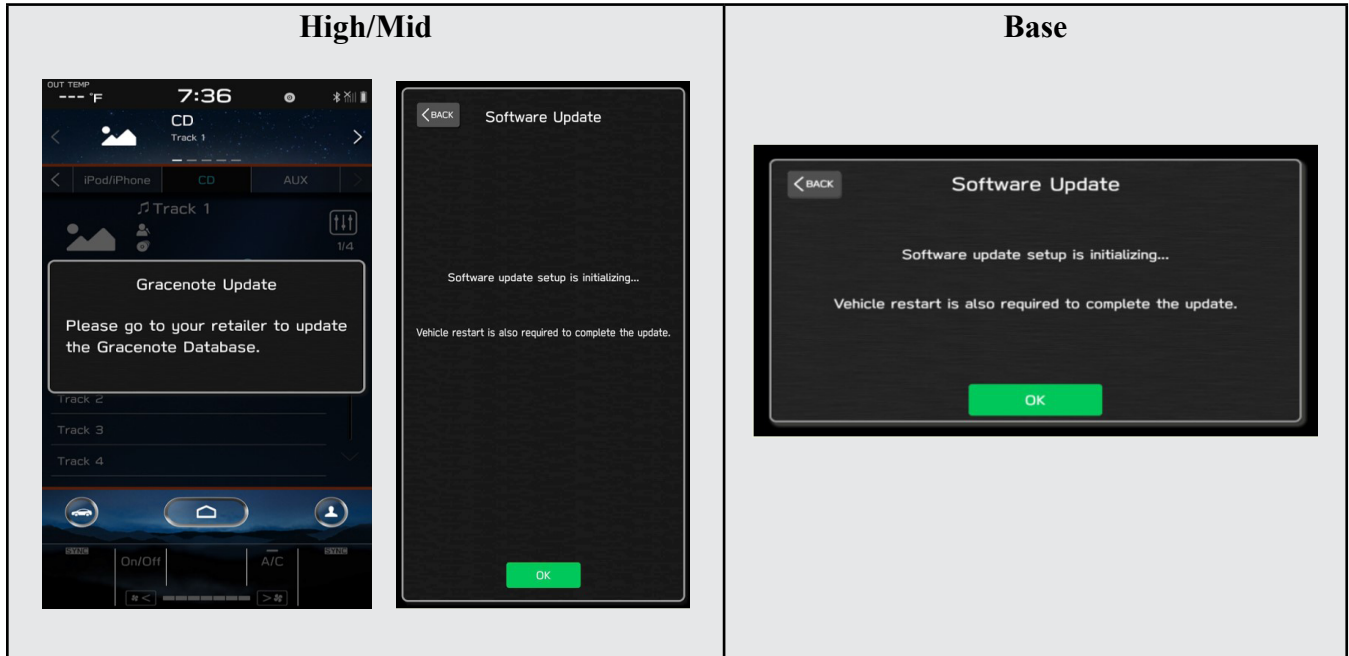
In case the Gracenote update popup screen appears or software initializing screen does not go away for more than 20 minutes, please perform steps 2-1 to 2-11.

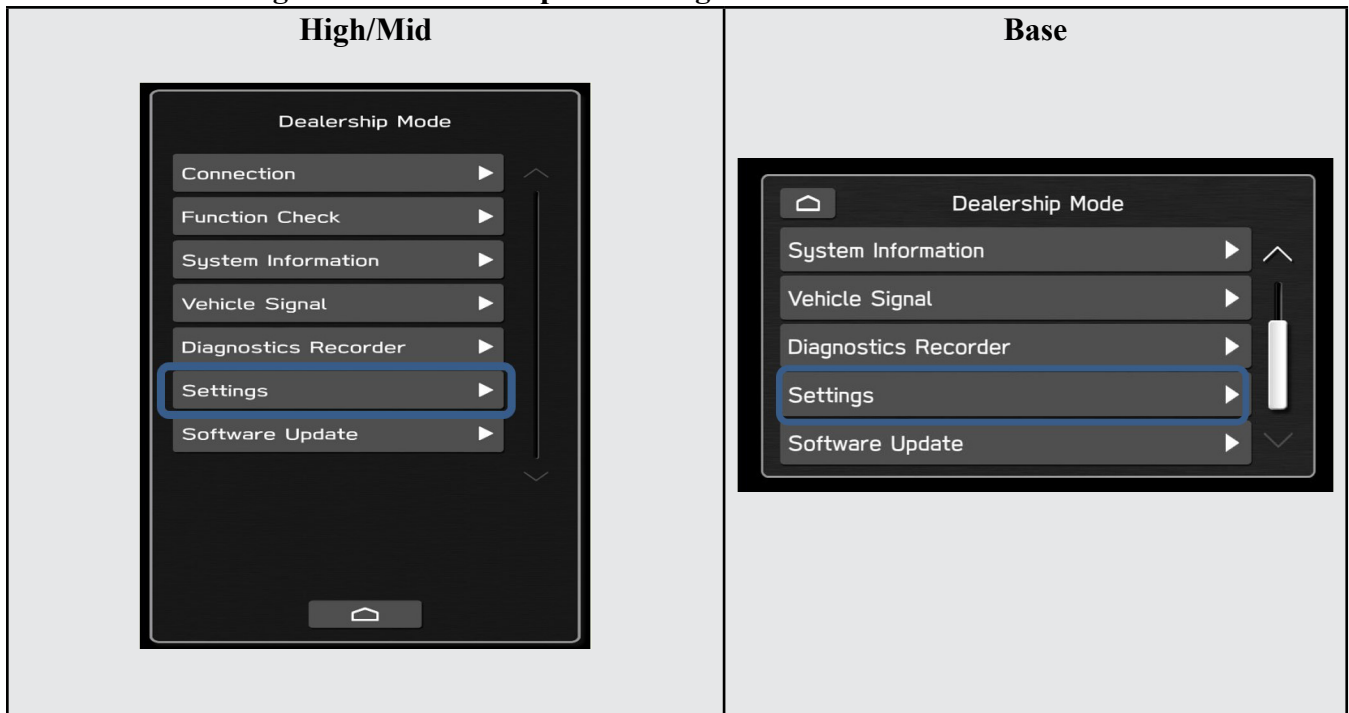
2-1. Select “Settings” in the Dealership Mode diagnostics screen.

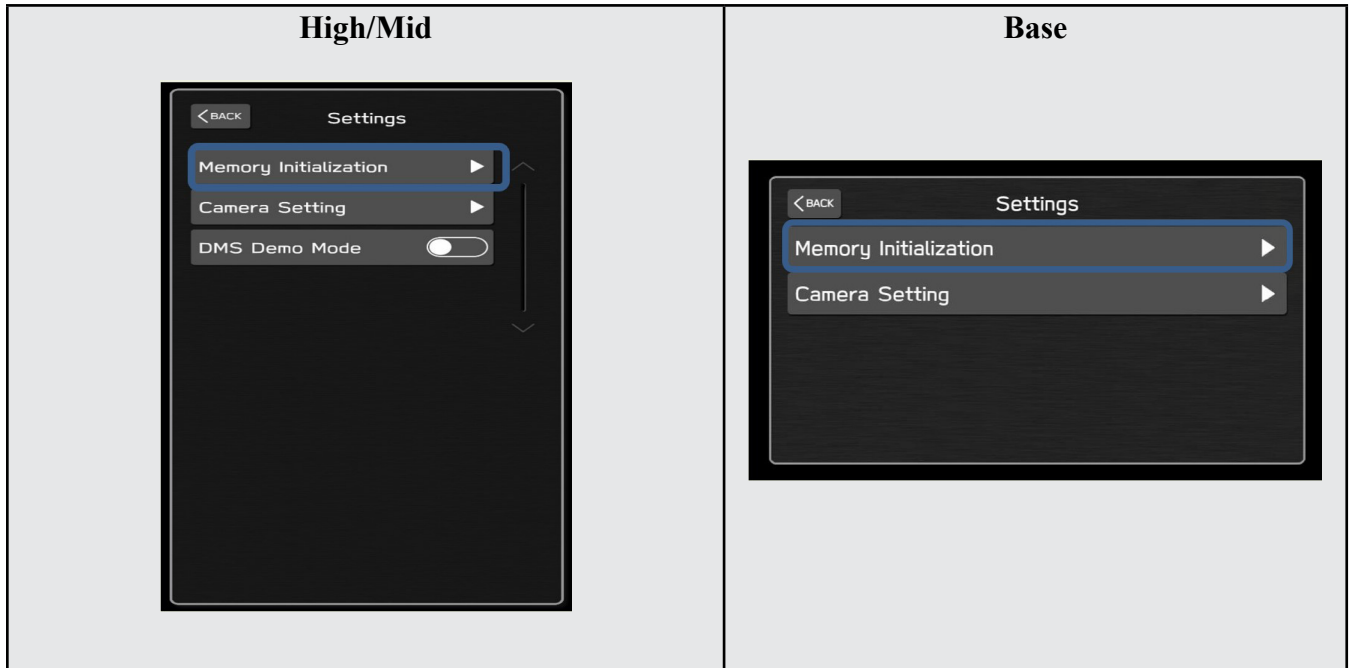
2-2. Select “Memory Initialization”

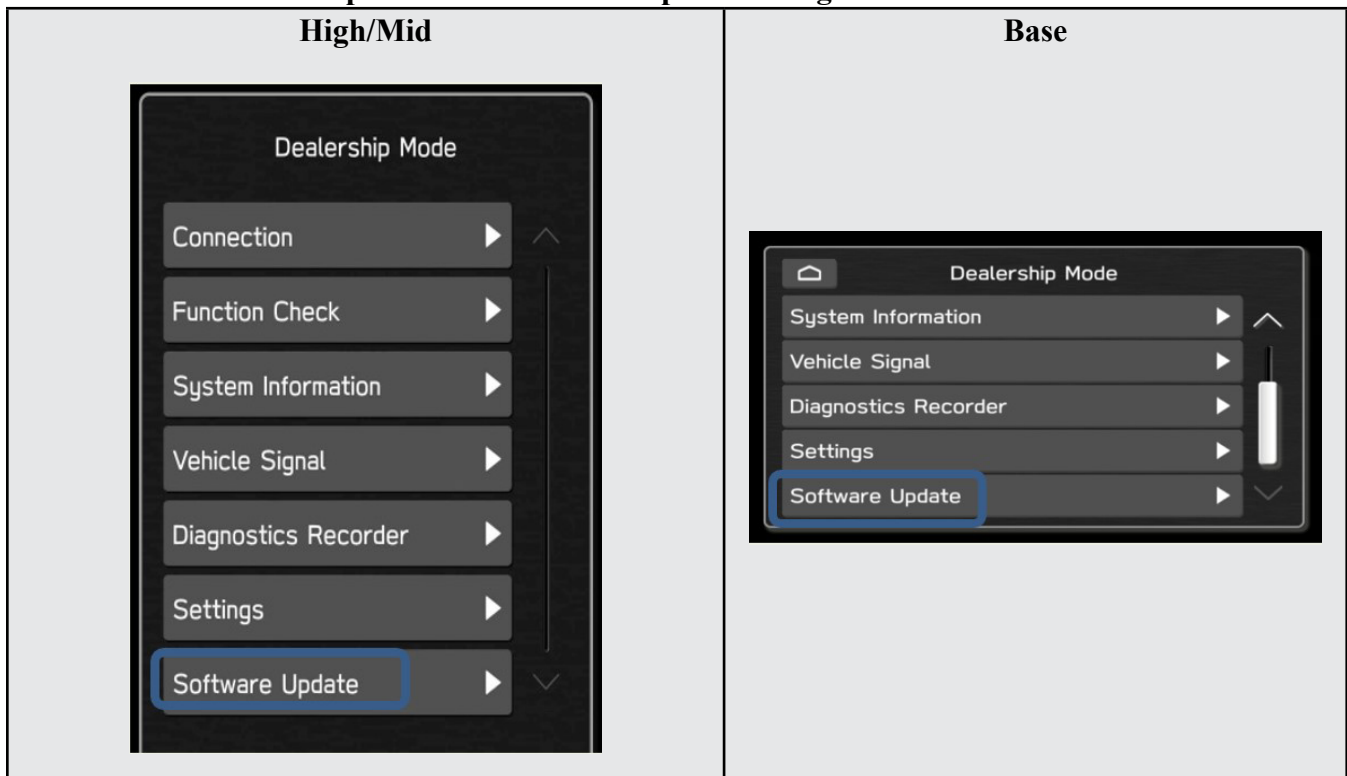
2-6. Select “Software Update” in the Dealership Mode diagnostics screen.

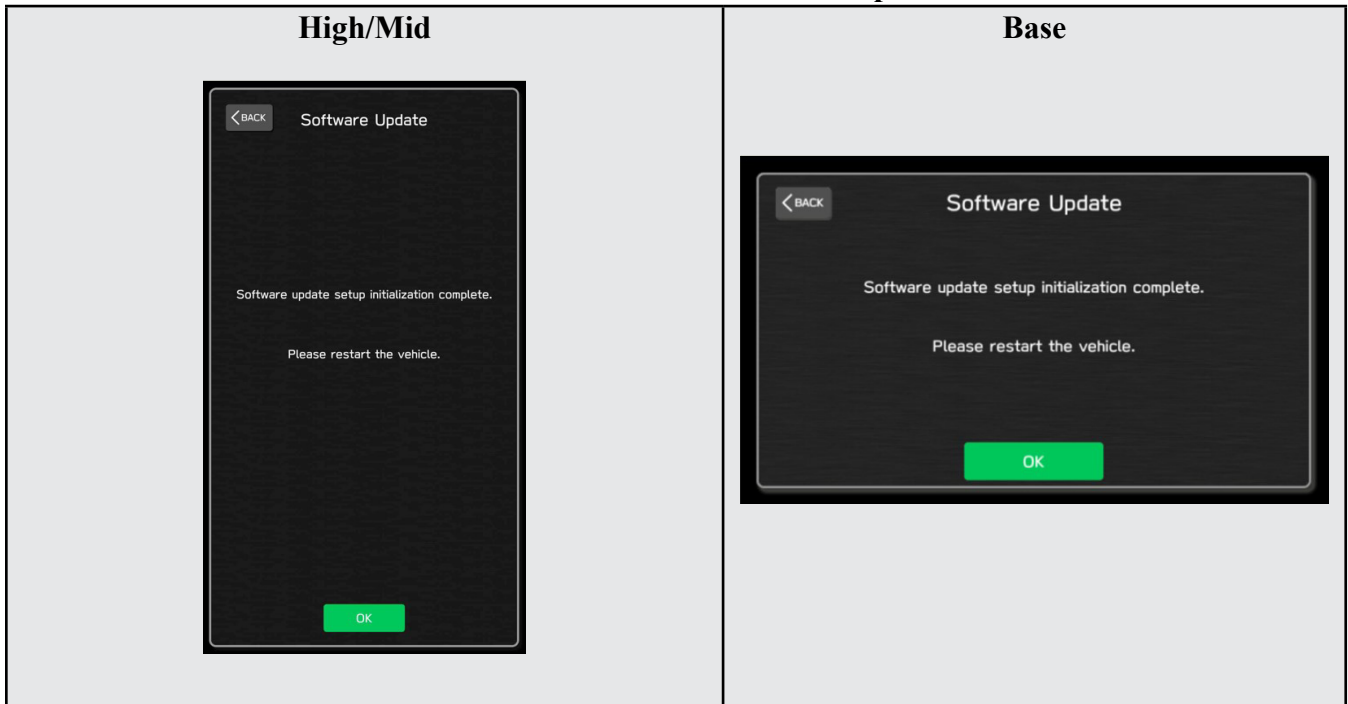
2-8. You will see the screen below when the initialization is complete.
