SAFETY RECALL

Communication #: I-22-04

SUBJECT: FTR COOLANT JUNCTION

To address this concern, Indian Motorcycle has released this safety recall with instructions to replace the coolant junction with an improved part.

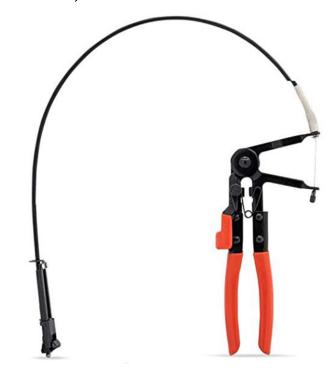
Remote Action Hose Clamp Tool (Commercially Available)

The tool needs to have clamps that close completely when squeezed.
