# Customer Satisfaction Program

## N212354522 Heated Vented Seats Retrofit Due to Chip Shortage - Front and Rear Seats

**Release Date:** October 2022

**Revision:** 02

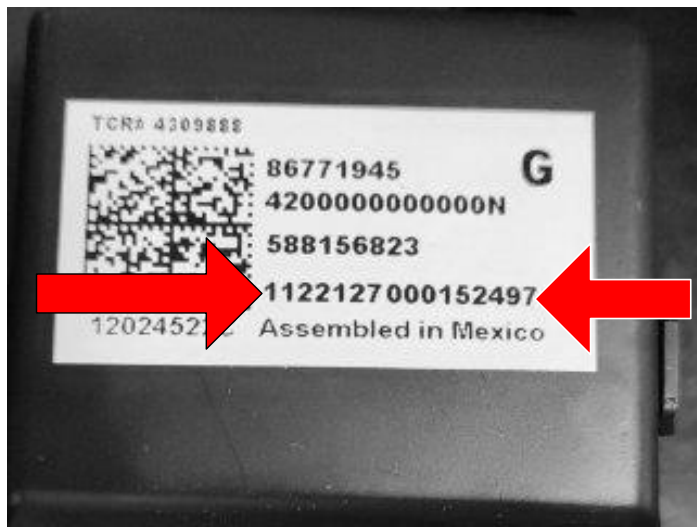
**Record the serial number on the front and rear seat heater vent control module labels.**

**IMPORTANT: \* (TECHNICIAN and WARRANTY ADMINISTRATOR) SERIAL NUMBER RECORDING REQUIREMENT.** The replacement Front and Rear Seat Heater Vent Control Module serial numbers must be captured by the technician and recorded on the job card. The Warranty Administrator **MUST** enter the replacement Front and Rear Seat Heater Vent Control Module serial numbers in GWM (Global Warranty Management) or in DMS (Dealer Management System). Enter the serial number of the **replacement** Front and Rear Seat Heater Vent Control Modules in the '**General Comments**' comments section. Failure to enter this serial number will cause the claim to reject.
