Technical Service Bulletin

Subject: MYMAZDA APP CANNOT COMMUNICATE WITH THE VEHICLE PROPERLY	Bulletin No.: 09-030/22
	Last Issued : 09/28/2022

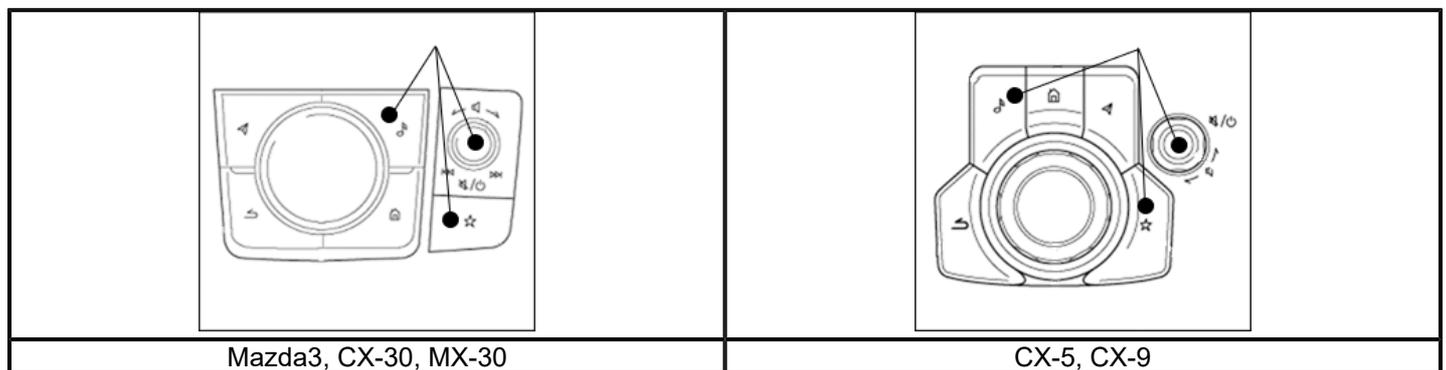
5. Press and hold the volume knob, then press and hold the Entertainment and Favorites buttons at the same time for 3-5 seconds and the Factory/Service Inspection screen will appear.

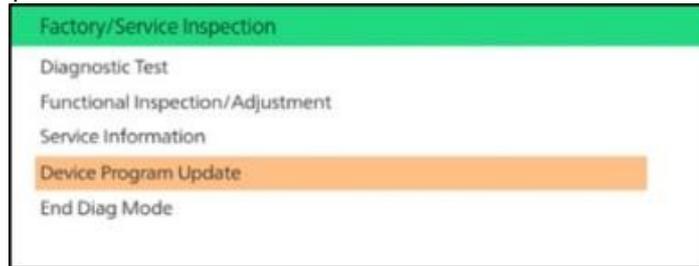
6. Select "Device Program Update" on the screen below.

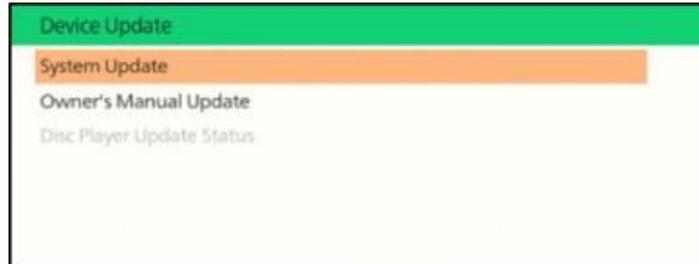
7. Select "System Update" on the screen below

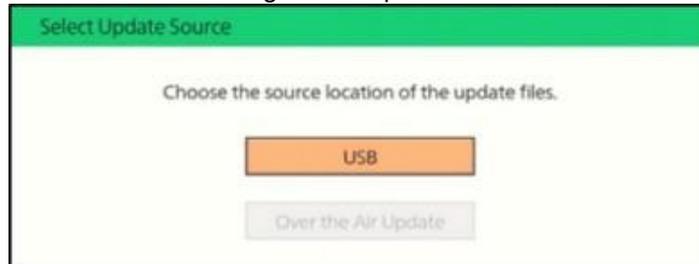
8. Select "USB" on the screen below to start checking for the update file.

NOTE: If "Update file(s) not found" message appears, an incorrect file may be stored in the USB memory stick or the vehicle has already been updated.

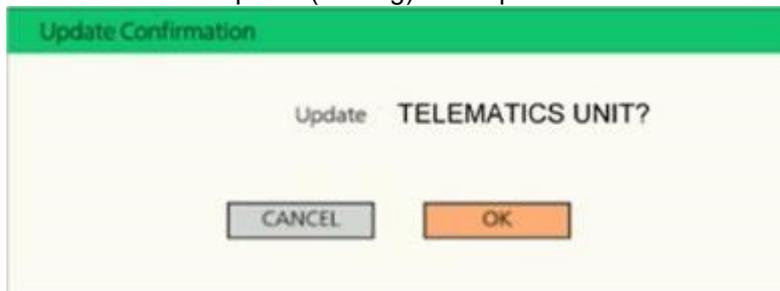
10. Select "OK" on the screen below and wait until the update (loading) is completed.

NOTE: DO NOT switch ignition OFF until the update (loading) is completed.

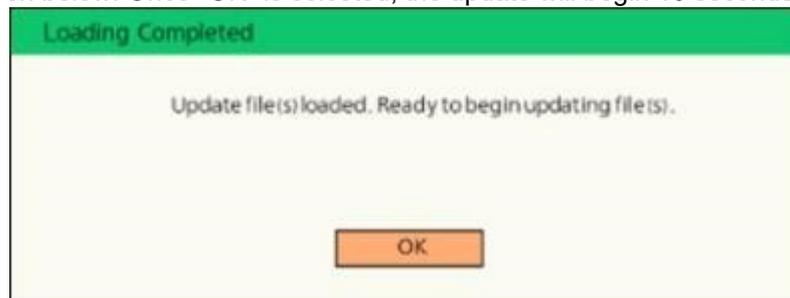
11. Select "OK" on the screen below. Once "OK" is selected, the update will begin 10 seconds after the selection.

NOTE: The system will reboot and the display will turn black after selecting "OK", followed by the screens below:

- Sending update file(s)
- Checking update file(s)
- Installing update file(s)
- Completed

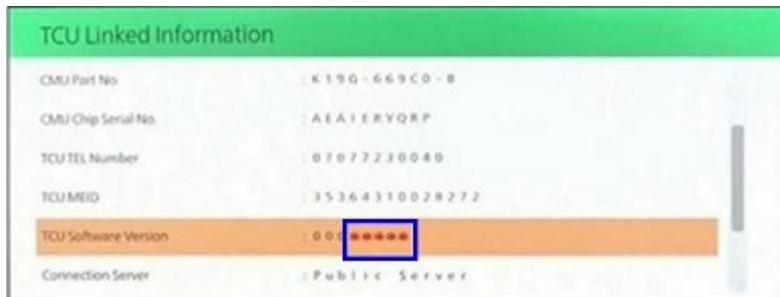
16. Select TCU Linked Information, then scroll down to TCU Software Version.

17. Confirm that the software version has been updated.
