# Technical Service Bulletin

SUBJECT:		No: <b>TSB-22-55-002</b>	
<b>A/C UNINTENTIONALLY TURNS OFF</b>		DATE: <b>September 2022</b>	
		MODEL: <b>2022 Outlander</b>	
<b>CIRCULATE TO:</b>	<input type="checkbox"/> GENERAL MANAGER	<input checked="" type="checkbox"/> PARTS MANAGER	<input checked="" type="checkbox"/> TECHNICIAN
<input checked="" type="checkbox"/> SERVICE ADVISOR	<input checked="" type="checkbox"/> SERVICE MANAGER	<input checked="" type="checkbox"/> WARRANTY PROCESSOR	<input type="checkbox"/> SALES MANAGER

This Campaign Bulletin provides instructions to reprogram the HVAC ECU with updated software.

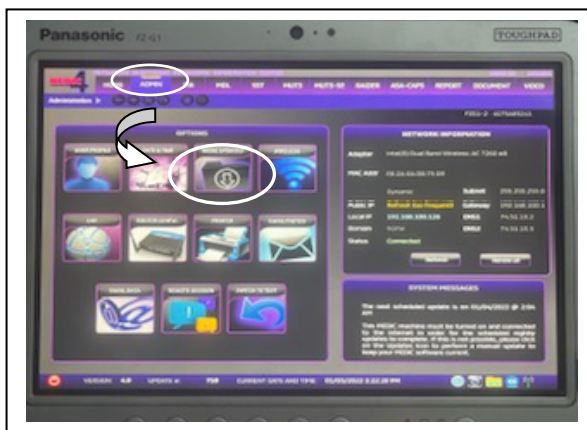
3. Select the MEDIC 3.5/4 Admin tab and click on "Updates".

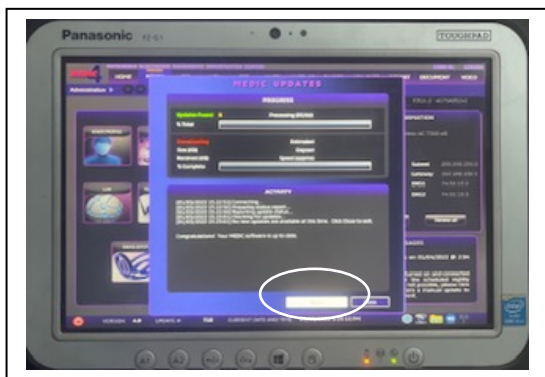
4. If the MEDIC update screen advises updates are available, click the "Begin" button. After all updates are complete, **GO TO THE REPROGRAMMING PROCEDURE.**

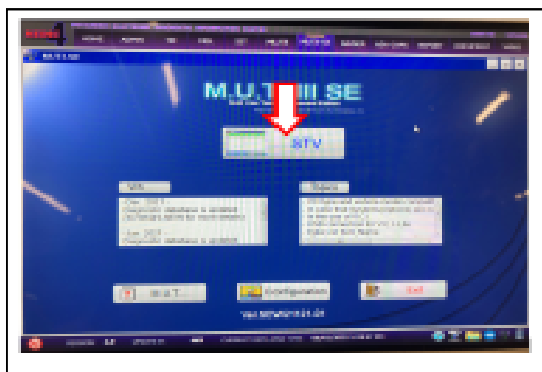
- a. Press the MUT-III SE STV icon.

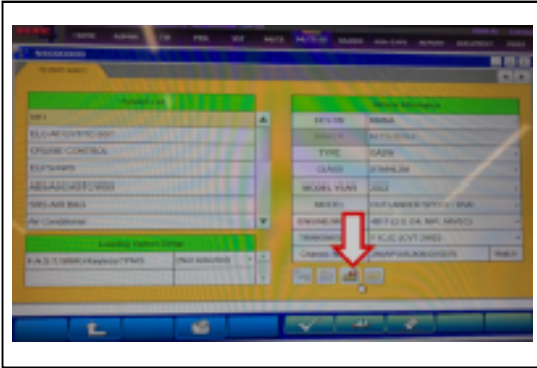
b. Press the ECU Reprogramming button.

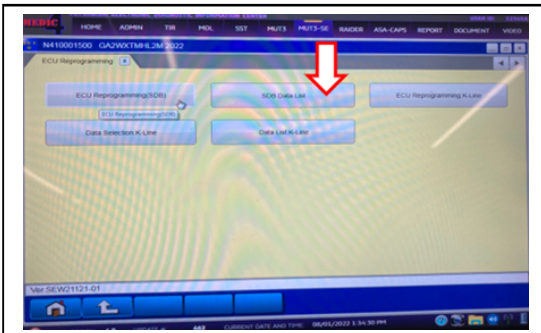
c. Press SDB Data List, select the reprogramming data system and press the OK button.

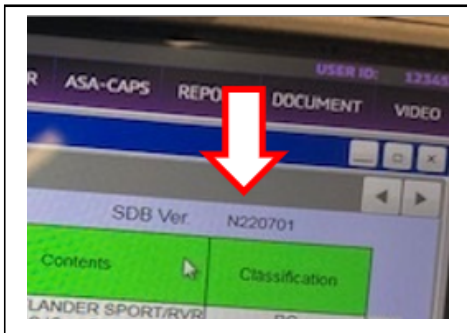
d. Confirm that the database number displayed in the upper right above the chart is **N220701** or higher.

- i. If the database number displayed on your MUT-III SE is **N220701** or greater, continue to the next section.
- ii. If the reprogramming database number displayed on your MUT-III SE is lower than **N220701**, then the MUT-III SE database needs to be updated.
- iii. Once the database number is confirmed, hit the Home button to go back to the System Select screen.

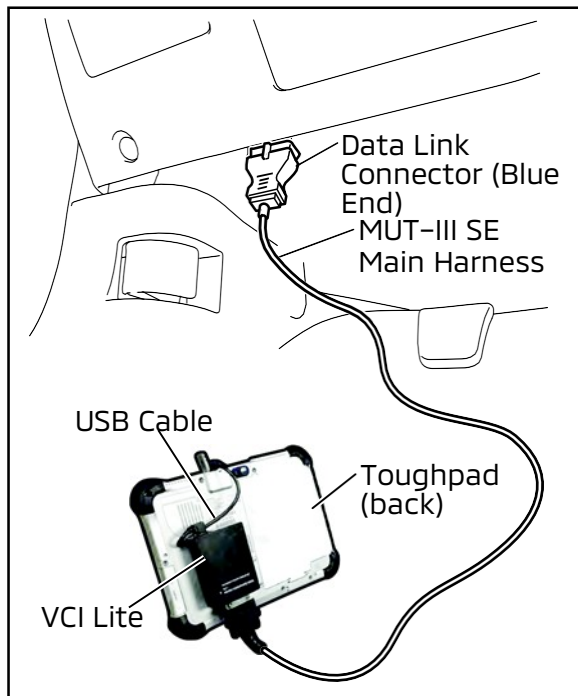
1. Connect the equipment as follows:

**NOTE:** VCI Lite and MEDIC 4.0 Toughpad shown for illustration purposes only.

- Turn the MEDIC PC/tablet on. If the battery indicator in the lower right hand corner of the screen does not show a full charge, it is recommended that either the battery be charged prior to beginning or be used with the A/C power adaptor connected.
- Connect the USB cable to the VCI/VCI Lite. When the laptop/tablet displays the MUT-III SE main screen, connect the USB cable to the device.
- Connect the MUT-III SE main harness with the blue DLC connection to the VCI/VCI Lite. Connect the blue connection of the MUT-III SE main harness to the vehicle's data link connector.
- For VCI only (p/n MB991824): Turn the VCI power switch ON. Verify that the indicator lamp in the upper right corner of the screen is green.

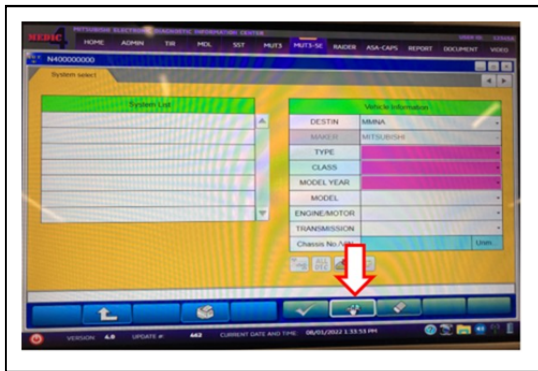
b. Press the model information display button (car icon) and verify all vehicle info is correct.

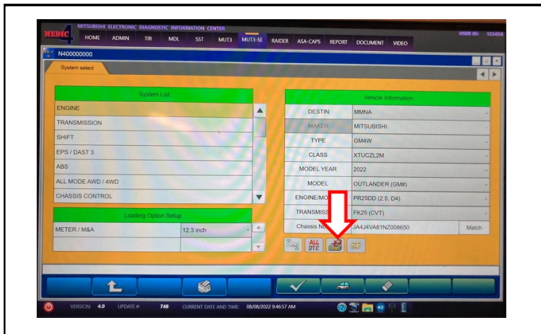
c. Press the reprogramming icon button.

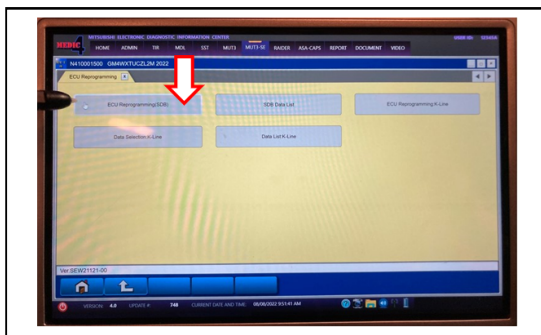
d. Press the "ECU reprogramming" (SDB) button.

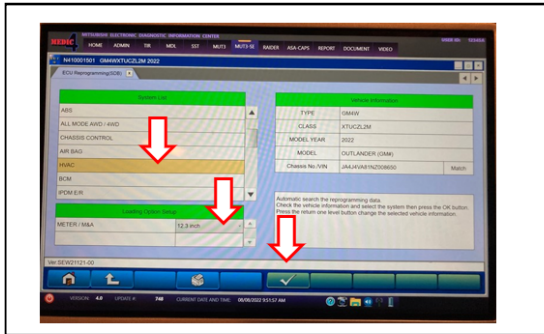
- e. Select "HVAC" from the System List and equipped meter size from the Loading Option Setup.

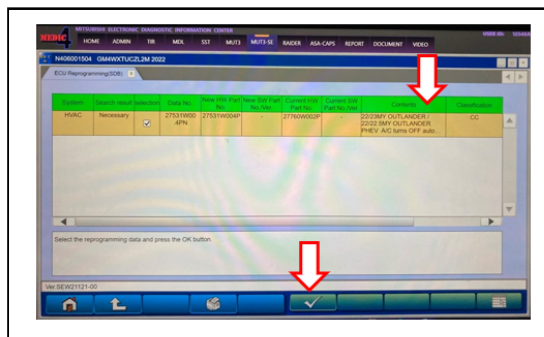
- f. The Automatic ECU Reprogramming (SDB) database screen will display. Press the OK button.

- Verify that the correct "NEW" ECU Software (22/23MY Outlander/22/22.5MY Outlander PHEV A/C turns OFF auto...) is listed in the table.

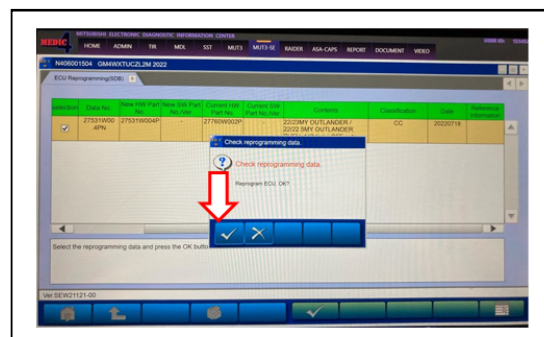
- g. Press the OK button to start the reprogramming.

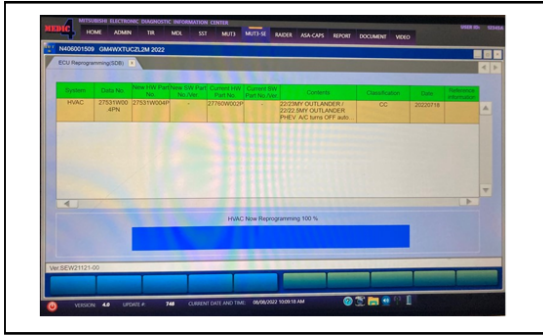
- h. Once the reprogramming is initiated, the screen will show the reprogramming progress.

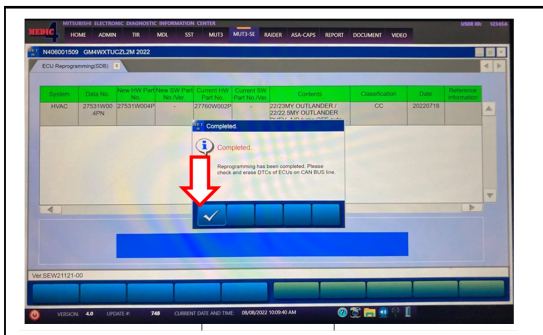
- i. When reprogramming is completed; turn the ignition switch to the OFF position and press the OK button to confirm the results of reprogramming.

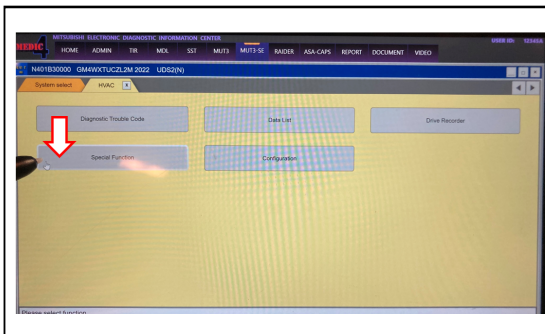
- j. Verify the software by turning the ignition switch to the ON position and select the "Special Function" button under the HVAC tab.

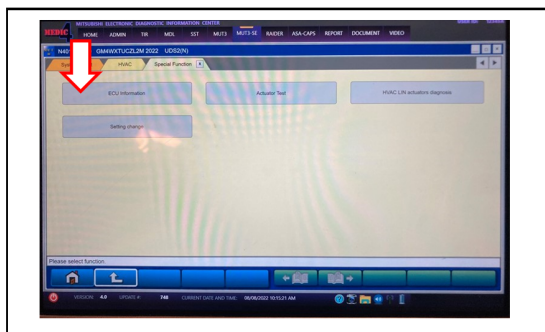
- k. Select "ECU Information" under the Special Function tab.

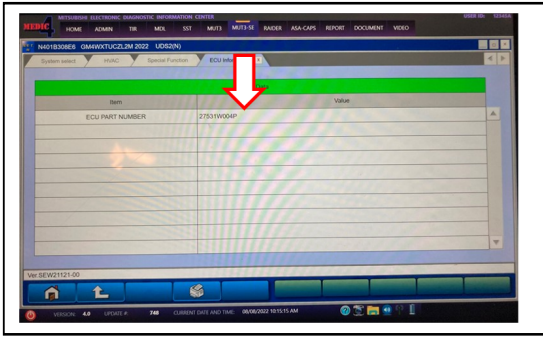
- l. Verify that the software version has been updated to 27531W003P or 27531W004P depending on the vehicles specification.

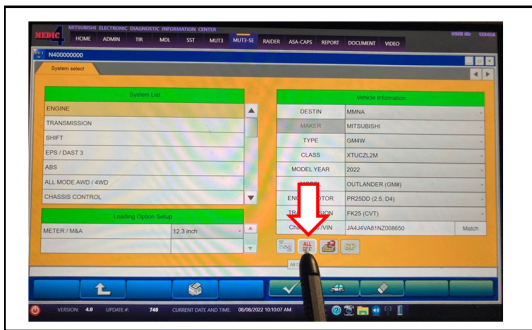
- m. Press "ALL DTC" button to initiate the "Erase and Read all DTCs". Press OK when complete.

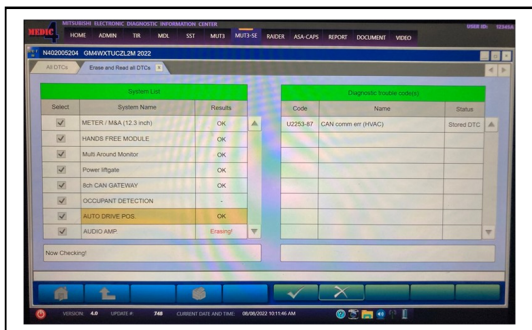
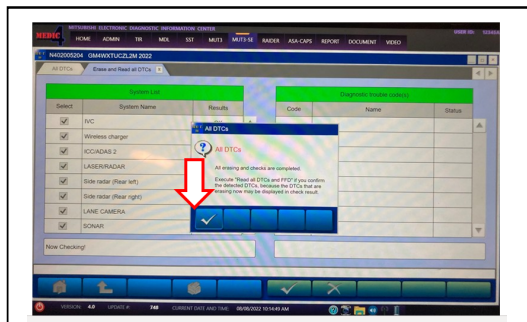
**IMPORTANT:** The "Erase and Read all DTCs" must be performed since HVAC related DTCs may be generated and stored.
