GROUP	MODEL
Service Campaign	2020-2022MY Telluride (ON)
NUMBER	DATE
SC243 (Rev 1, 10/04/2022)	August 2022

VOLUNTARY SERVICE CAMPAIGN

FRONT RADAR FCA/SCC MISDETECTION PREVENTION LOGIC IMPROVEMENT (SC243)

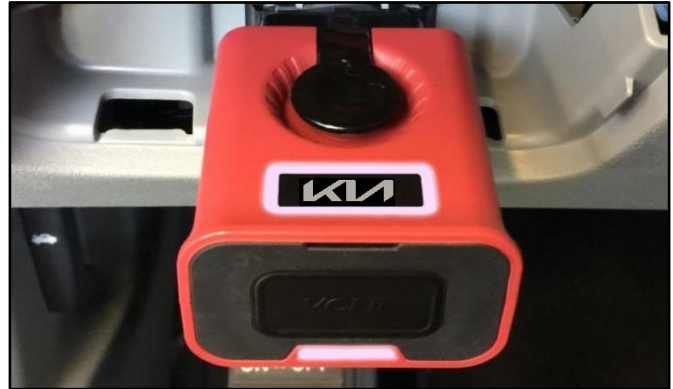
The ECU upgrade function on KDS operates wirelessly. It is not necessary to perform the upgrade via USB cable.

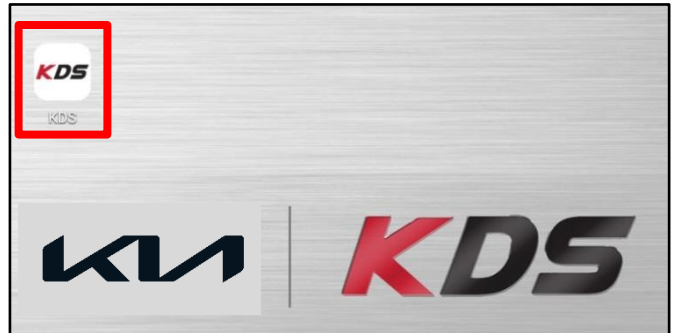
2. With the ignition ON, turn ON the KDS tablet. Select 'KDS' from the home screen.

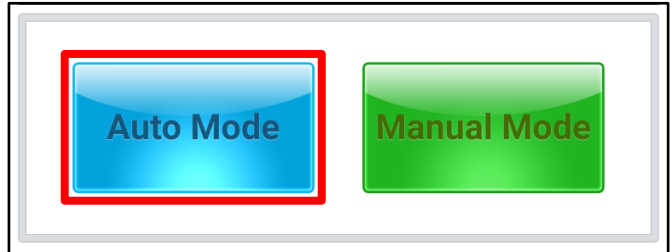
- Select Auto Mode.

Do NOT attempt to perform a Manual Mode upgrade UNLESS Auto Mode fails. Always follow the instructions given on the KDS in either Auto or Manual mode.
