DCM Reset and Firmware Update (LG)

Service Category Audio/Visual/Telematics

Section Cellular Communication

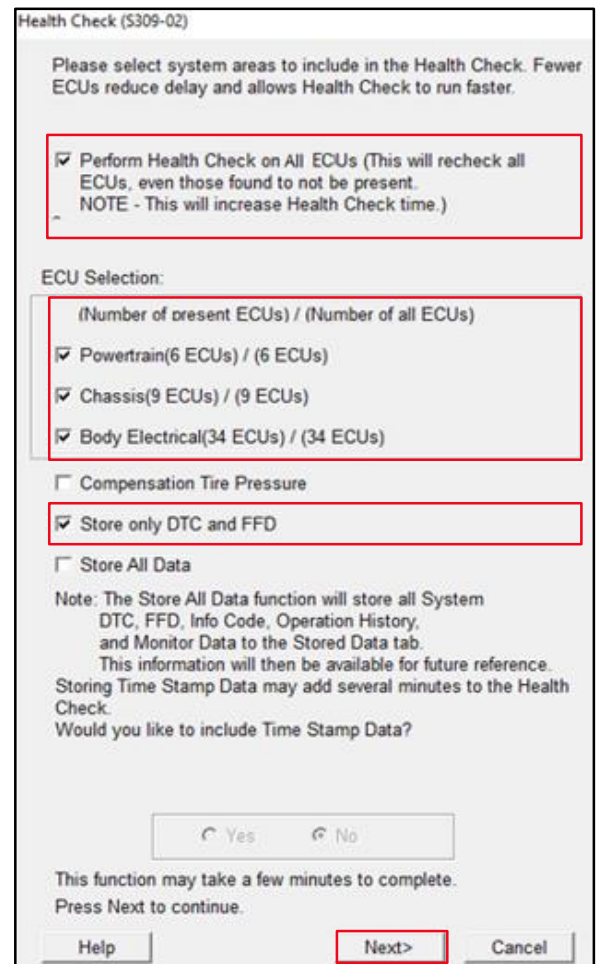
Figure 1.

2. Using Techstream, perform a Health Check and clear ALL DTCs.
 - A. Check the “Perform Health Check on all ECUs” box.
 - B. Check the “Store only DTC and FFD” box.
 - C. Click on Next.

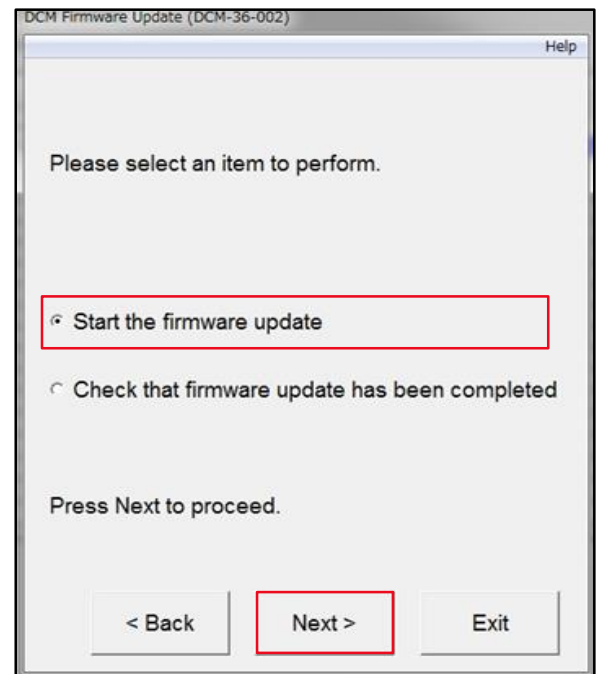
Figure 4.

- Select "Start the firmware update" and click on Next when the item selection screen appears.

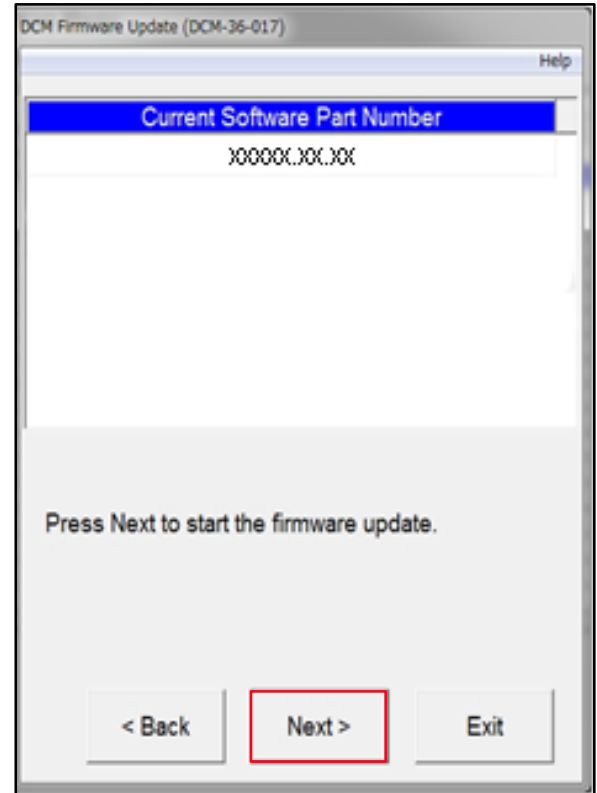
Figure 5.

- Click on Next when the current software part number screen appears.

- Do NOT press Exit until the update process has completed.
- During the update process, the green and red LEDs will both be ON and will reset several times resulting in the LEDs being temporarily OFF during the process. The download process will take about 5 – 10 minutes.

If the screen in Figure 5 does NOT appear and an error message displays, begin the Firmware Update Procedure again from step 4. The battery reset MUST be performed again.

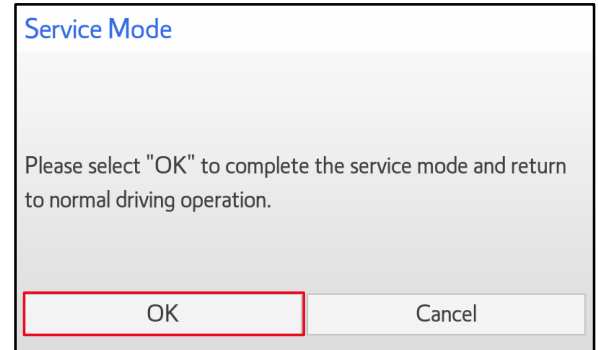
Figure 7.

- The green LED will be ON when the update process has completed. AFTER the process has completed, wait for the radio screen to display the service mode screen BEFORE you click OK to exit.

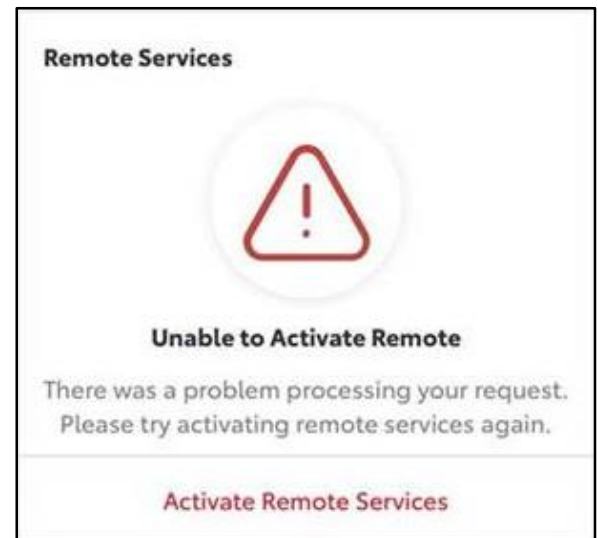
Figure 8.

- Using Techstream, perform a Health Check and clear ALL DTCs that may have occurred during the update process.
- In the customer’s Toyota app, perform steps 17 – 19 for customers with the “Unable to Activate Remote” message.

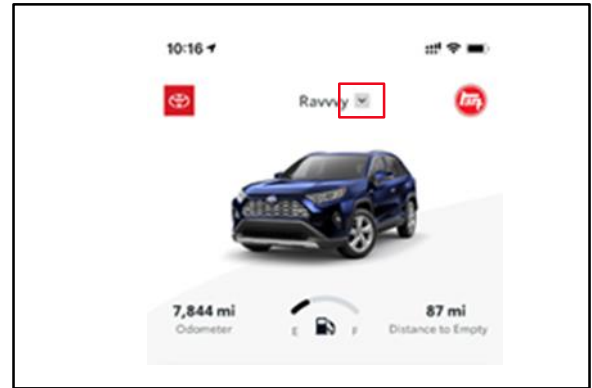
Figure 9.

17. Click on the arrow by the vehicle name/nickname.

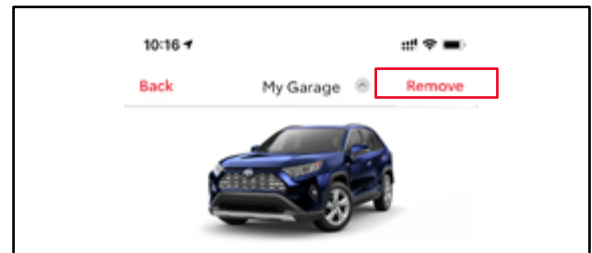
Figure 10.

18. Click on Remove.

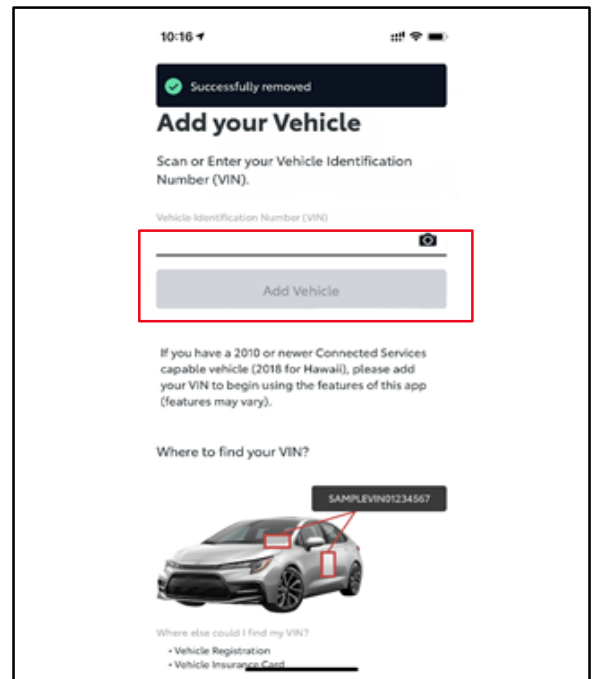
Figure 11.

19. Click on Add Vehicle to perform the enrollment again.
