DCM Reset and Firmware Update (LG)

Service Category Audio/Visual/Telematics

Section Cellular Communication

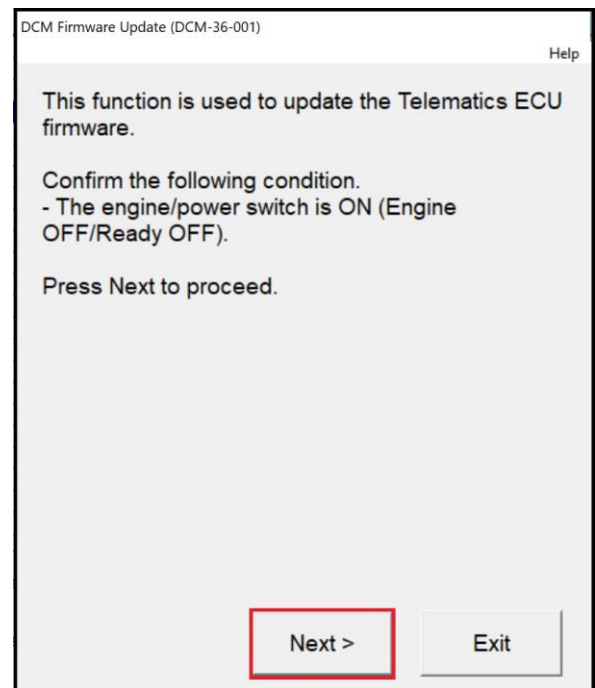
Figure 3.

9. Click on Next when the DCM firmware update screen appears.

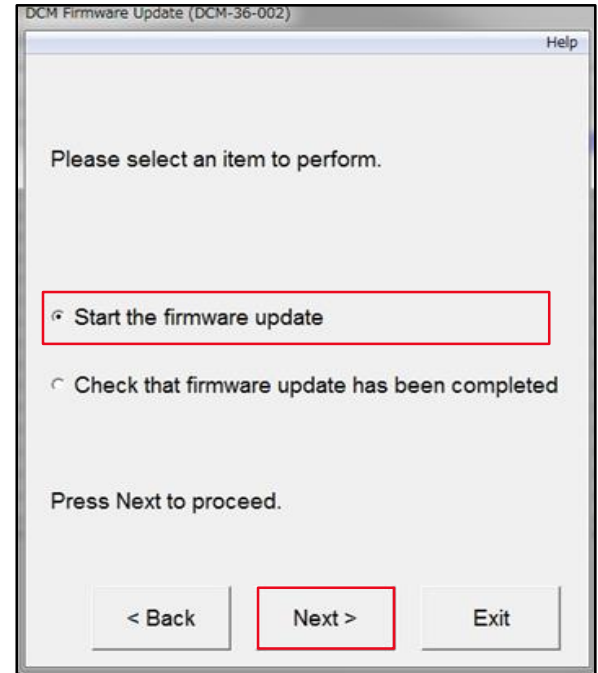
Figure 4.

10. Select “Start the firmware update” and click on Next when the item selection screen appears.

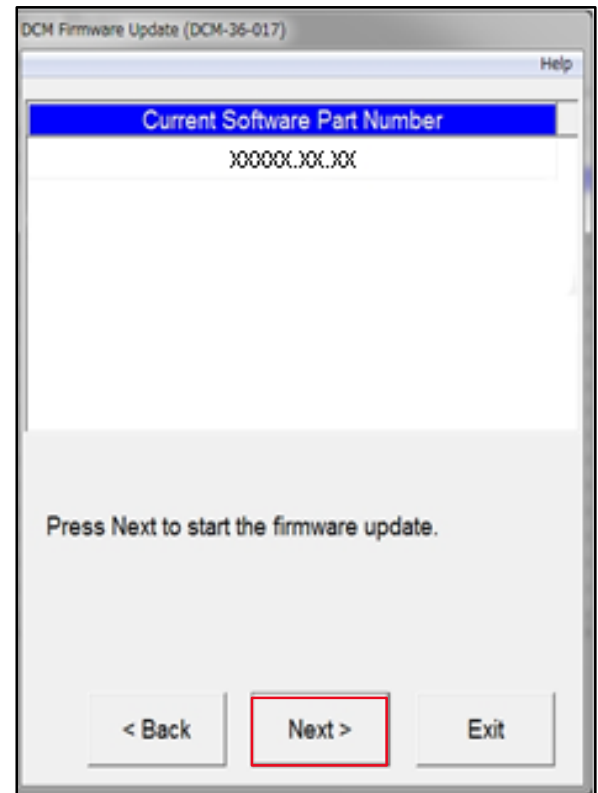
Figure 5.

11. Click on Next when the current software part number screen appears.

If the screen in Figure 5 does NOT appear and an error message displays, begin the DCM Firmware Update Procedure again from step 4. The battery reset MUST be performed again.

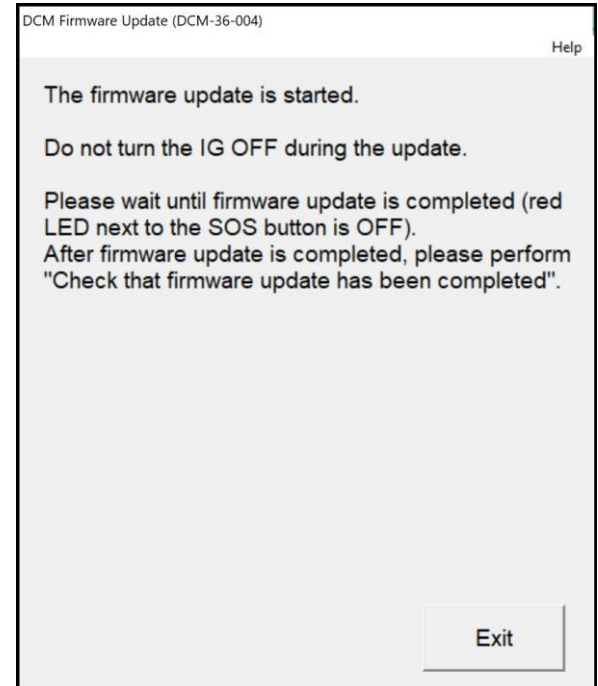
Figure 6.

- The firmware update will begin. Do NOT turn the vehicle OFF during this time.

- Do NOT press Exit until the update process has completed.
- During the update process the green and red LEDs will both be ON and will reset several times resulting in the LEDs being temporarily OFF during the process. The download process will take about 5 – 10 minutes.

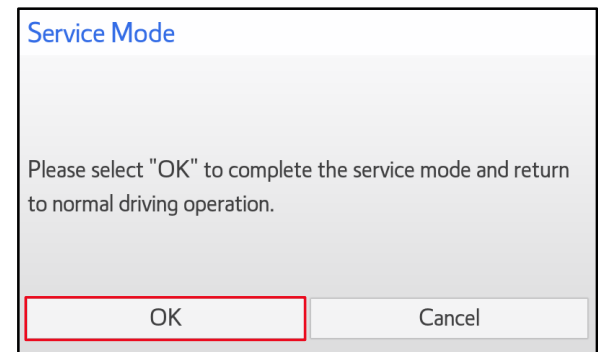
Figure 7.

- The green LED will be ON when the update process has completed. AFTER the process has completed, wait for the radio screen to display the service mode screen BEFORE you click OK to exit.

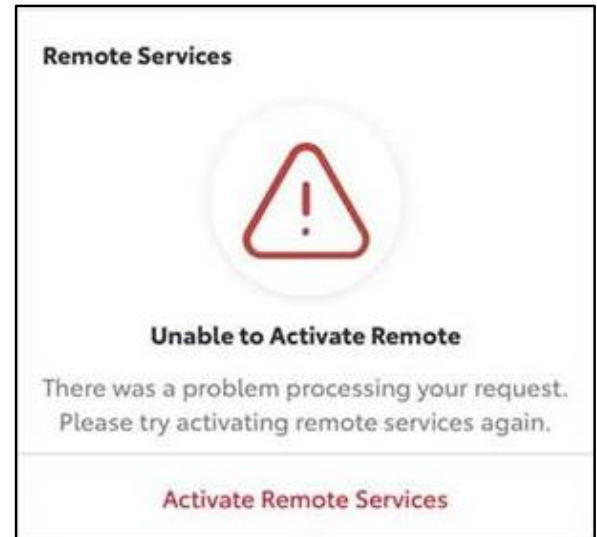
Figure 8.

15. Using Techstream, perform a Health Check and clear ALL DTCs that may have occurred during the update process.
16. In the customer’s Lexus app, perform steps 17 – 19 for customers with the “Unable to Activate Remote” message.

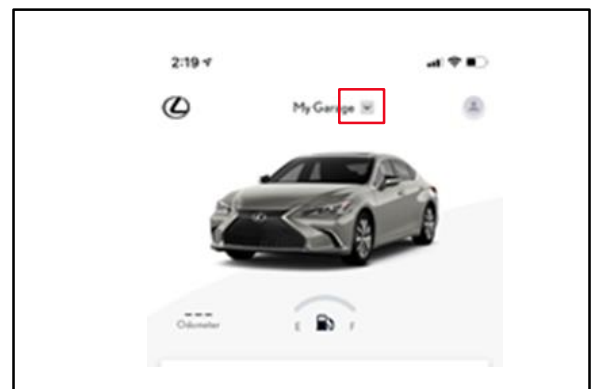
Figure 9.

17. Click on the arrow by the vehicle name/nickname.

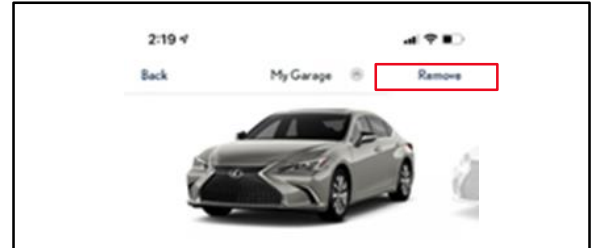
Figure 10.

18. Click on Remove.

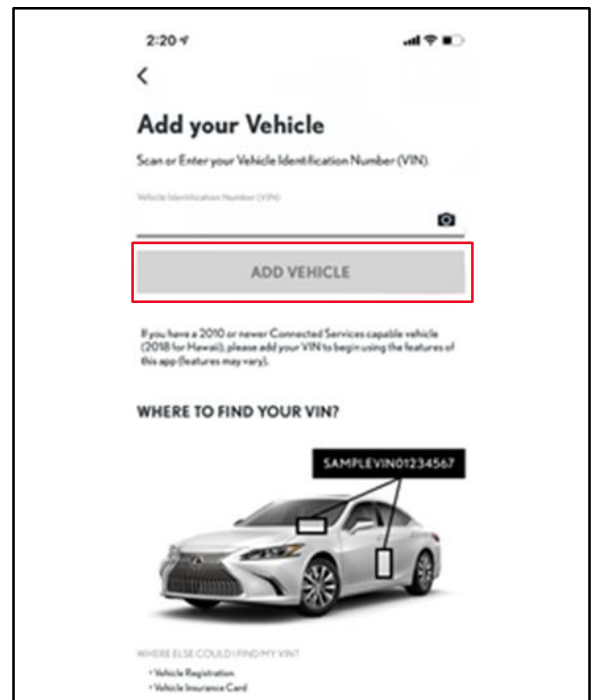
Figure 11.

19. Click on Add Vehicle to perform the enrollment again.
