TECHNICAL INSTRUCTIONS

LIMITED SERVICE CAMPAIGN 22TD01

SOFTWARE UPDATE FOR EV CONTROL COMPUTER

CERTAIN 2021 MODEL YEAR MIRAI VEHICLES

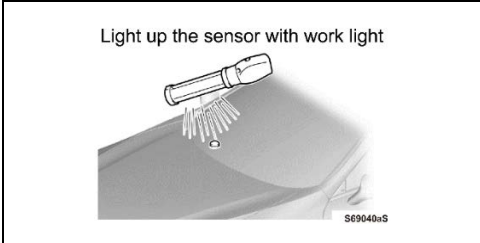
- i. Confirm the following conditions:
 - Vehicle in the IG position (engine off).
 - Open the driver's door window.
 - Transaxle in P range.
 - Parking brake engaged.
 - Turn off all electrical accessories (i.e. air conditioning system, audio system, etc.).
 - Headlight switch in the DRL OFF position.(w/ DRL OFF position)
 - Windshield wiper switch in the OFF position.
