**NUMBER:** 08-167-22

Radio Over The Air R41 to R45 Software Version Updates

This bulletin provides information regarding the latest Flash Over The Air (FOTA) update and provides the service technician an overview of the steps a customer will need to take to complete the update. The radio software will be updated from R41 to R45.

2022 (MP) Jeep Compass

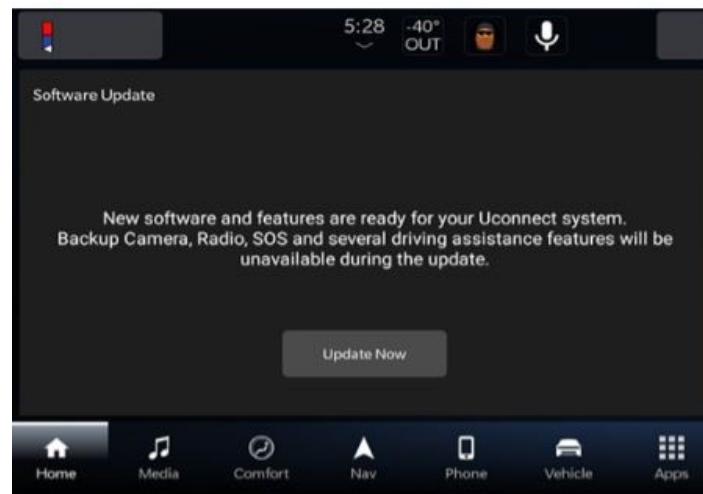
**Fig. 1**  
**Software Acceptance Screen**

1. The vehicle needs to be in 'park'. The ignition needs to be in the off position.
2. If the customer selects "Update Now" they can shut off the vehicle and leave. The update will be completed automatically.

Vehicles sold in the U.S. and Canada can now receive software updates "over-the-air". Updates to software will occur in a phased roll-out. The software is updated through a built-in cellular modem in the vehicle. Customers will see a notification on their radio screen when new software is available for their radio (Fig. 1) . The owner will have the option to update the radio or schedule the update for later. There is not an option to decline the update indefinitely, the update must be performed.

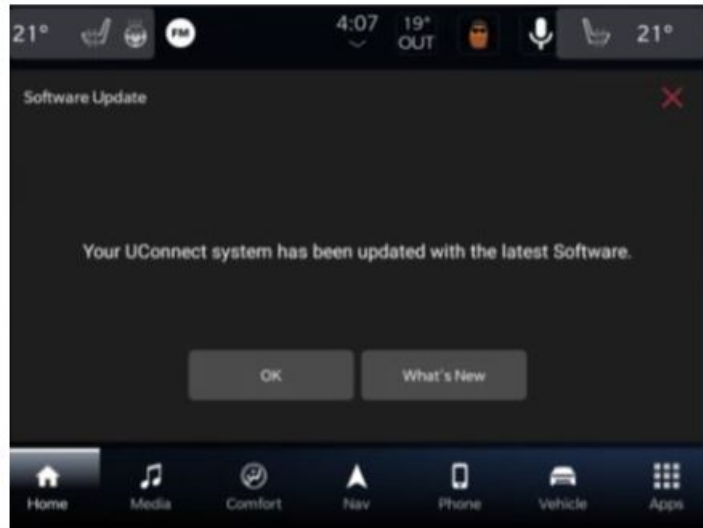
3. Upon completion of update, the radio will display a confirmation message (Fig. 2) .

Fig. 2  
Software Update Confirmation Screen
