HYUNDAI Technical Service Bulletin	GROUP CAMPAIGN	NUMBER 22-01-076H-1
	DATE OCTOBER, 2022	MODEL(S) Elantra (CN7, CN7a) Elantra Hybrid (CN7 HEV)
SUBJECT: ICU (INTEGRATED CENTRAL CONTROL UNIT) SOFTWARE UPDATE (SERVICE CAMPAIGN T8T)

This bulletin provides the service procedure to update the ICU (Integrated Central Control Unit) software to resolve the conditions stated above.

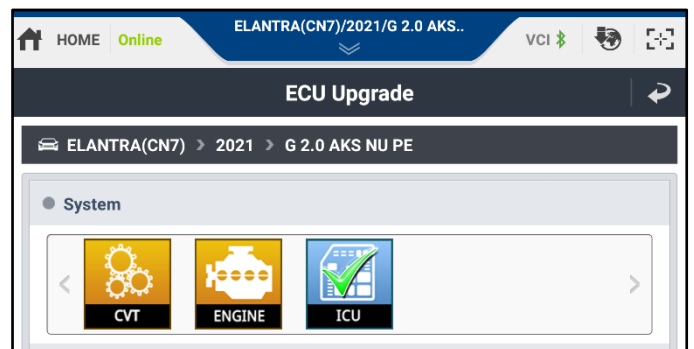
- 3. Select ICU system.

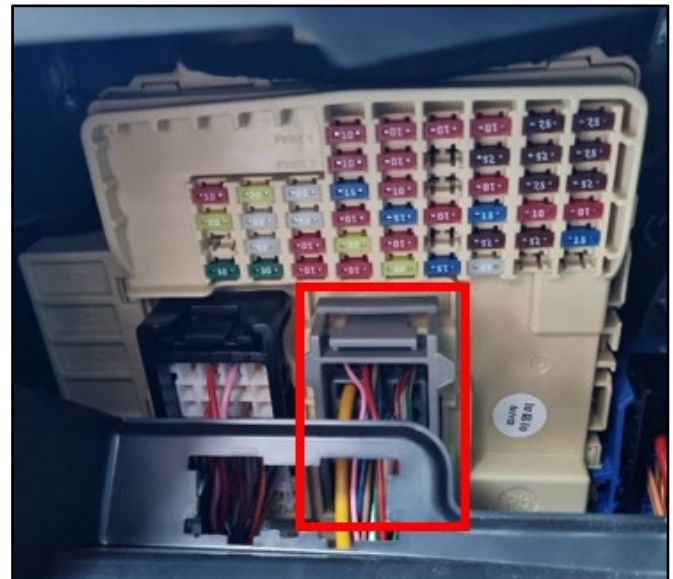
10. **After upgrade, remove power connector of indoor fuse box, and reconnect it after 5 seconds**

Check if any incidental Diagnostic Trouble Codes (DTC) have been created by the upgrade and clear the DTC(s) present.

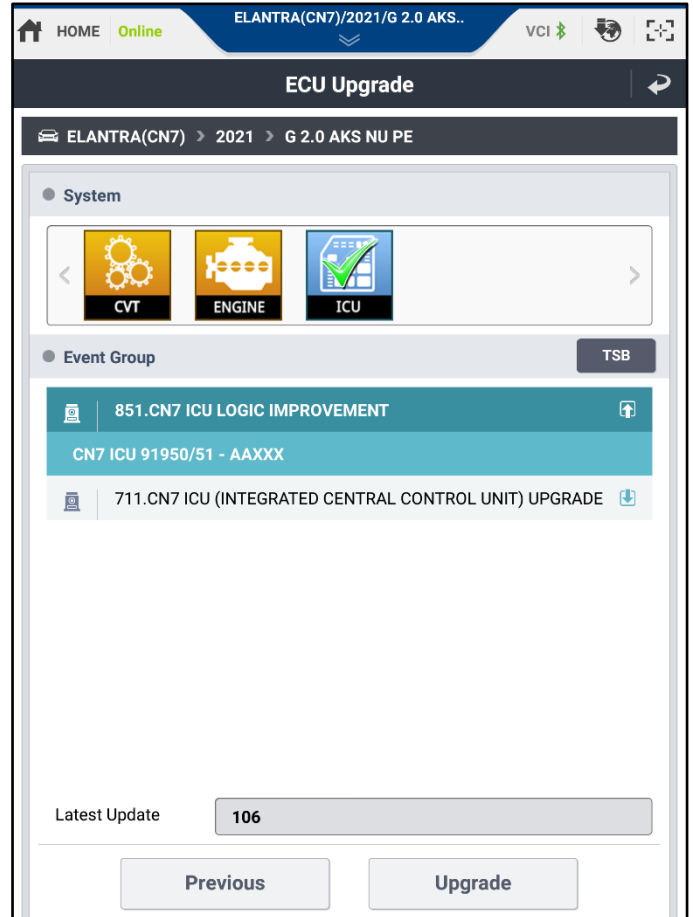
13. Check that the newest event with reference to the above ROM ID Information Table is selected and tab Upgrade.

CN7: 851.CN7 ICU LOGIC IMPROVEMENT

CN7a: 852.CN7a ICU LOGIC IMPROVEMENT

CN7 HEV: 864.CN7 HEV ICU LOGIC IMPROVEMENT

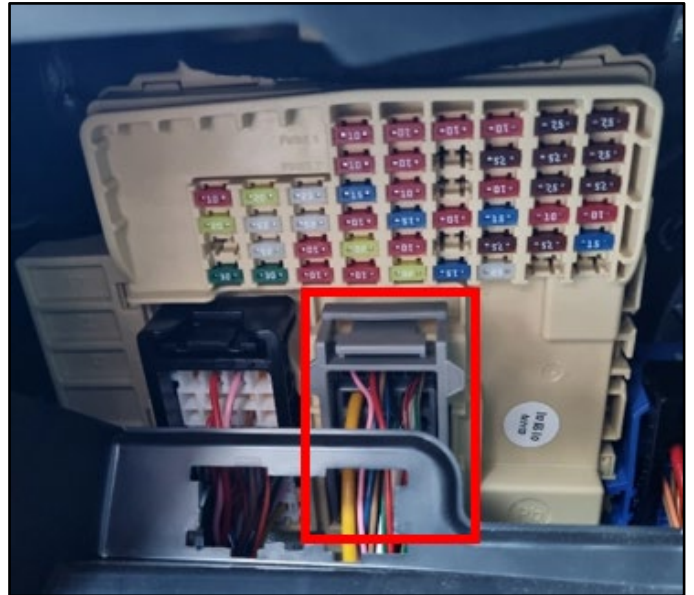
19. **After upgrade, remove power connector of indoor fuse box, and reconnect it after 5 seconds**

Check if any incidental Diagnostic Trouble Codes (DTC) have been created by the upgrade and clear the DTC(s) present.
