GLOBAL SAFETY FIELD INVESTIGATIONS
DCS6324
URGENT - DISTRIBUTE IMMEDIATELY

Subject: N222383970 - Service Update
Transmission Control Module Loss of Communication

Models: 2023 Chevrolet Equinox

N222383970 Transmission Control Module Loss of Communication

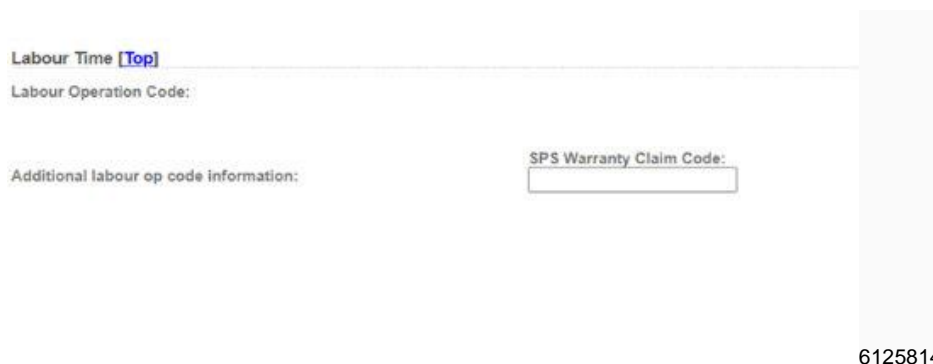
Important: * To avoid warranty transaction rejections, carefully read and follow the instructions below:

- The Warranty Claim Code from the programming event must be accurately entered in the "Warranty Claim Code" field of the transaction.
- When more than one Warranty Claim Code is generated for a programming event, it is required to document all Warranty Claim Codes in the "Correction" field on the job card. Dealers must also enter one of the codes in the "Warranty Claim Code" field of the transaction, otherwise the transaction will reject. It is best practice to enter the FINAL code provided by SPS2.

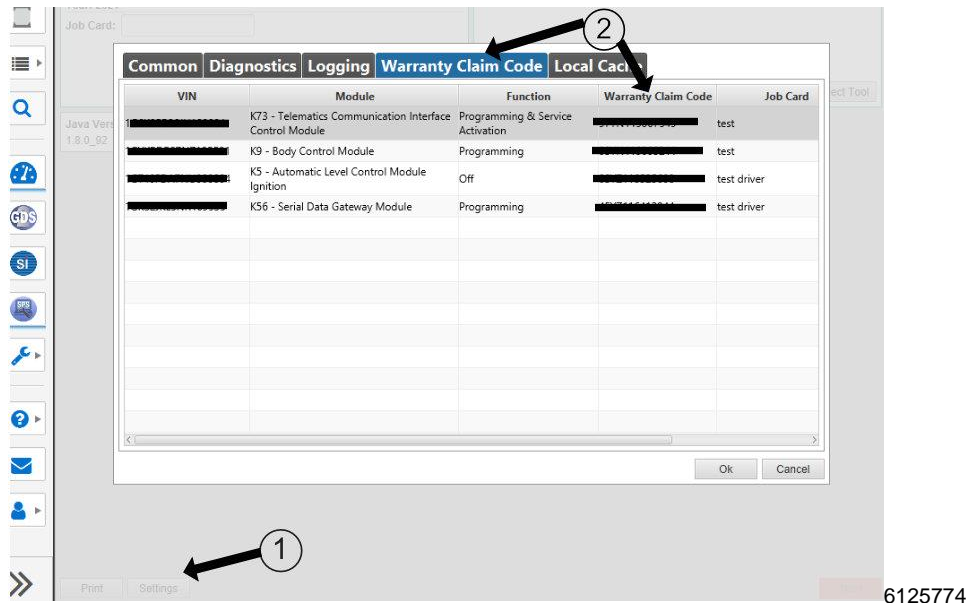
Warranty Claim Code Information Retrieval

If the Warranty Claim Code was not recorded on the Job Card, the code can be retrieved in the SPS2 system as follows:

1. Open TLC on the computer used to program the vehicle.
2. Select and start SPS2.
3. Select Settings (1).
4. Select the Warranty Claim Code tab (2).

The VIN, Warranty Claim Code and Date/Time will be listed on a roster of recent programming events. If the code is retrievable, dealers should resubmit the transaction making sure to include the code in the SPS Warranty Claim Code field.

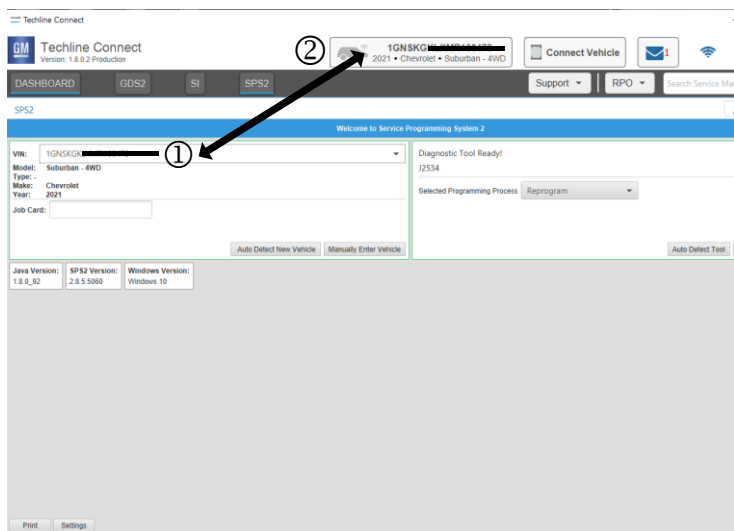
5743643

Caution: Be sure the VIN selected in the drop down menu (1) is the same as the vehicle connected (2) before beginning programming.

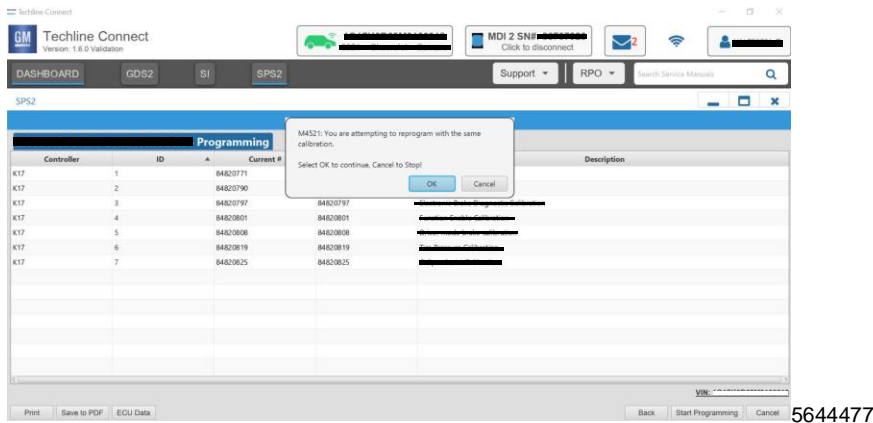
Important: Techline Connect screens shown above.

Important: If the same calibration/software warning is noted on the TLC Summary screen, select OK and follow screen instructions. After a successful programming event, the WCC is located in the Service Programming System dialogue box of the SPS Summary screen. No further action is required. Refer to the Warranty section of the bulletin.

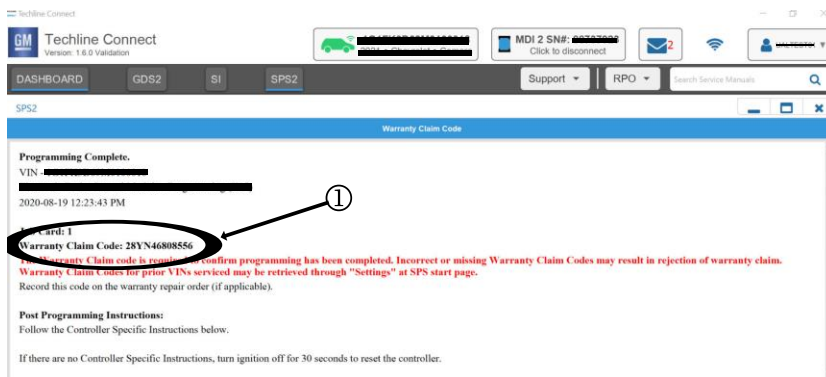
5644478

1. Reprogram the Engine Control Module. Refer to *K71 Transmission Control Module* or *Q8 Control Solenoid Valve Assembly: Programming and Setup (6T40 (MNH, MNK) or 6T45 (MHG))* in SI.
 - For this field action only, do NOT perform the setup portion (step 5 in SI) of the procedure. It is only necessary to perform the programming portion.

Note: The screenshot above is an example of module programming and may not be indicative of the specific module that is being programmed. Module selection and VIN information have been blacked out.
