**SUBJECT: NEW VEHICLE RECOMMENDED DELIVERY HOLD
 Customer Satisfaction Program 22P08 – Supplement #2**

Certain 2022 Model Year Expedition/Navigator, 2021-2022 Model Year F-150 and Mach-E Vehicles Equipped with Ford/Lincoln Co-Pilot and BlueCruise/ActiveGlide BlueCruise/ActiveGlide Maps Expiration

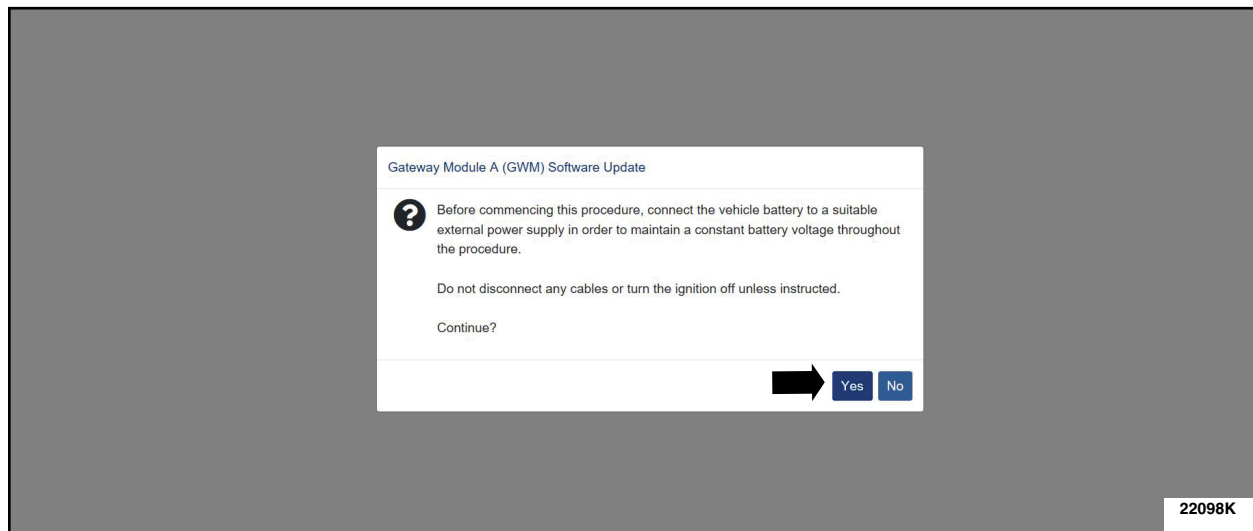
FIGURE 8

10. Verify that the vehicle is connected to a battery charger. Click yes and follow all on-screen instructions carefully. See Figure 8.

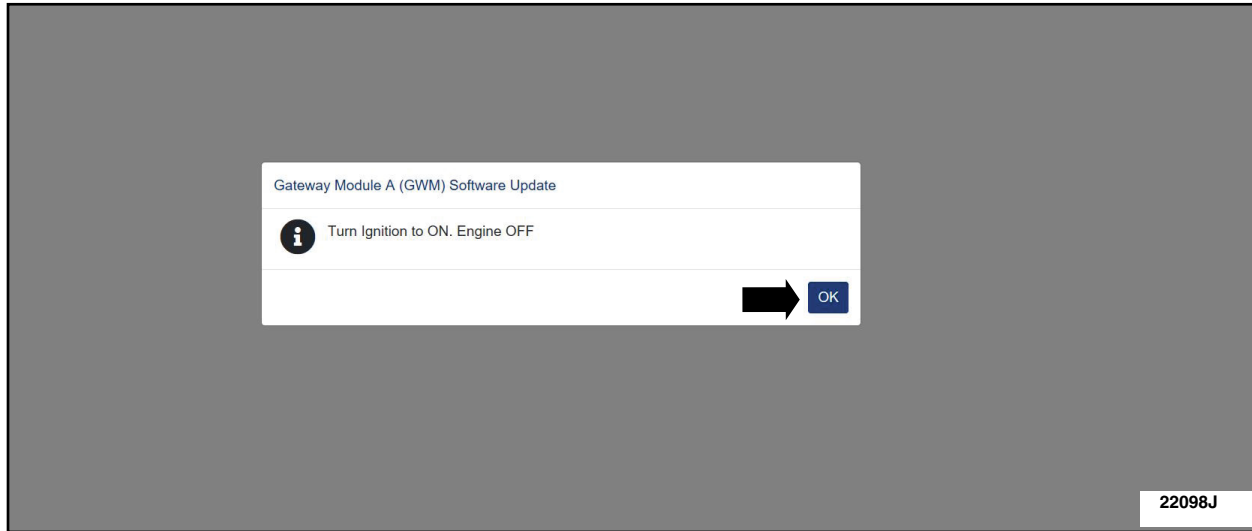
FIGURE 9

11. When prompted, turn the ignition to key on engine off and click the OK icon. See Figure 9.

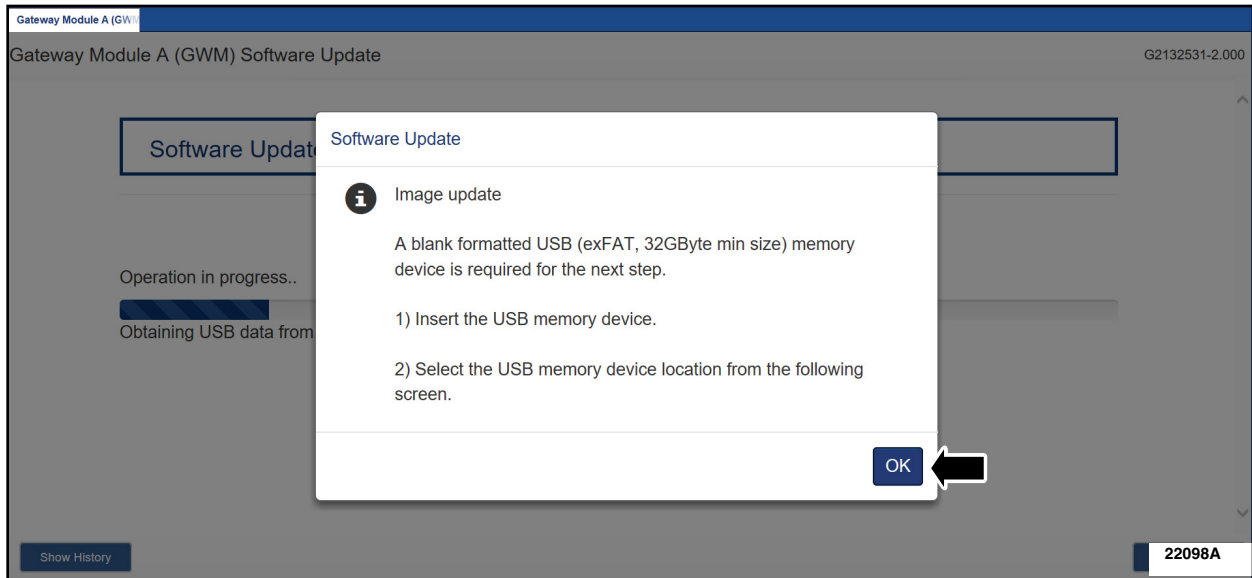
FIGURE 11

13. When prompted, connect the USB flash drive to the diagnostic scan tool and click the OK icon. See Figure 11.

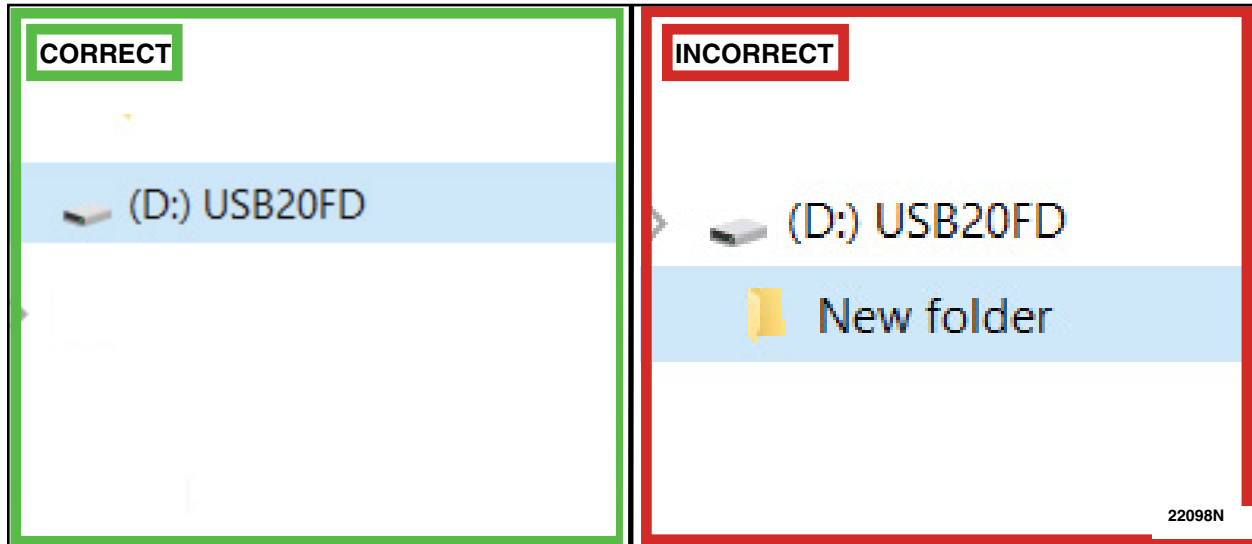
FIGURE 12

NOTE: Do not install the software update on a sub folder on the USB drive. See Figure 12.

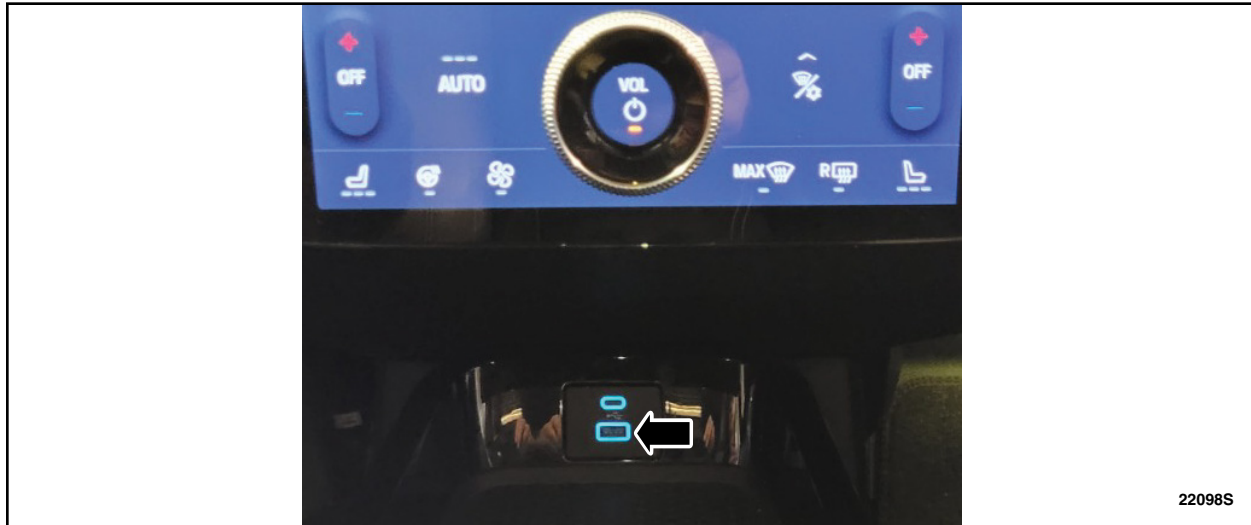
FIGURE 15

15. When prompted by the diagnostic scan tool, safely remove/eject the USB flash drive from the diagnostic scan tool and connect it to the USB hub in the vehicle to install the software into the GWM. See Figure 15.

NEW ! NOTE: Mach-E shown Expedition, Navigator and F-150 vehicles similar.

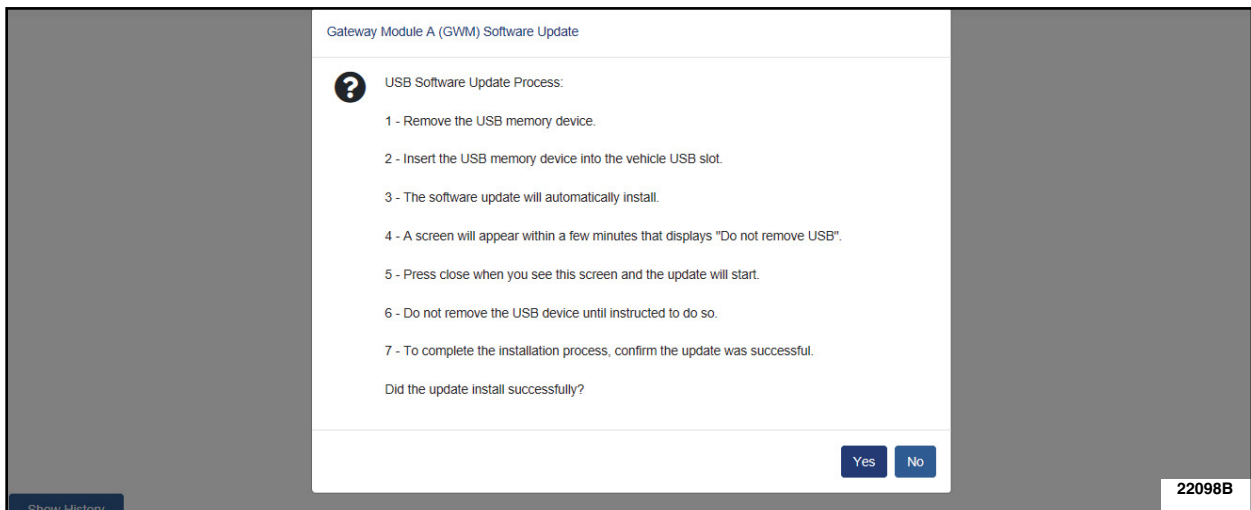
FIGURE 16

16. The update should start automatically. It is normal for the GWM to reset during this step. See Figure 16.

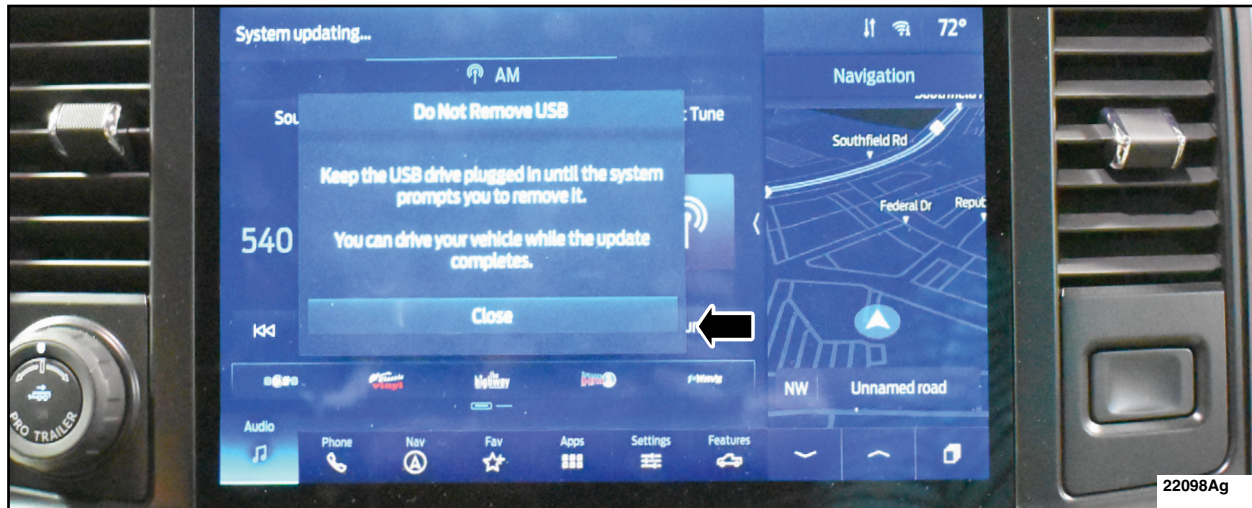
FIGURE 17

17. Press the close icon on navigation screen. The GWM software update will start automatically.
See Figure 17.
18. Set a timer for 10 minutes to ensure enough time passes to allow the update to complete before removing the USB drive.

NEW ! NOTE: F-150 shown Expedition and Navigator vehicles similar.

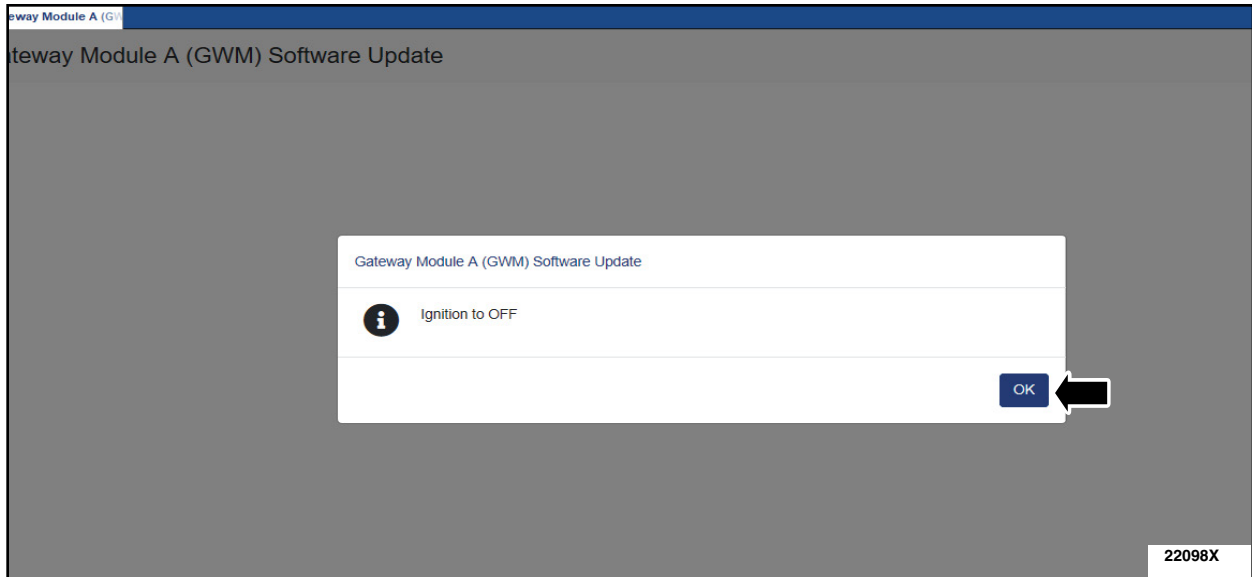
FIGURE 20

22. Turn ignition to off and click the OK icon on the FDRS screen. See Figure 20.

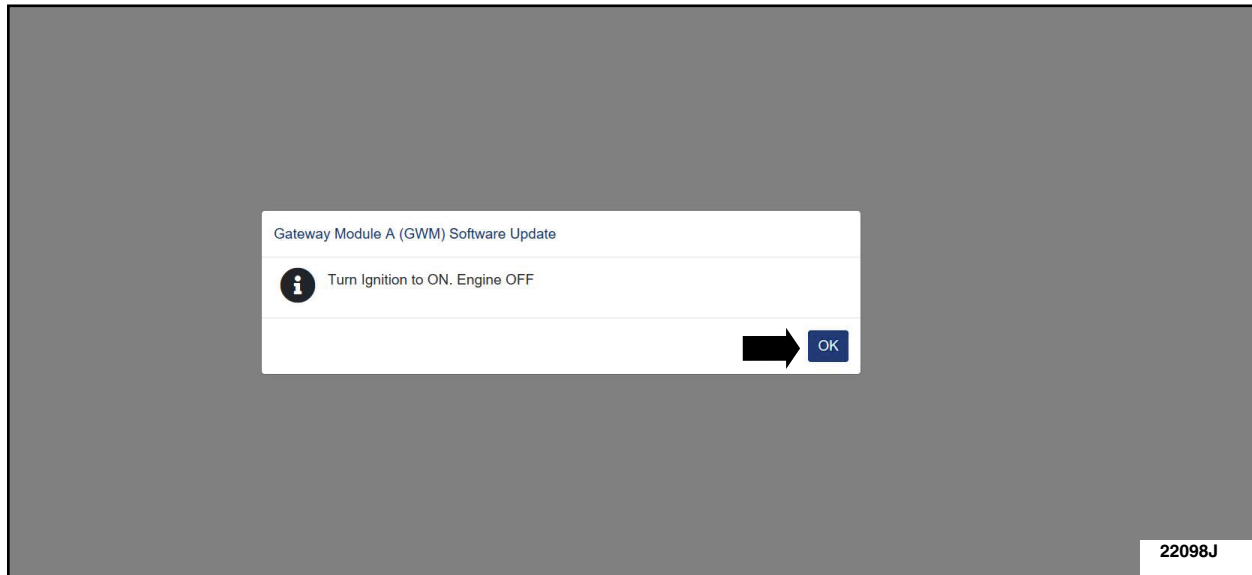
FIGURE 21

23. Turn ignition to the ignition on engine off position and click the OK icon on the FDRS screen. See Figure 21.

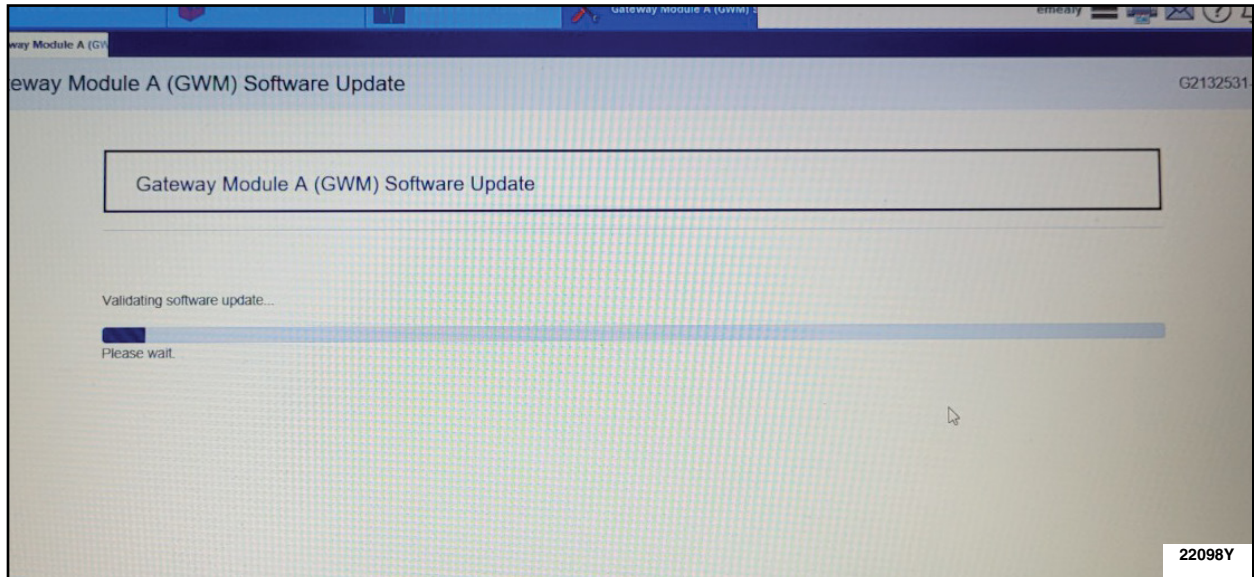
FIGURE 22

24. On the FDRS screen wait for the validating software process to finish. See Figure 22.

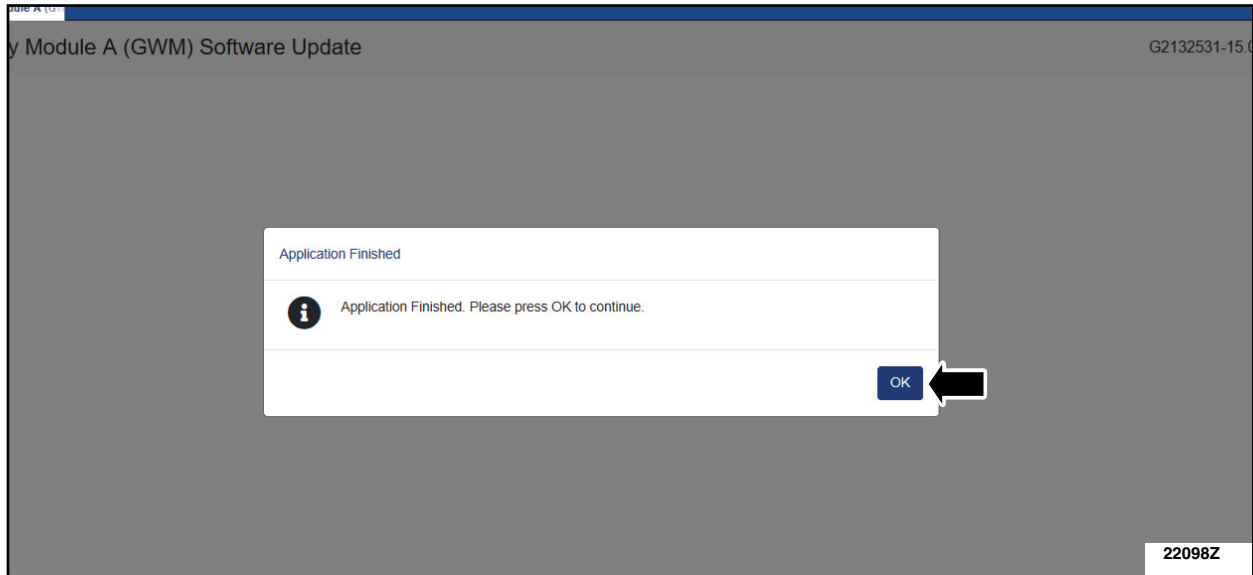
FIGURE 24

26. Click OK on the FDRS screen when the application finished message appears. See Figure 24.

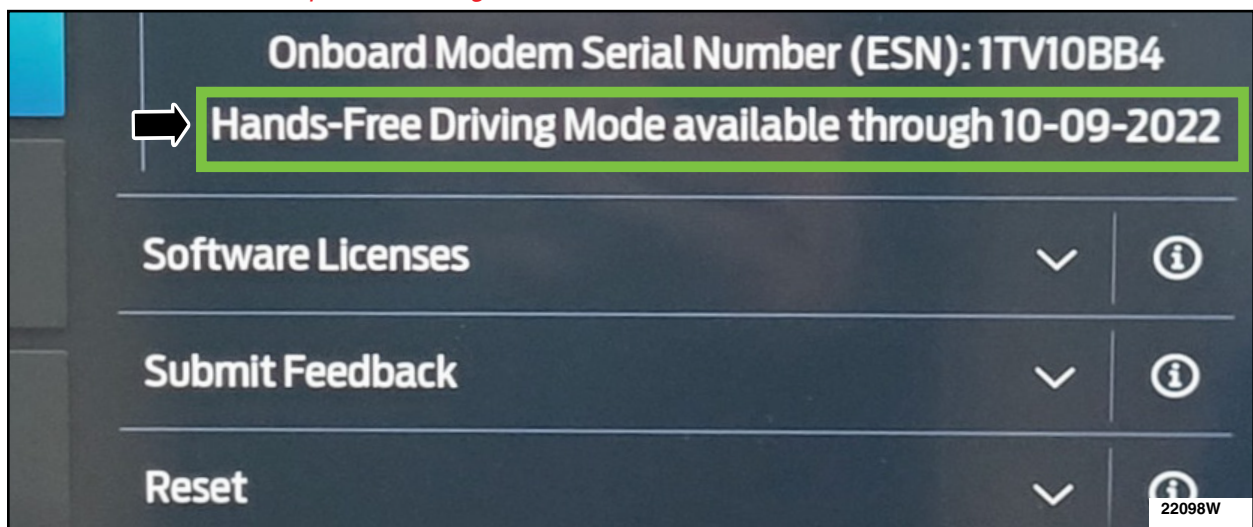
FIGURE 25

31. On the center display screen, navigate to Settings > About SYNC > Hands-Free Driving Mode available through DD-MM-YYYY. Verify that expiration date is in the future. See Figure 25.

NEW ! *NOTE: Mach-E shown Expedition, Navigator and F-150 vehicles similar.*

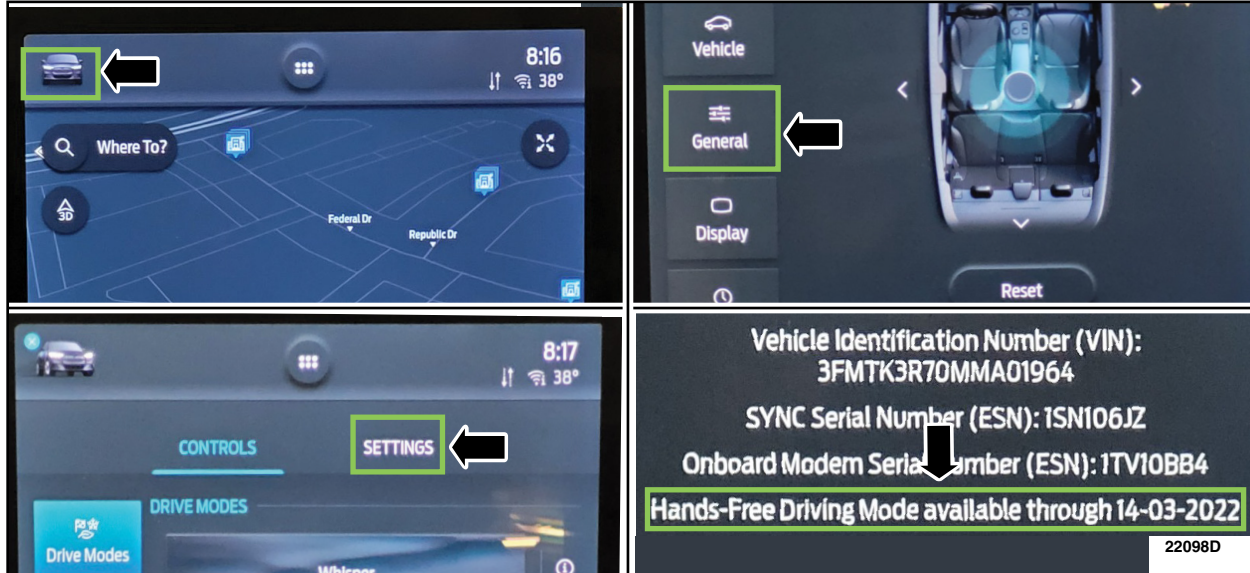
FIGURE 1

3. On the center display screen, navigate to Settings > About SYNC > Hands-Free Driving Mode available through DD-MM-YYYY. Record the expiration date. See Figure 1.

NEW ! NOTE: Mach-E shown Expedition, Navigator and F-150 vehicles similar.

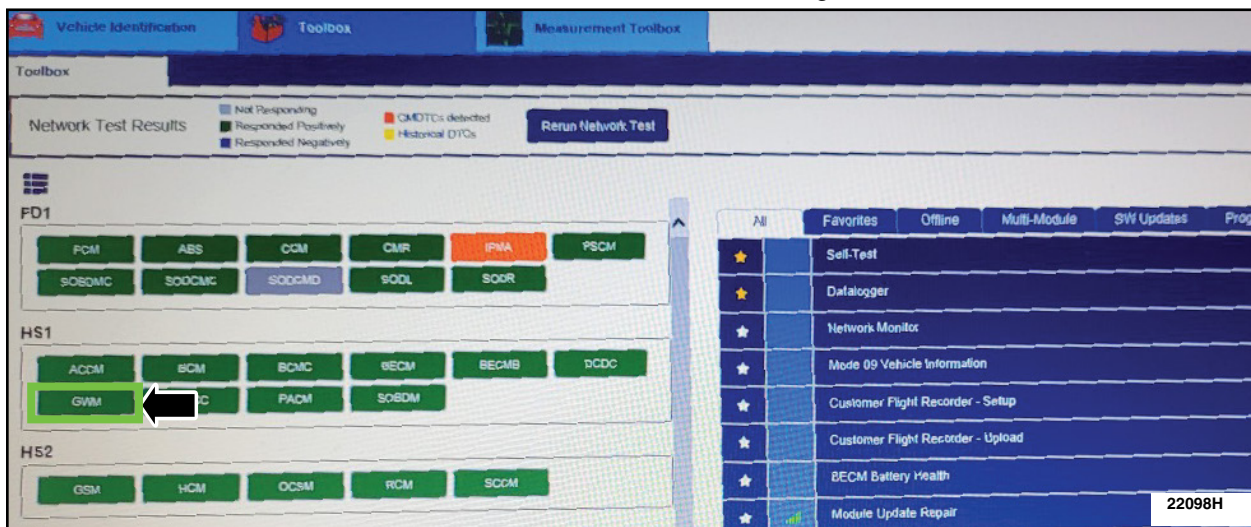
FIGURE 3

7. From the list on the LH side of the screen, select the GWM. See Figure 3.

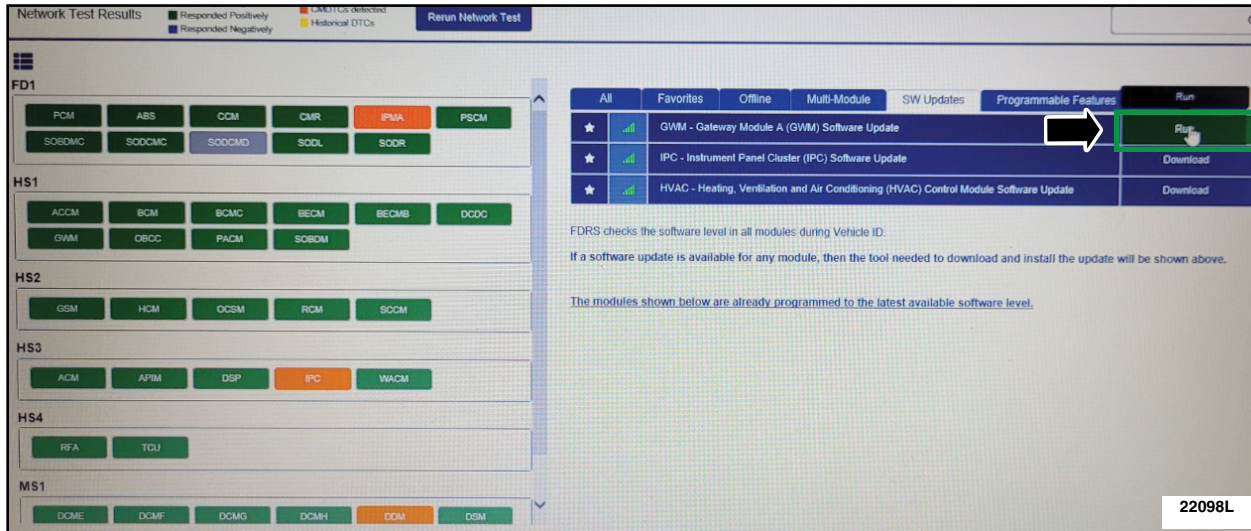
FIGURE 7

9. Click RUN to start the GWM update. See Figure 7.

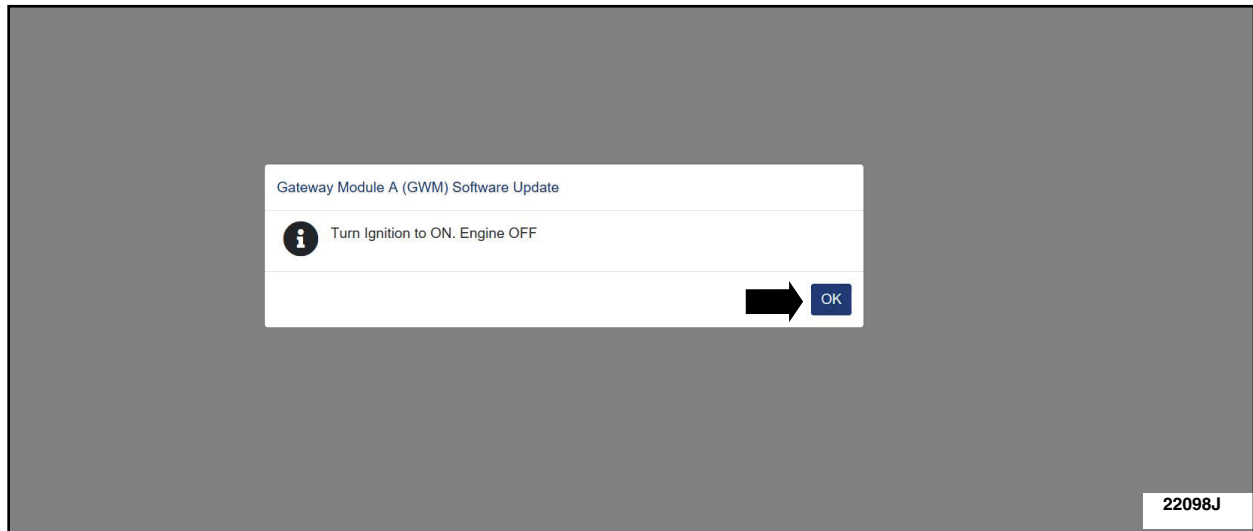
FIGURE 9

11. When prompted, turn the ignition to key on engine off and click the OK icon. See Figure 9.

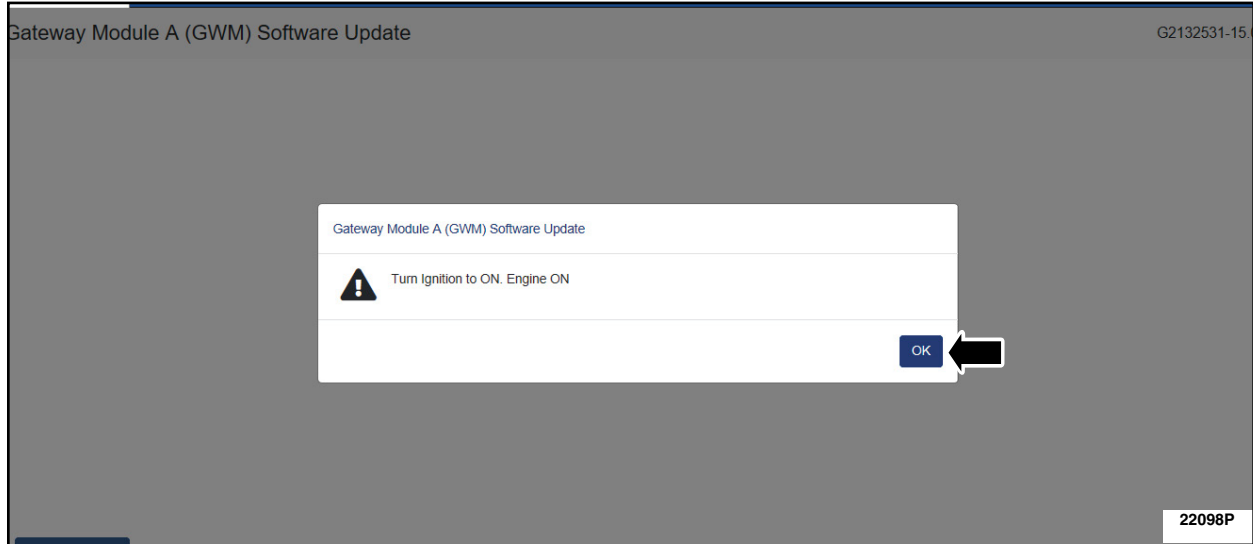
FIGURE 13

14. Cycle the ignition to the ignition on engine on position and click the OK icon. See Figure 13.

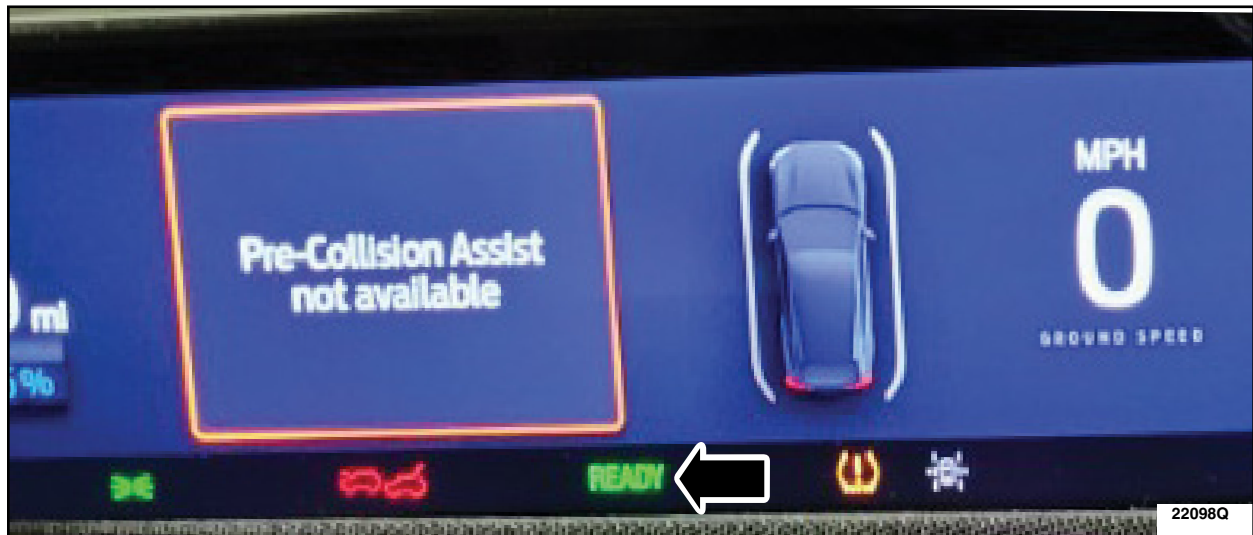
FIGURE 14

15. Verify that the green ready light is on on the instrument cluster. See Figure 14.

NOTE: Close all the doors on the vehicle. If a door must be left open during the service procedure, mechanically latch the door latch to simulate a closed door and ensure that the trunk is closed if applicable.

NEW ! NOTE: Mach-E shown Expedition, Navigator and F-150 vehicles similar.

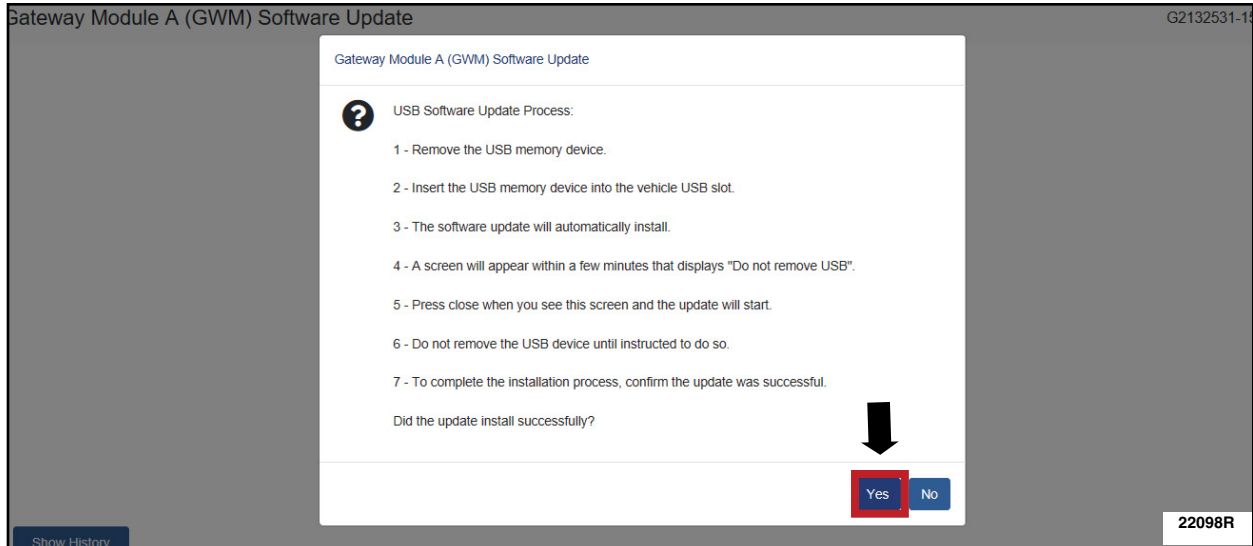
FIGURE 15

IMPORTANT: Do not select the Yes button in FDRS until the software update on the USB drive has been completed. See Figure 15.

NOTE: If the yes or no icon in FDRS is pressed by accident the software update will not be successful. **DO NOT PROCEED WITH THE CAN FLASH.** You may receive an inaccurate message stating that the software update was successful but the bluecruise maps will not be updated.

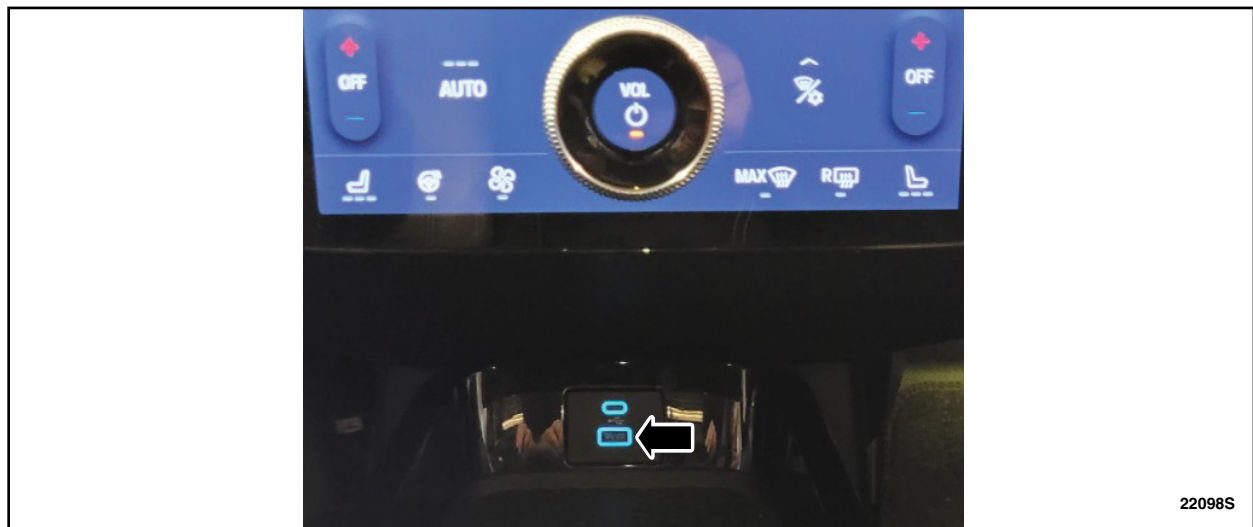
FIGURE 16

16. When prompted by the diagnostic scan tool, safely remove/eject the USB flash drive from the diagnostic scan tool and connect it to the USB hub in the vehicle to install the software into the GWM. See Figure 16.

NEW ! NOTE: Mach-E shown Expedition, Navigator and F-150 vehicles similar.

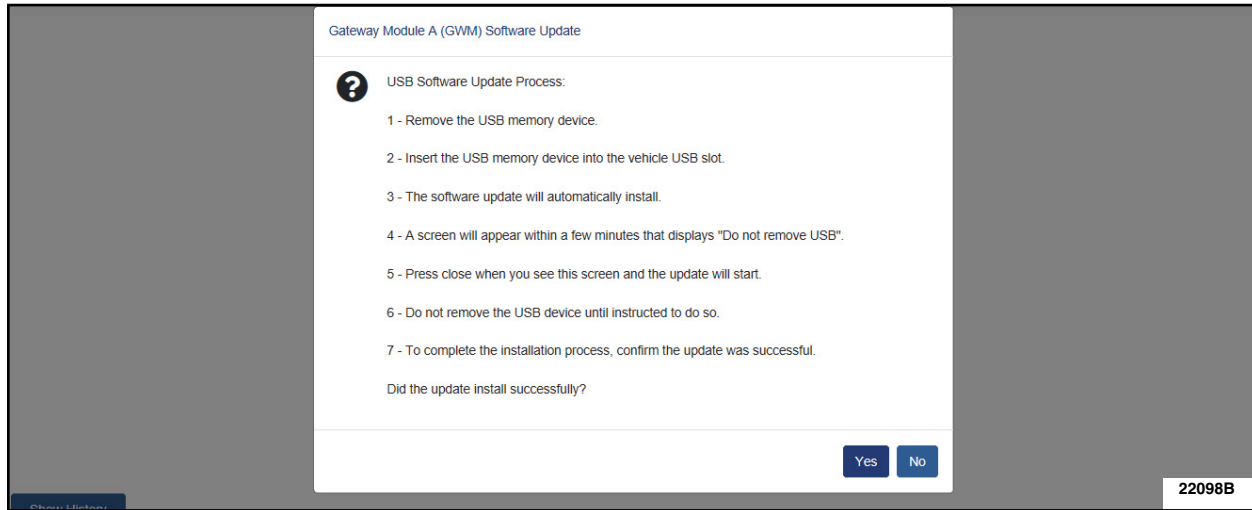
FIGURE 17

17. The update should start automatically. It is normal for the GWM to reset during this step.
See Figure 17.

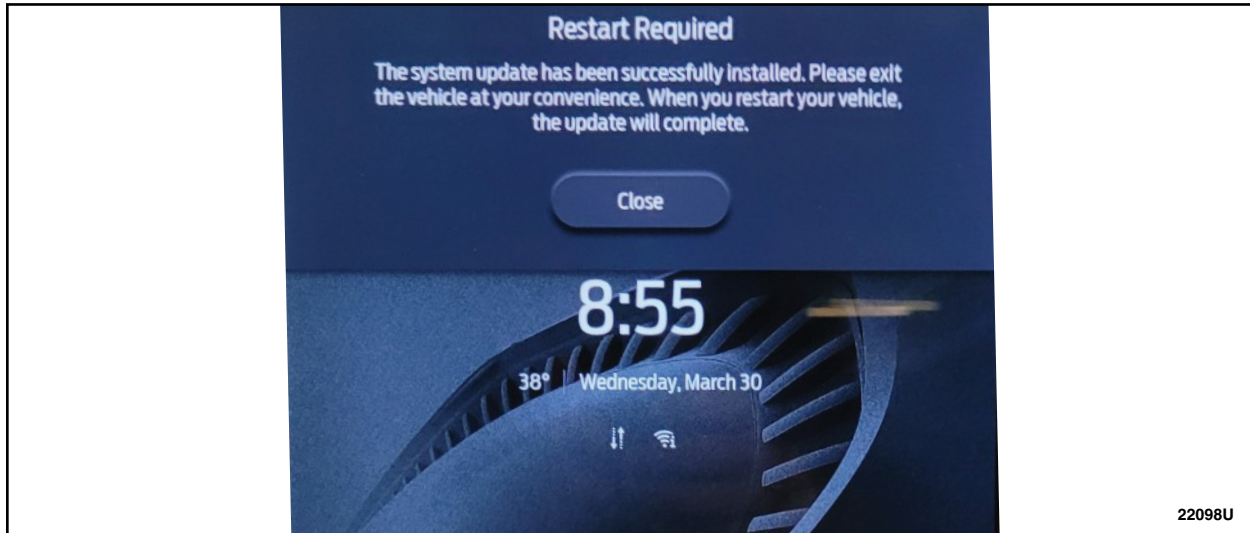
FIGURE 19

NEW ! 20. Turn off the vehicle and open and close the driver's door. See Figure 19.

NOTE: You may receive a question regarding the alarm system. Click yes or no as appropriate.

NEW ! NOTE: Mach-E shown Expedition, Navigator and F-150 vehicles similar.
