# Service Bulletin

Bulletin No.: 22-NA-201

**Subject:** MIL L5P ECM/TCM Update with DTCs Set

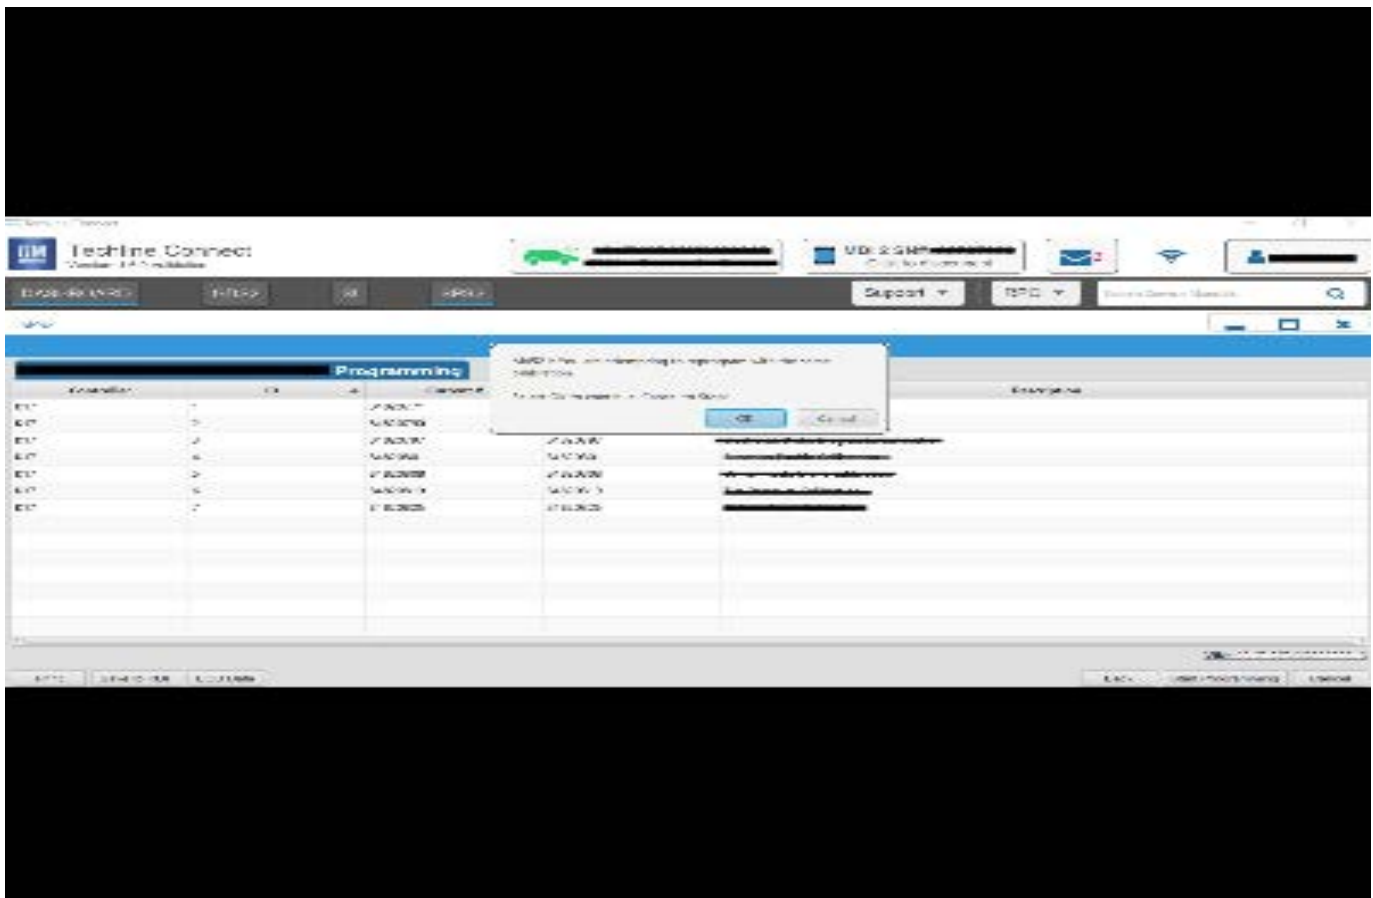
5644477

**Important:** Techline Connect and TIS2WEB screens shown above.
