Subject: N222378350 - Customer Satisfaction Program  
Power Take Off Unwanted Disengagement

Models: 2019 – 2021 Chevrolet Silverado 4500HD/5500HD/6500HD  
Equipped with Power Take Off (RPO PTO)

# Customer Satisfaction Program

## N222378350 Power Take Off Unwanted Disengagement

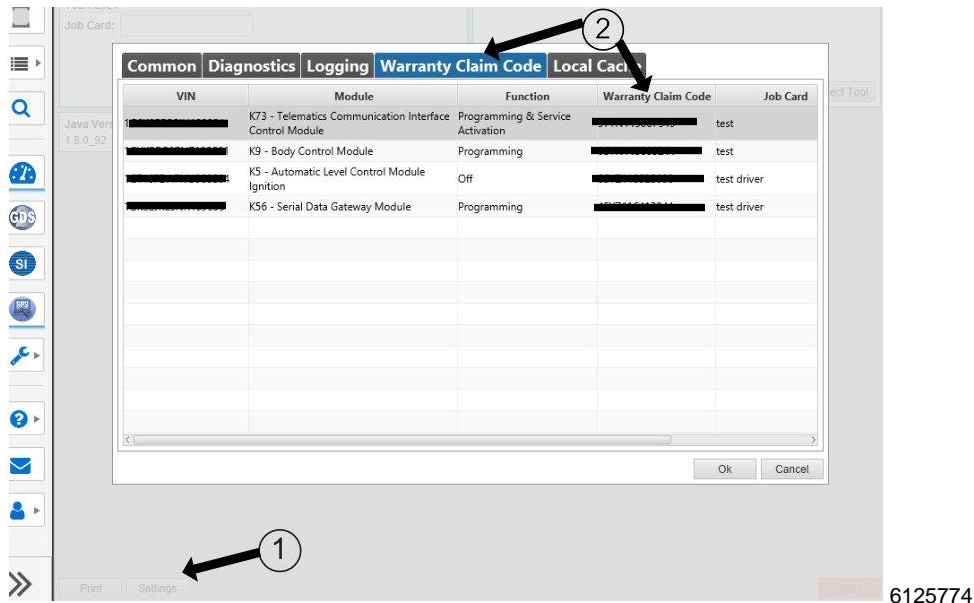
### Warranty Claim Code Information Retrieval

1. Open TLC on the computer used to program the vehicle.
2. Select and start SPS2.
3. Select Settings (1).
4. Select the Warranty Claim Code tab (2).

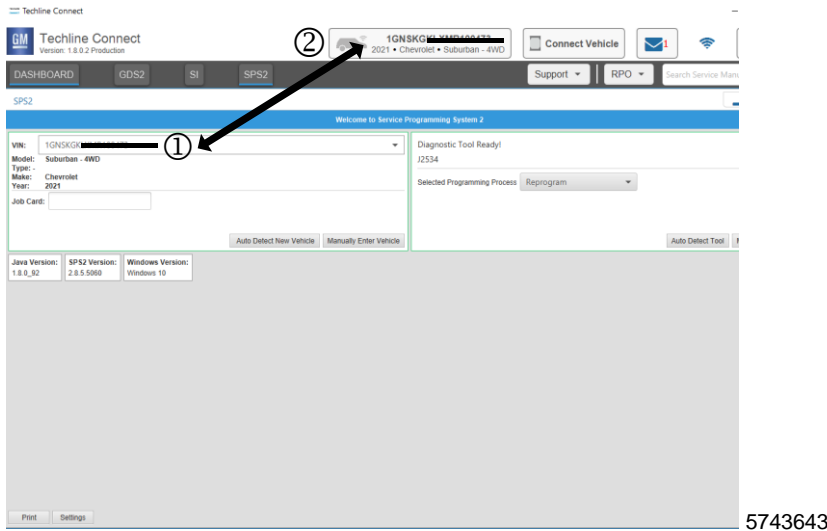
**Caution:** Be sure the VIN selected in the drop down menu (1) is the same as the vehicle connected (2) before beginning programming.

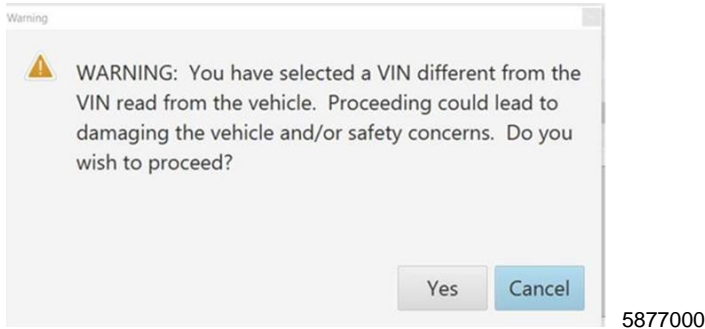
**Important:** If the vehicle VIN DOES NOT match, the message below will be shown.

**Important:** Techline Connect screens shown above.

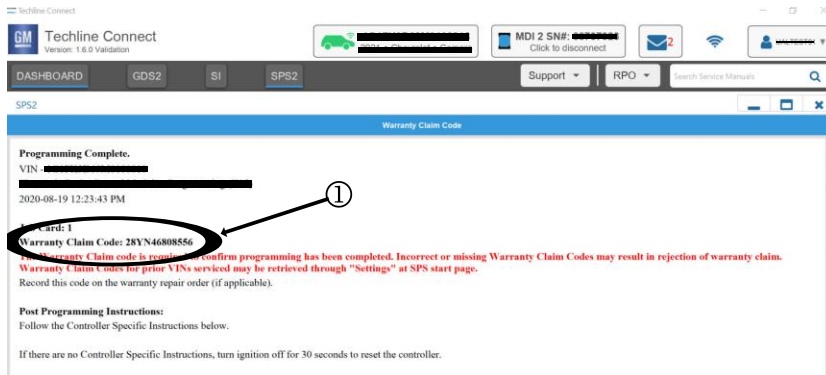
5644478

1. Reprogram the Engine Control Module. Refer to *K20 Engine Control Module: Programming and Setup* in SI.

**Note:** The screenshot above is an example of module programming and may not be indicative of the specific module that is being programmed. Module selection and VIN information have been blacked out.
