Service Bulletin

Bulletin No.: 22-NA-188

Subject: MAF Sensor Calibration Update – DTCs P227C and P10BC Set After ECM Replacement

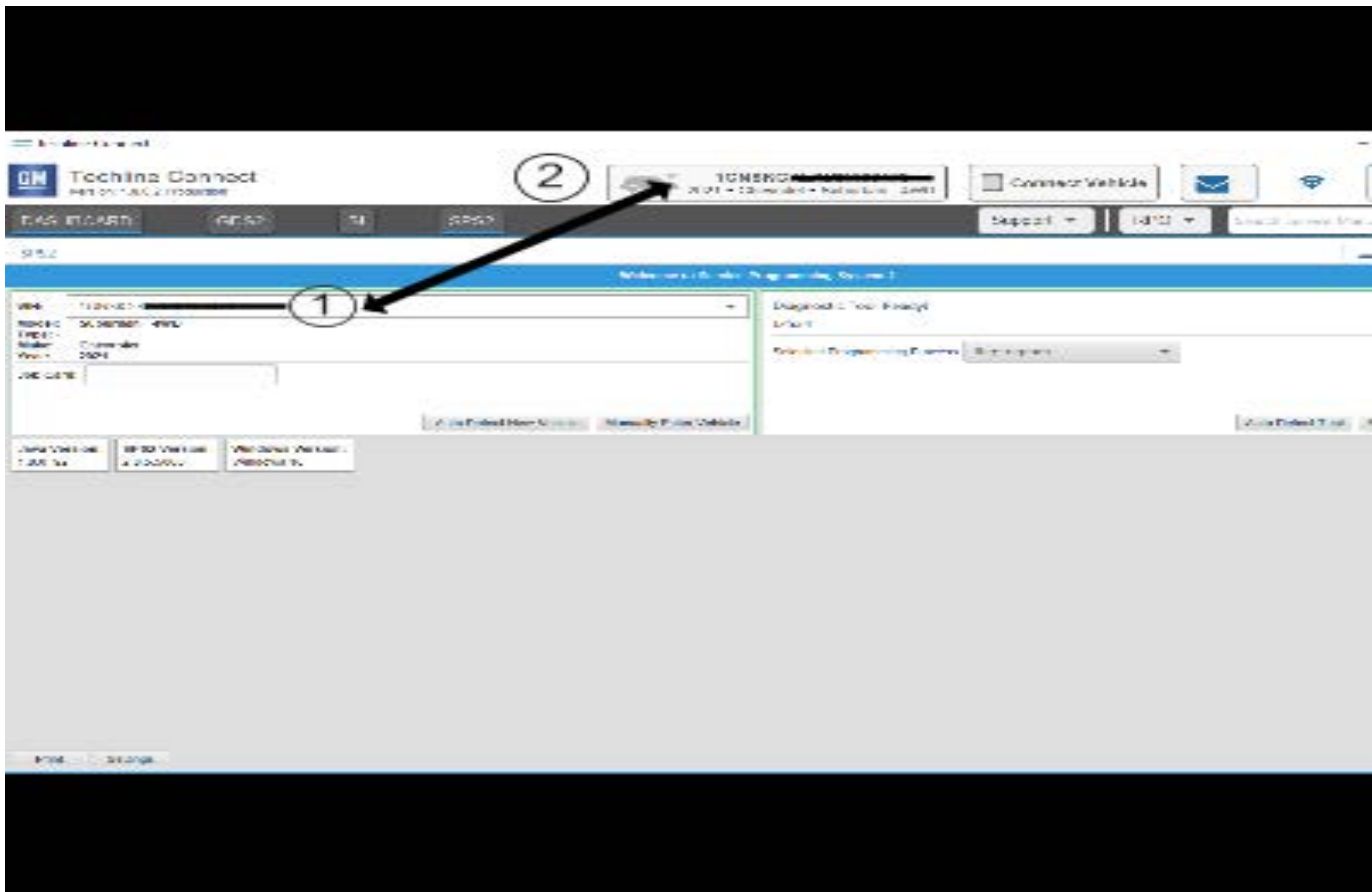
Caution: Be sure the VIN selected in the drop down menu (1) is the same as the vehicle connected (2) before beginning programming.
