# Service Bulletin

Bulletin No.: 21-NA-171

**Subject: Information on Body Control Module Programming due to Window Motor Changes Related to Microprocessor Shortage**

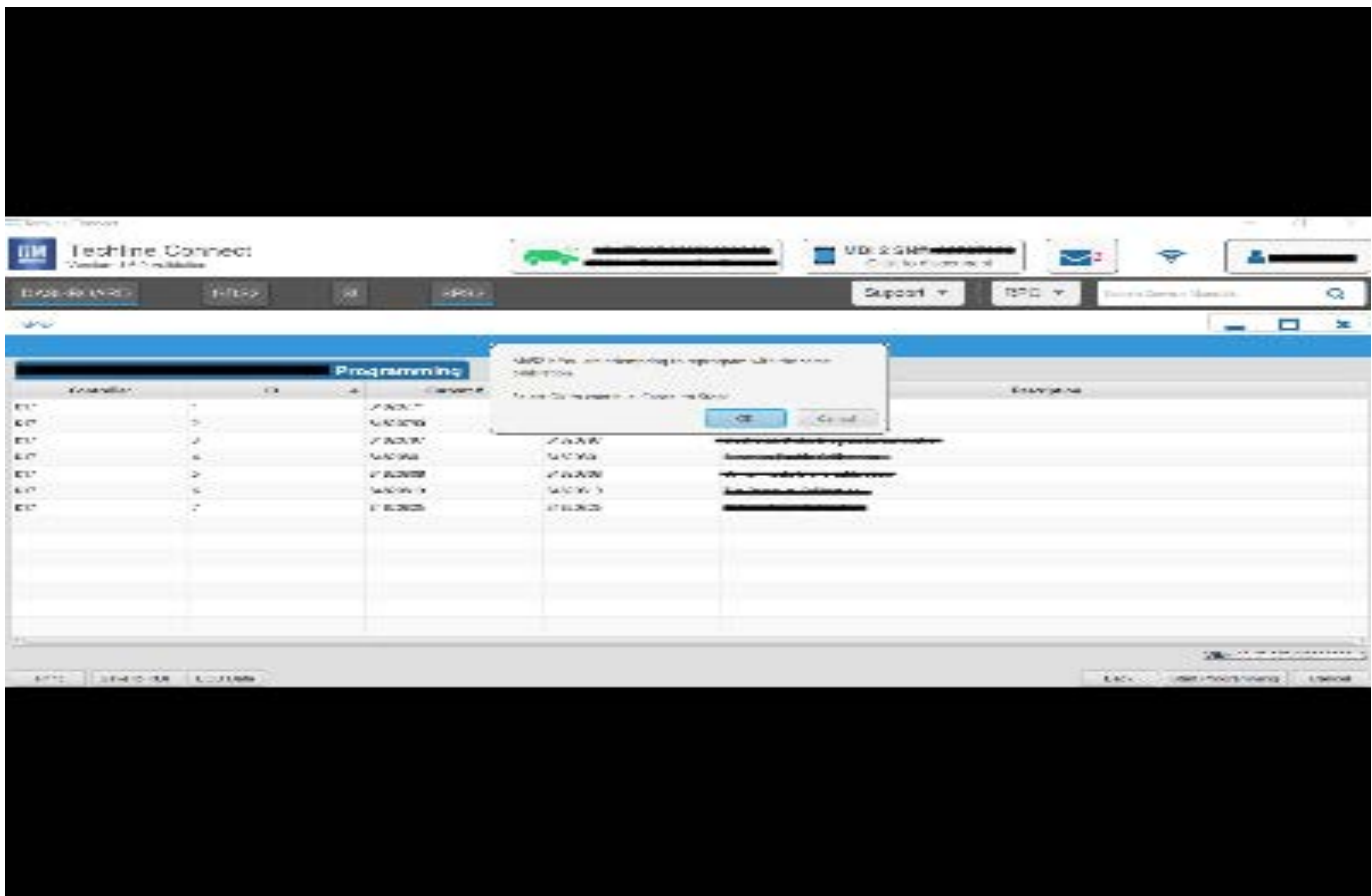
5644477

**Important:** Techline Connect and TIS2WEB screens shown above.

**Important:** If the same calibration/software warning is noted on the TLC or SPS Summary screen, select OK and follow screen instructions. After a successful programming event, the WCC is located in the Service

Programming System dialogue box of the SPS Summary screen. No further action is required. Refer to the Warranty section of the bulletin.
