**NUMBER:** 08-160-22 REV. B

Radio Over The Air R141.01.12, 139.01.53, 136.10.04 to R145.00.15 Software Version Updates

This bulletin provides information regarding the latest Firmware Over The Air (FOTA) update and provides the service technician an overview of the steps a customer will need to take to complete the update. The radio software will be updated from R141.01.12, 139.01.53, 136.10.04 to R145.00.15.

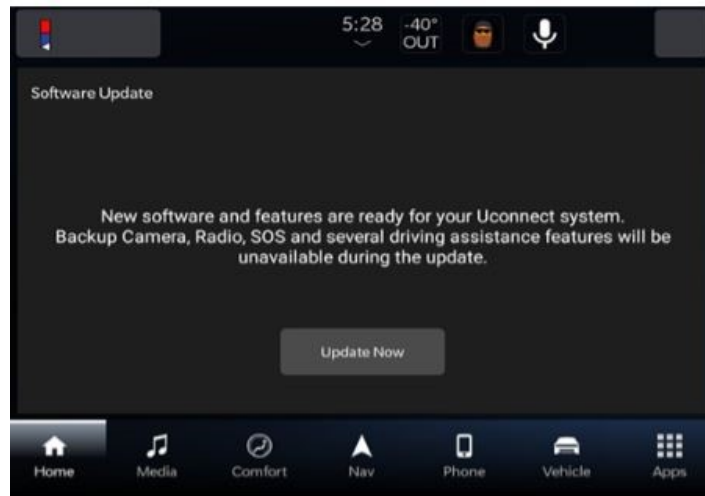
**Fig. 1**  
**Software Acceptance Screen**

1. The vehicle needs to be in 'park'. The ignition needs to be in the off position.
2. If the customer selects "Update Now" they can shut off the vehicle and leave. The update will be completed automatically.

Vehicles sold in the U.S. and Canada can now receive software updates "over-the-air". Updates to software will occur in a phased roll-out. The software is updated through the built-in cellular modem in the radio. Customers will see a notification on their radio screen when new software is available for their radio (Fig. 1) . The owner will have the option to update the radio or schedule the update for later. There is not an option to decline the update indefinitely, the update must be performed.

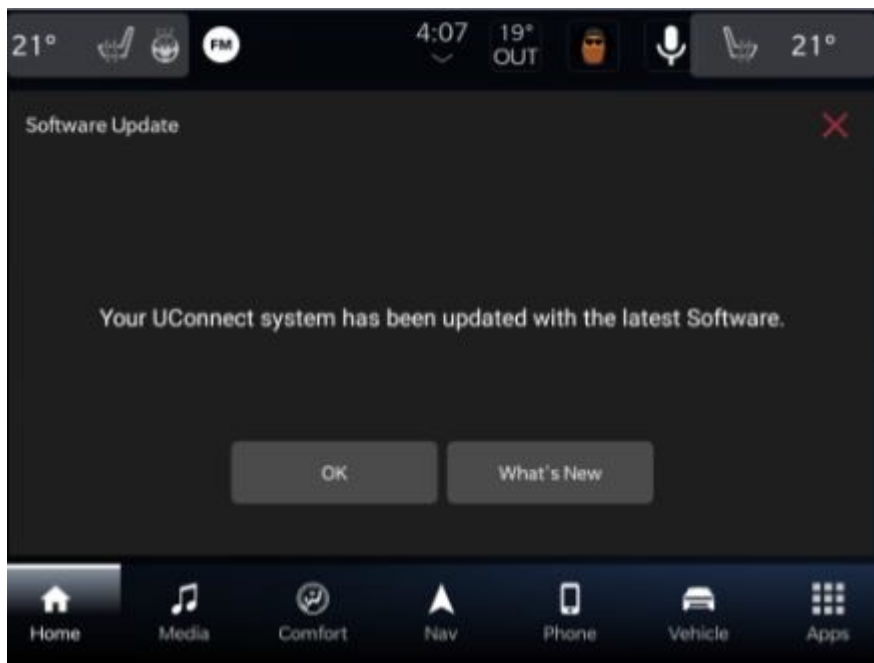
**Fig. 2**  
**Software Update Confirmation Screen**

3. Upon completion of update, the radio will display a confirmation message ([Fig. 2](#)) .
