TECHNICAL SERVICE BULLETIN

Classification: AN22-015A	Reference: NTB22-047A	Date: October 13, 2022
------------------------------	--------------------------	---------------------------

SOFTWARE UPDATE FOR INFOTAINMENT ISSUES

APPLIED VEHICLES: 2020-2022 Titan/Titan XD (A61)

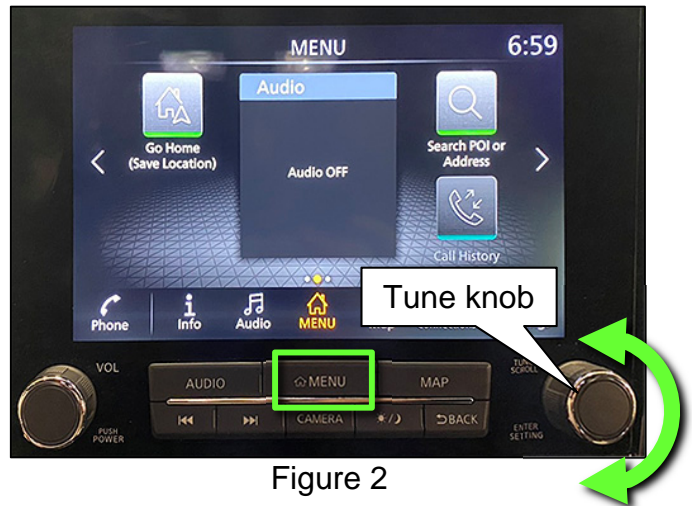
Figure 2

1. While holding the **MENU** button down, turn the tune knob left-right-left.

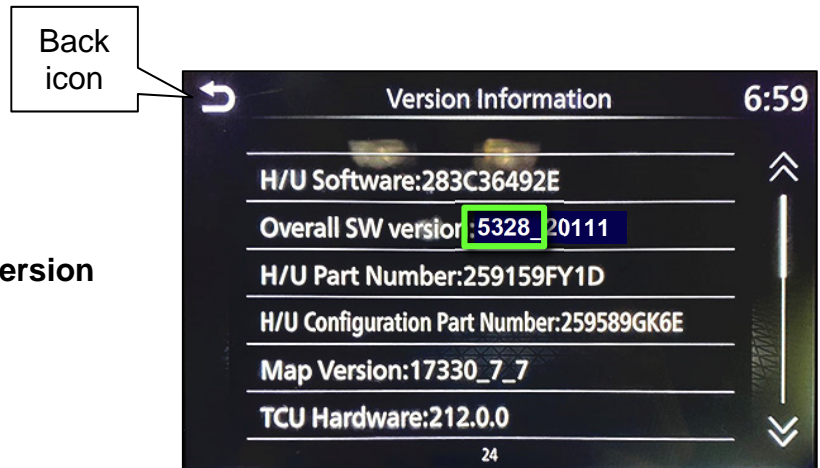
Figure 5

4. Confirm if the **Overall SW version** begins with "5328".

- If the **Overall SW version** begins with "5328", this bulletin does not apply. Select the back icon, and then proceed to **CLAIMS INFORMATION**.
- If the **Overall SW version** does not begin with "5328", select the back icon and then continue to step 5 on page 5.

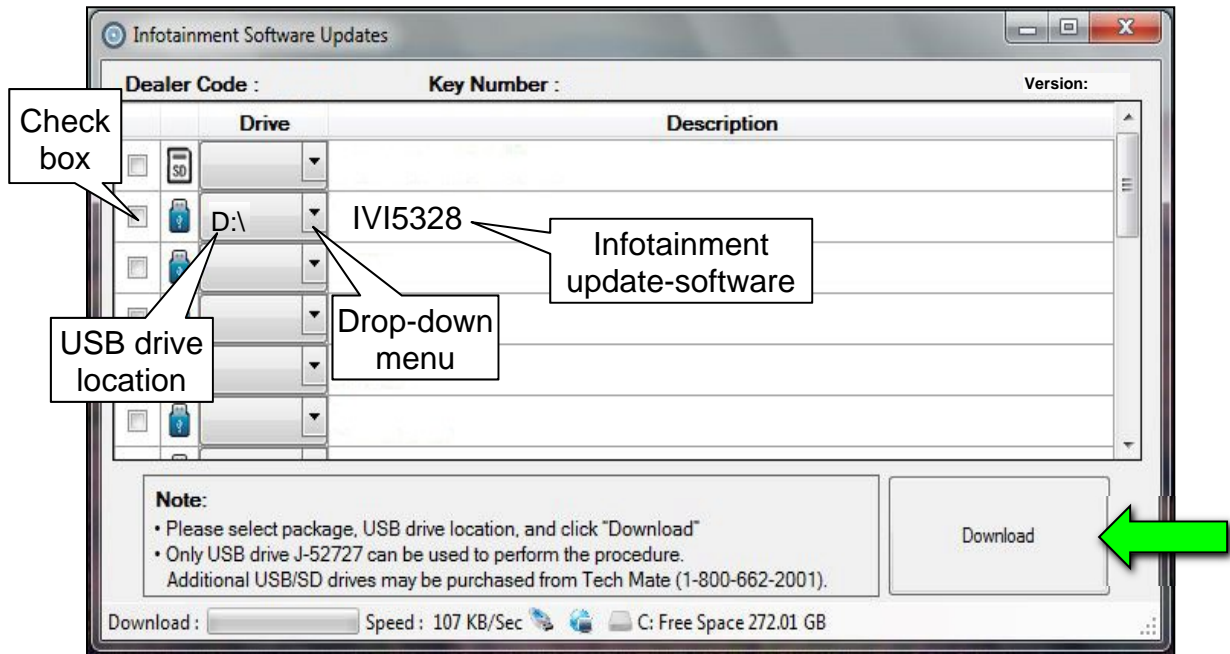
Figure 7

8. Select the check box next to infotainment update-software "IVI5328" (Figure 7).
9. Use the drop-down menu and select the location of the USB drive that was inserted in step 5.

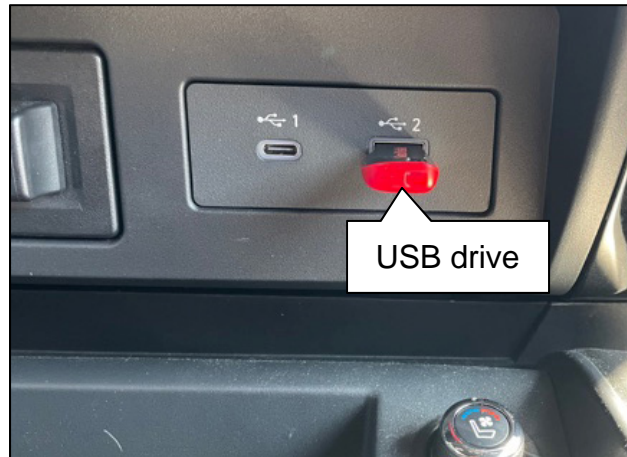
Figure 11

16. Insert the USB drive with the infotainment update-software into the vehicle's USB media port (Figure 11).
- Do not remove the USB drive during the update to the vehicle until instructed to.

Do not insert the USB drive into a charging port. If used, the update-software and/or USB drive may become damaged. Only insert the USB drive in a USB media port.

HINT: Charging ports are marked in the vehicle with a “lightning bolt” symbol.

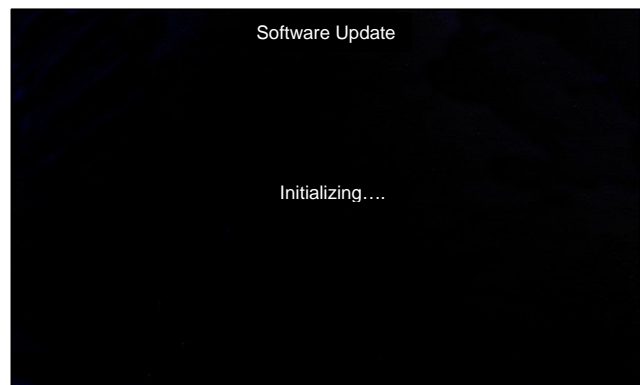
17. Wait approximately 10-30 seconds for the screen in Figure 12 to appear.

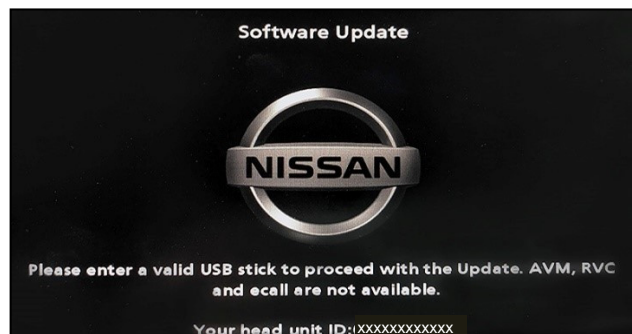
- The screen in Figure 13 may briefly appear. **Do not remove the USB drive.** The audio system will detect the USB drive and continue the update.

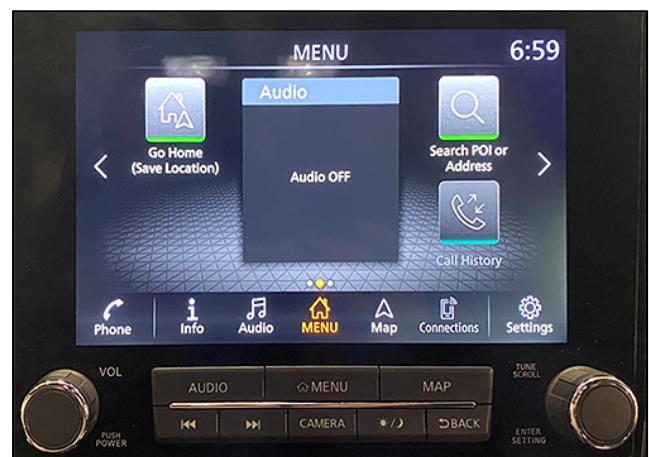
25. After the Nissan logo appears, wait about 1 minute.
 - The **MENU** (Home) screen in Figure 17 will be displayed.
